# University of Washington

Historic Resources Addendum

Magnuson Health Sciences Center and Certain Additions

Roof Replacement Projects

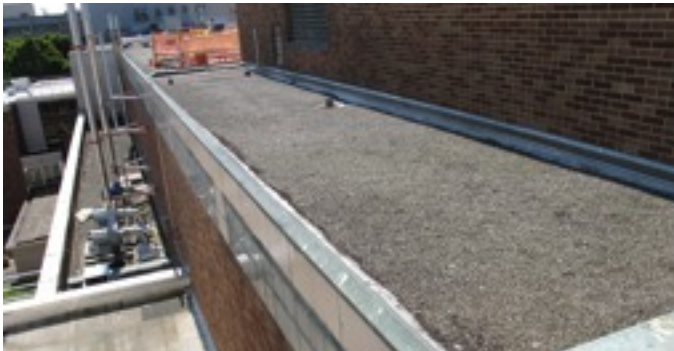
Roof C1 and C2 with high parapet conditions on the left and roof D4 with a gravel stop.

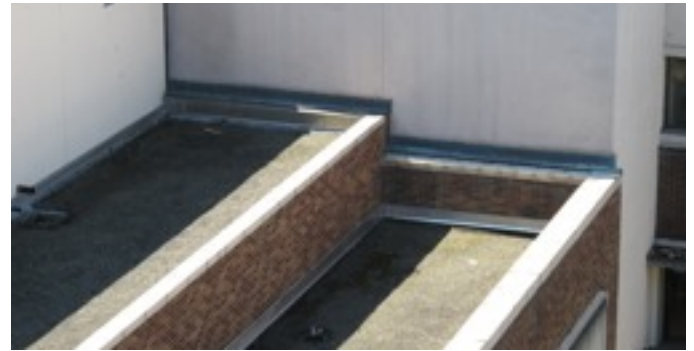
Roof F7 on the left with a low parapet is not visible from below, and F8 has a high parapet.

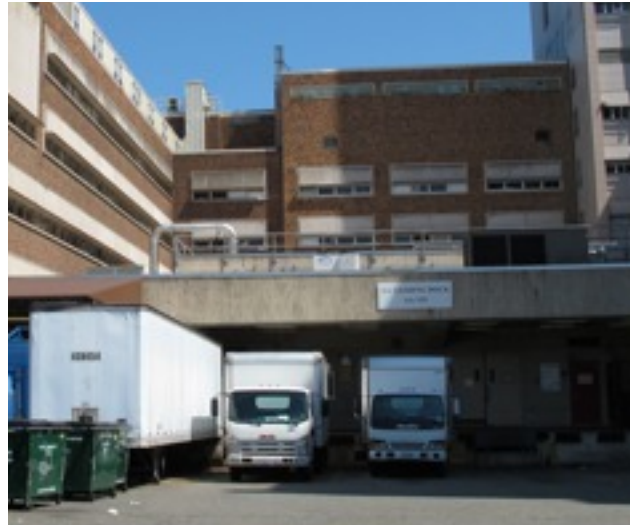
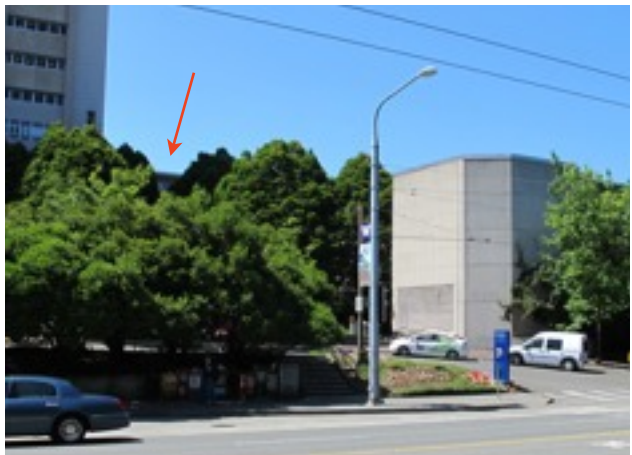
The existing roof edge has a painted galvanized metal gravel stop over the brick veneer exterior wall below. Much of the paint has flaked off the vertical surface of the gravel stop, which is about 12 inches tall. The existing brick exterior wall is a standard sized tapestry face brick with colors varying from a tan/ocher to a brick red to a dark brown. The roof is a built-up hot-mop tar and felt with gravel ballast. The façade-to-roof AA transition is only visible over the AA loading dock at NE Columbia Road and from the windows of the adjacent buildings including wings B and RR as well as the UW Medical Center 'Aagaard' tower to the Southeast (previously BB wing). It was once visible from Pacific Street NE but the trees have grown and completely obscure the view.

AA wing seen from NE Columbia Rd.

AA wing seen from NE Pacific St.

In order to raise the exterior wall approximately 18 inches for the roofing improvements, the added exterior wall area should be compatible with the original tapestry brick. An exact match is not expected. An appropriate solution would be to extend the existing brick veneer wall with new tapestry brick capped with a copper cap flashing similar in color and material to the adjacent portions of the building creating a parapet. The difference between the existing original brick and the new brick along with a brick end course separating them, should provide adequate differentiation between old and new while the similar color and finish should allow the added height to blend with the original building.

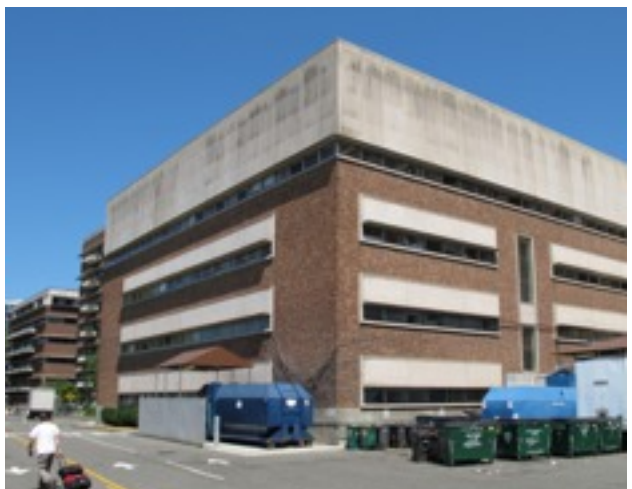
The existing roof edge has a painted galvanized metal cap flashing and gravel stop over a precast concrete wall cap above the vertically extended precast concrete window treatment. The precast concrete appears to have an integral color and is currently unpainted. The roof is a built up hot mop tar and felt membrane with gravel ballast. The façade-to-roof transition is visible primarily from NE Columbia Road and from the windows of the adjacent buildings including the UW Medical Center 'Aagaard' tower to the Southeast and wings AA, RR, C and D.

B wing seen from NE Columbia Rd.

In order to raise the exterior wall approximately 14 inches for the roofing improvements the added exterior wall area should coordinate with the existing concrete façade treatment. An appropriate solution would be to have the new extension be a painted stainless steel clad parapet creating a horizontal element at the top of the building consistent with the vocabulary of the building. The horizontal orientation of the extended parapet will provide adequate differentiation between new and existing while blending with the vocabulary of the façade.

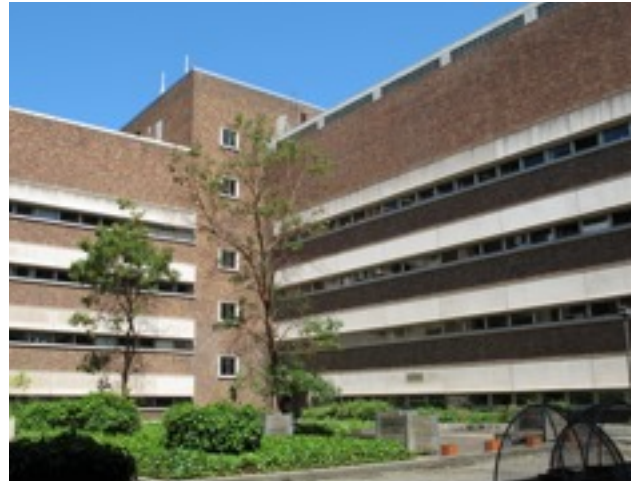
The existing roof edges have copper cap flashing gravel stops over a glazed terra cotta veneer exterior wall below. The copper has attained a natural green patina, and extends about two inches down on the exterior face of the wall and slopes up and back towards the roof at about a 45 degree angle. The terra cotta band runs horizontally forming a visual 'cornice' at the top of the building. In some locations glass blocks make up sections of the band, though they never extend through the top row of terra cotta. The roof is a built-up hot-mop tar and felt membrane with gravel ballast. The façade-to-roof transition is visible primarily from NE Columbia Road looking between B, D, and F wings, from the windows of the adjacent buildings including the UW Medical Center 'Aagaard' tower to the Southeast, as well as from the courtyard created by A, C, D, and T wings (the original main entry to the complex)

C wing seen from the B, C, and D wing courtyard

In order to raise the exterior wall approximately 17 inches to create a parapet, the added height should be materially compatible with the existing building materials. An appropriate solution is to extend the height with a stepped back parapet clad in copper. The change in plane from the existing brick wall to the stepped back parapet should provide adequate differentiation between old and new while minimizing the visual impact of the added height.

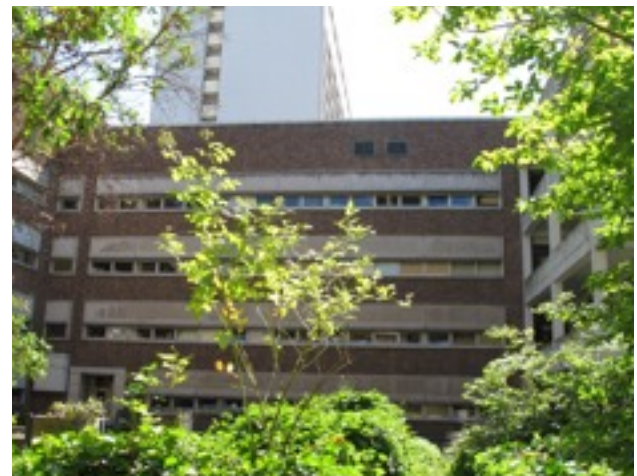
The existing roof parapet has a glazed terra cotta cap on copper through flashing over the brick veneer exterior wall below. The copper has attained a natural green patina, projects and extends only about one quarter inch down on the exterior face of the wall, and extends down about four inches on the interior face of the parapet. The top of the parapet is about sixteen inches above the top of the existing roofing. The existing brick exterior wall is a standard sized tapestry face brick with colors varying from a tan/ocher to a brick red to a dark brown. The roof is a built-up hot-mop tar and felt membrane with gravel ballast. The façade-to-roof transition is only visible from the courtyard created by B, C, and D wings, which is itself a roof.

B wing seen from the B, C, and D wing courtyard

The existing glazed terra cotta capped parapet may only need to be extended approximately four inches to achieve the desired 8-inch curb. The existing terra cotta caps are already severely damaged and may be further damaged in removal and possible replacement. Therefore it may be more desirable to replace the terra cotta caps “in-kind” with matching terra cotta caps or a “faux” terra cotta material that has a similar visible appearance. The flashing should be copper. A metal stepped back condition will minimize the visual impact, while the replaced caps should integrate the added height with the building and maintain the horizontal stripe of the original parapet detail.

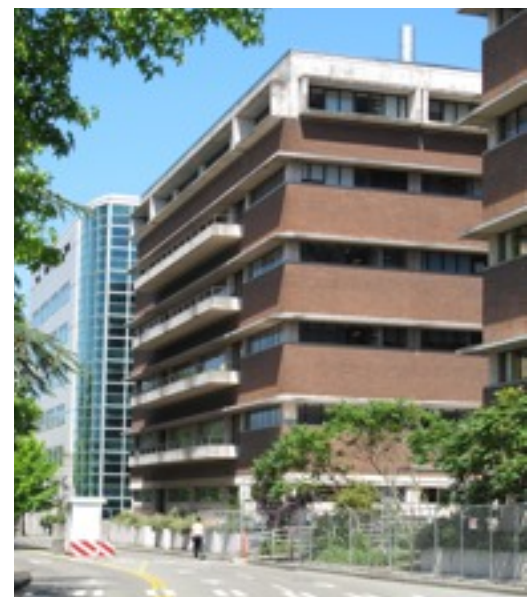
The existing roof parapet has a stainless steel cap flashing over the poured concrete parapet and exterior wall below. The metal cap flashing extends about six inches down on the exterior and interior faces of the parapet wall. The top of the parapet is about twelve inches above the top of the existing roofing. The existing poured concrete exterior wall appears to be painted and has a one inch horizontal reveal cast into it about nine inches below the cap flashing. The roof is a built-up hot-mop tar and felt membrane with gravel ballast. The façade-to-roof transition is visible from NE Columbia Road, the courtyards created by D, E, F, G, and H wings as well as the windows of the adjacent buildings.

F wing seen from NE Columbia Rd.

The existing roof parapet will likely need to be extended about six inches. This extension would appropriately be achieved with a stepped back stainless steel clad parapet, creating a horizontal element at the top of the building consistent with the aesthetic vocabulary of the building. The stepped back extended parapet will provide adequate differentiation between new and existing while blending with the vocabulary of the original building.

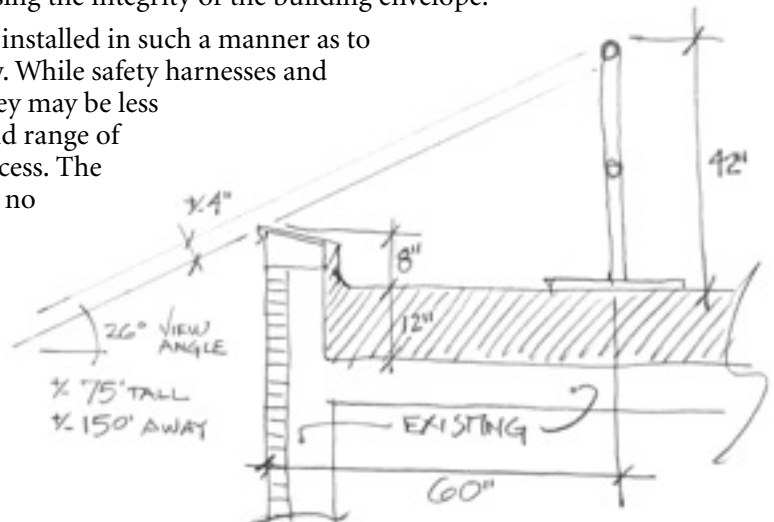
Visibility of safety rails from below at D5 & F4.

Any roof access safety rails or attachments should be installed in such a manner as to be useful and minimize the visual impact from below. While safety harnesses and attachment points do minimize the visual impact, they may be less practical than guard rails for worker ease of access and range of activity and amount of time required to allow safe access. The safety railing system should be of the variety that has no roof penetrations minimizing the possibility of future roof leaks. The existing metal safety rails on the roof of A wing are an example of rails set back from the roof edge minimizing the visual impact while providing safe roof access. A 42-inch high guardrail should be set back from the edge about 60 inches to minimize visibility from below while still allowing adequate access to the majority of the roof area.

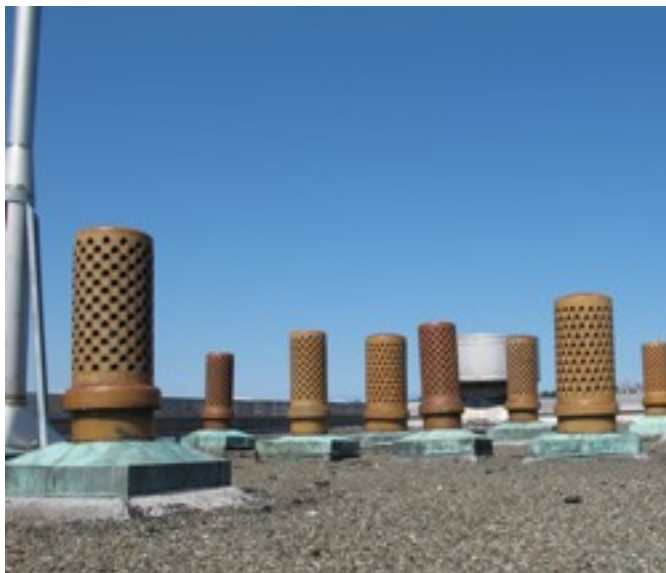
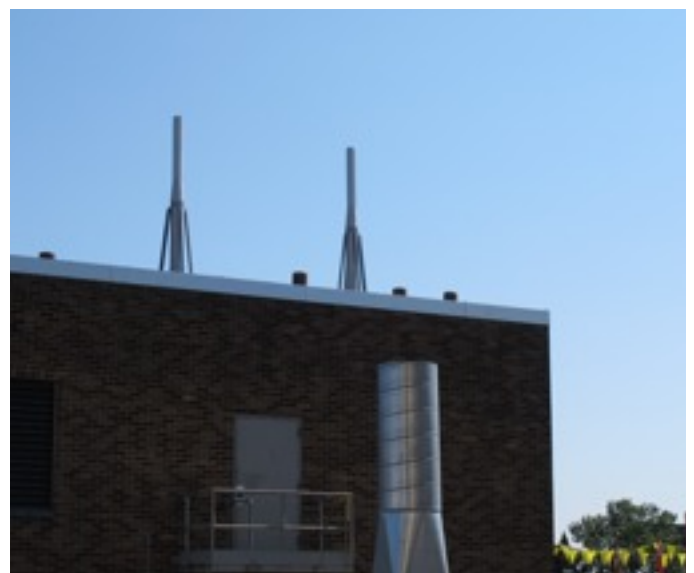
There are numerous existing vents on the roof that will need to be raised to accommodate the improvements to the roof. Current code will require those vents to be significantly taller than they are currently, thus more visible. These vents are a normal part of laboratory and medical buildings. Therefore, while an effort should be made to keep the vents back from the roof edges, their visibility from below will be difficult to avoid. The nature of the vents, tall stainless steel pipes, will make them readily identifiable as non-original and they are also considered reversible so that in the future the buildings could easily be brought back to their original condition. Primarily on roof D5, see scope diagram on page 6 for location.

Existing vents on D5, notice the new vent at left.

New and old vents on D5 visible from an adjacent roof.

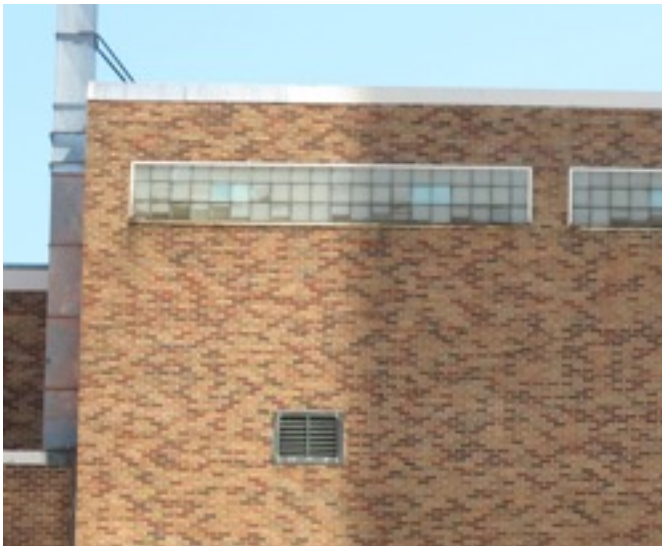
Existing façade-to-roof condition at roof AA.

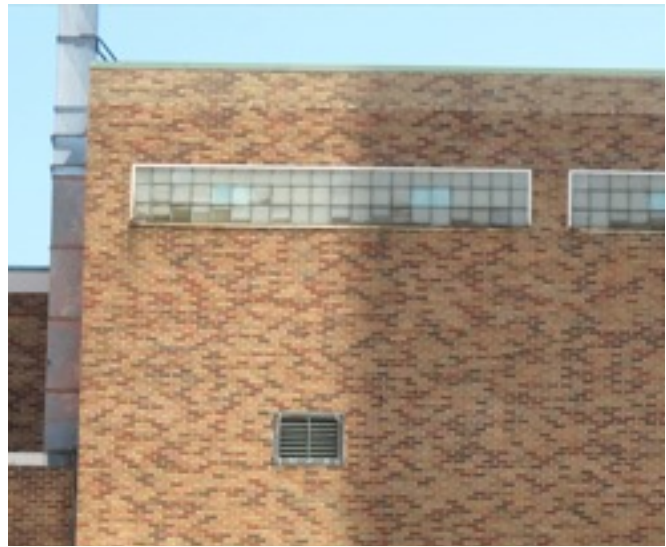
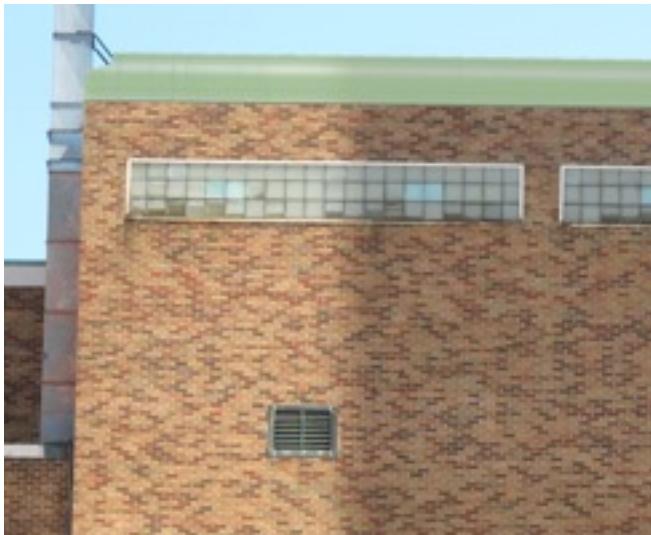
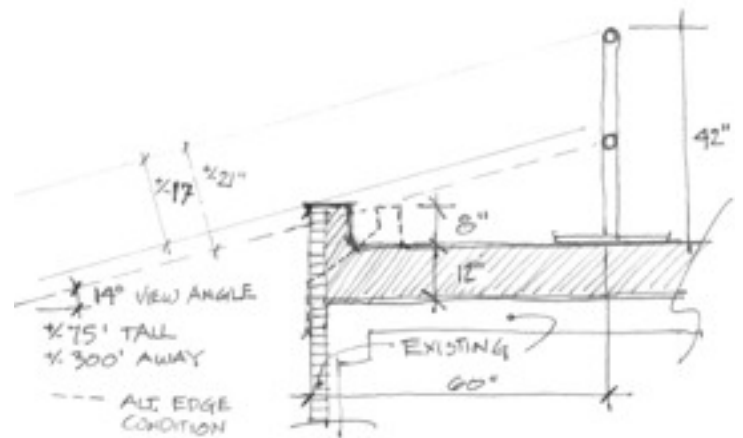
Recommended façade-to-roof condition at roof AA.

Recommended alternative façade-to-roof condition at roof AA.

Façade-to-roof conditions and guardrail sight-lines.

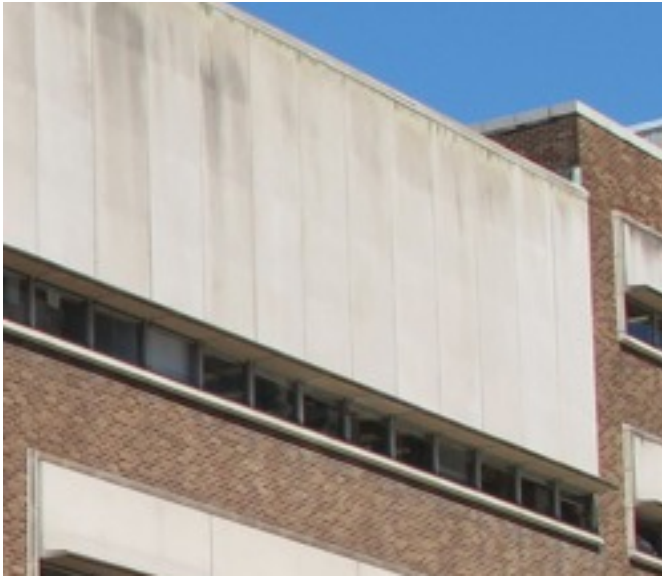
Existing façade-to-roof condition at roof B6.

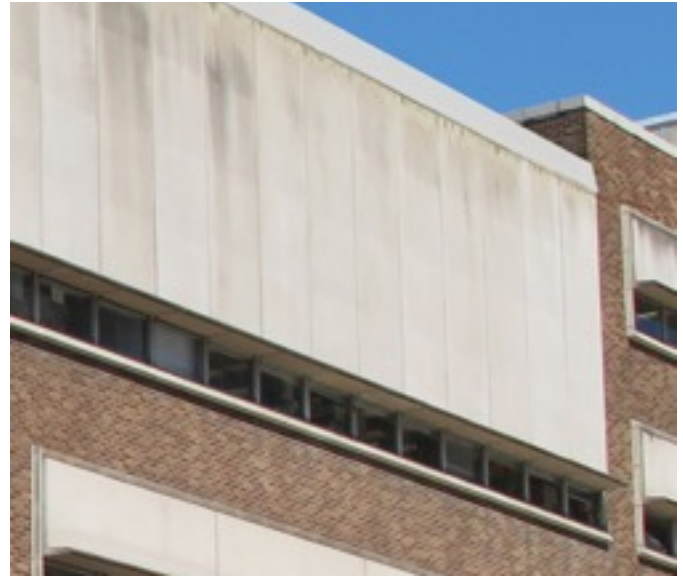
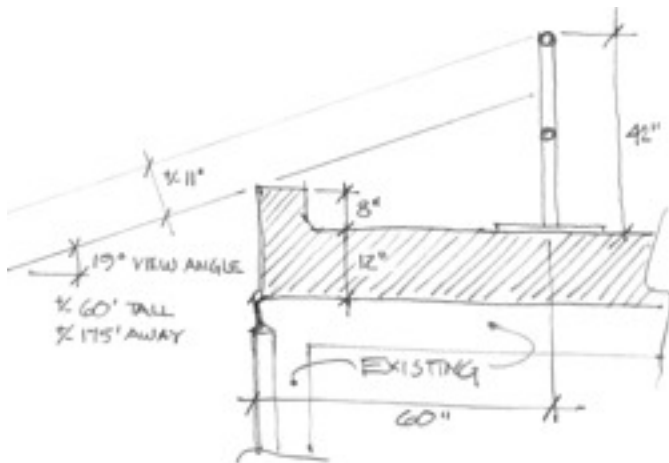
Recommended façade-to-roof condition at roof B6.

Façade-to-roof condition and guardrail sight-lines.

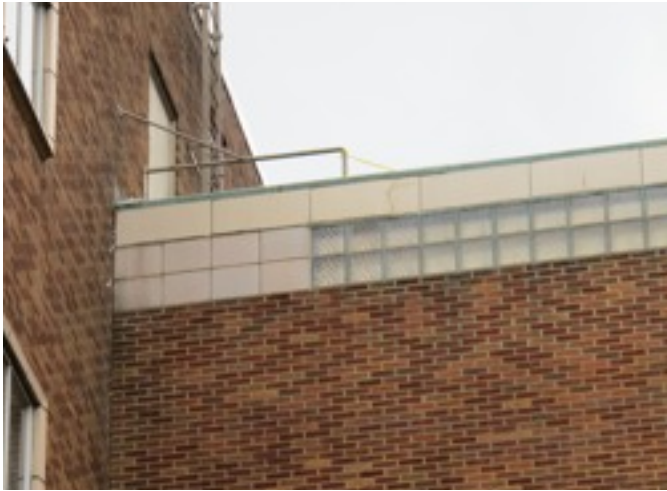
Existing façade-to-roof condition at roof C4.

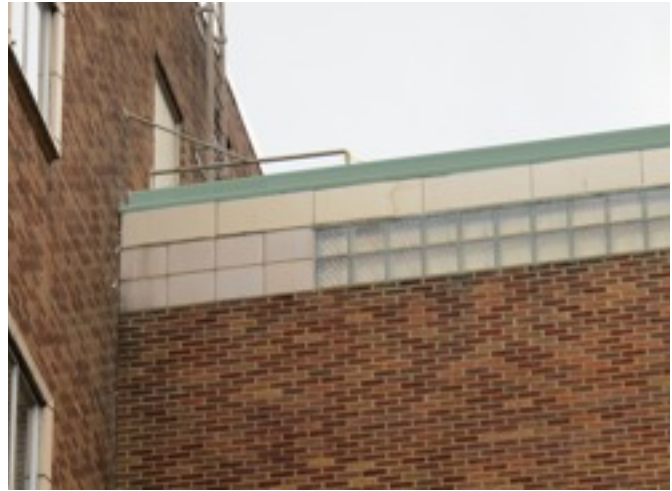
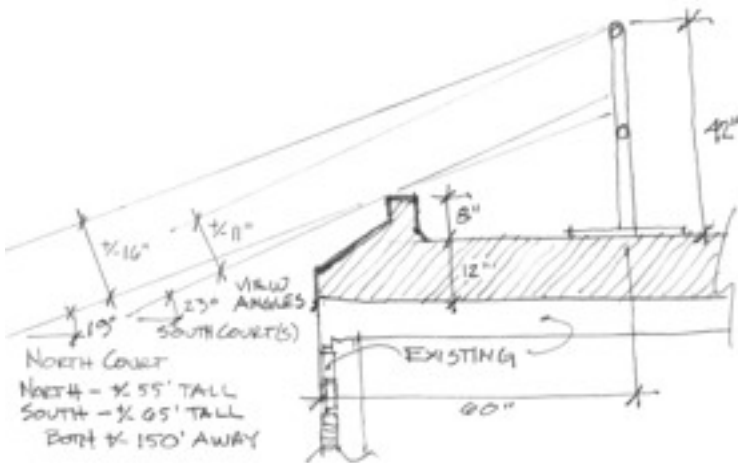
Recommended façade-to-roof condition at roof C4, D4, and E2.

Façade-to-roof condition and guardrail sight-lines.

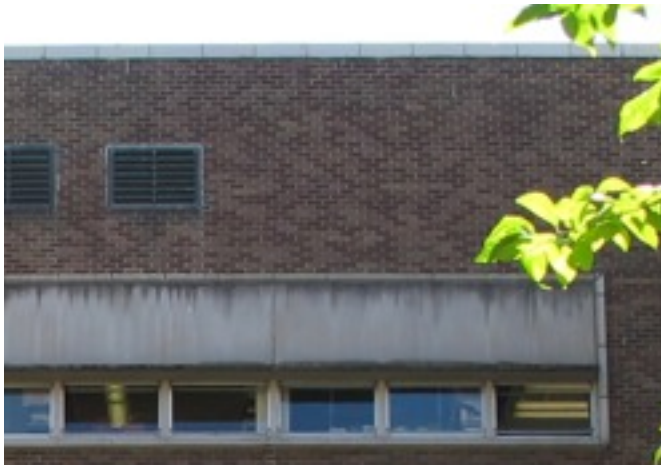
Existing façade-to-roof condition at roof B2.

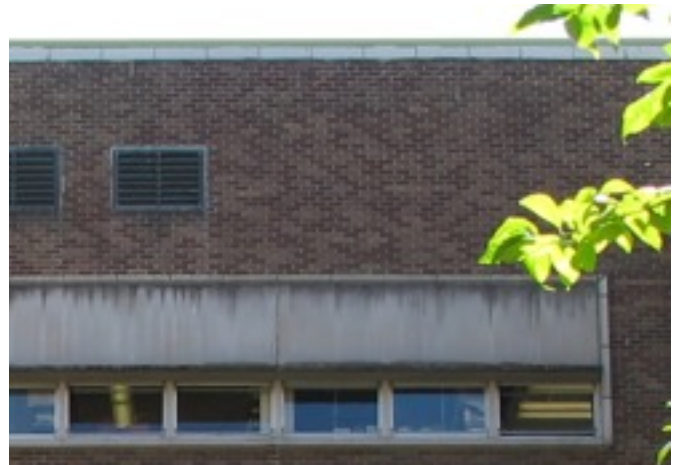
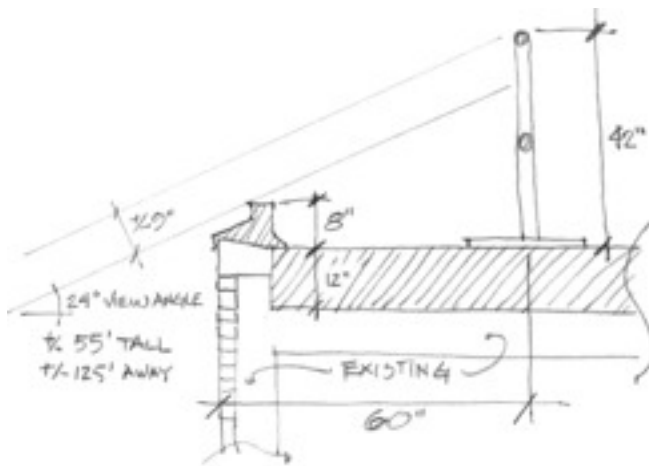
Recommended façade-to-roof condition at roof B2.

Façade-to-roof condition and guardrail sight-lines.

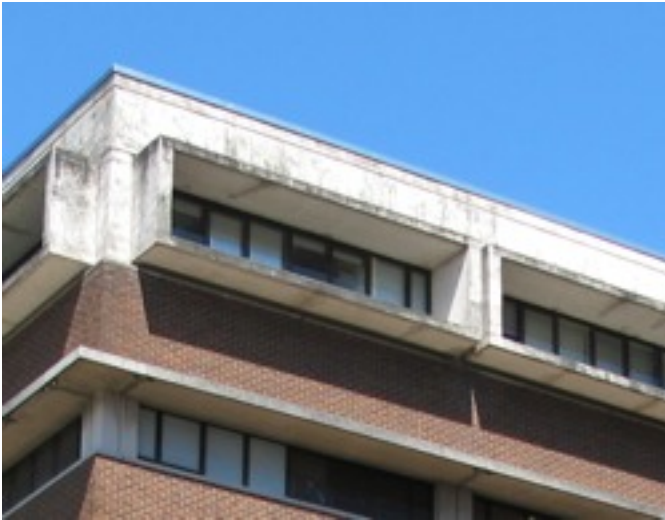
Existing façade-to-roof condition at roof F13.

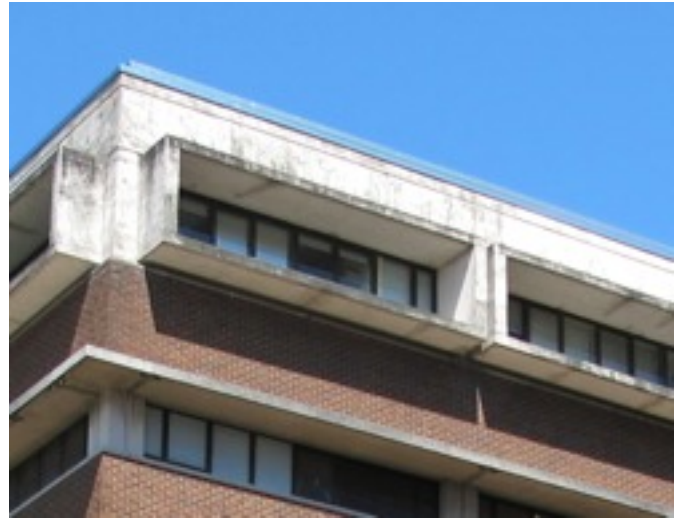
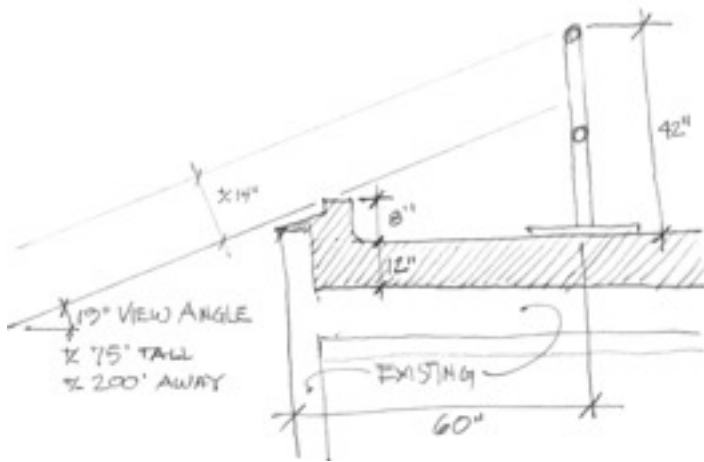
Recommended façade-to-roof condition at roof F13.

Façade-to-roof condition and guardrail sight-lines.
