**RE: SEPA Lead Agency
Husky Village Redevelopment
Building Permit # PRE2020-16957**

SEPA Consistency Memorandum for the Husky Village Redevelopment Project

The purpose of our geotechnical engineering services is to evaluate soil and groundwater conditions as a basis for developing design criteria for the geotechnical aspects of the proposed Husky Village Student Housing project. Our services were performed in general accordance with our proposal dated August 17, 2020 and subsequent Contract Amendment Nos. 1 and 2, dated August 25 and November 24, 2020.

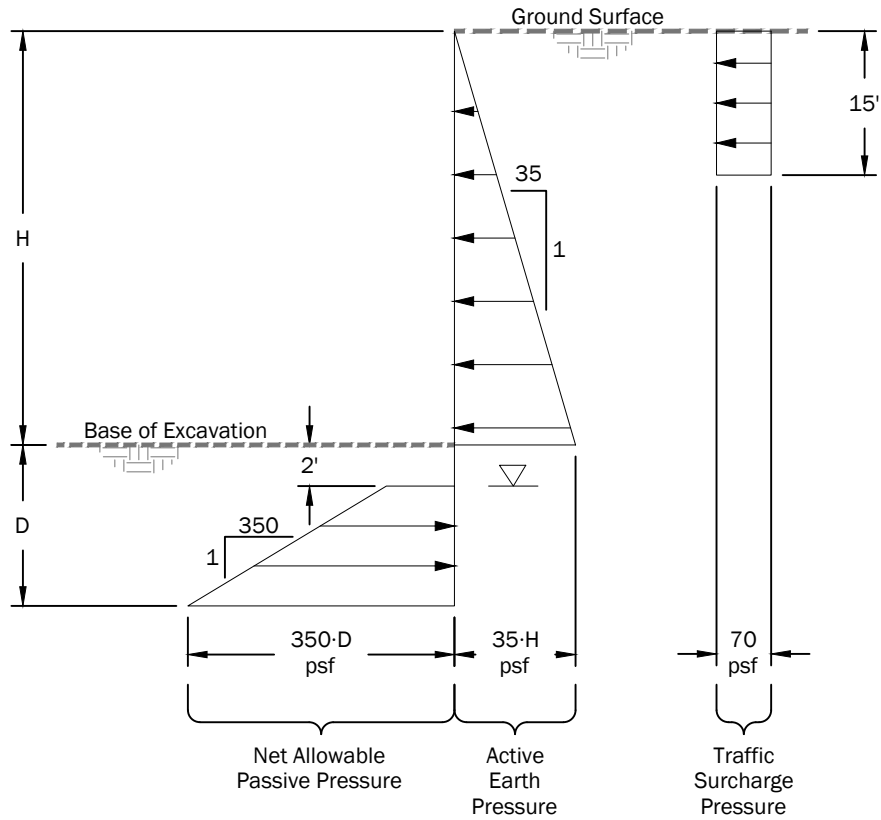
Cantilever Soldier Pile

Lateral Earth Pressure from Point Load, Q_p
(Spread Footing)

For $m \leq 0.4$ For $m > 0.4$ $\sigma_H = \sigma \cos^2 (1.1\theta)$

Lateral Earth Pressure from Line Load, Q_L
(Continuous Wall Footing)

Uniform Surcharges, q
(Floor Loads, Large Foundation Elements or Traffic Loads)

σ_H = Lateral Surcharge Pressure from Uniform Surcharge

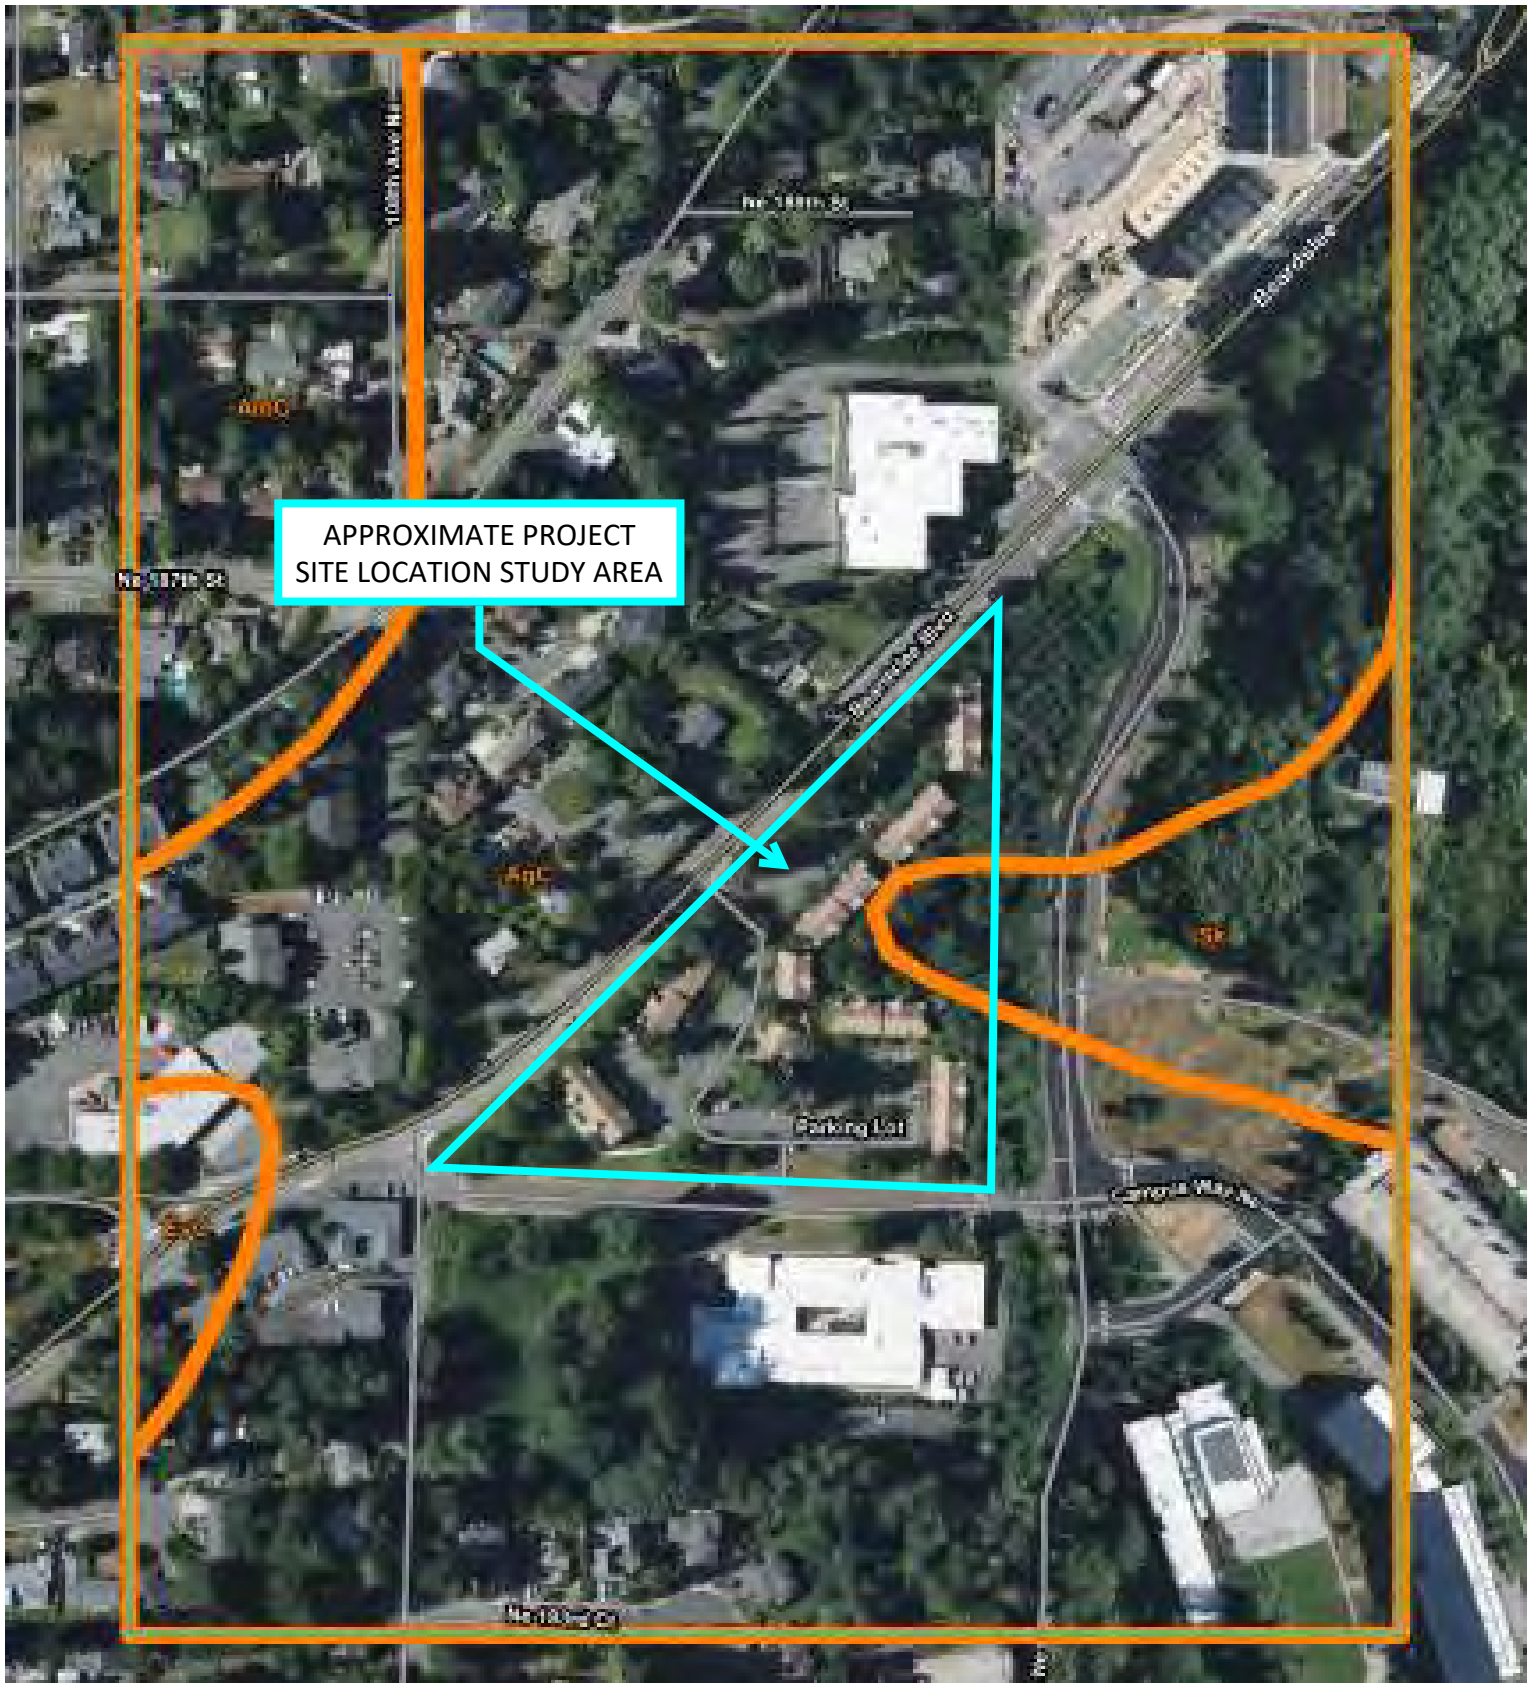
Map Unit Symbol	Map Unit Name
AgC	Alderwood gravelly sandy loam, 8 to 15 percent slopes
AmC	Arents, Alderwood material, 6 to 15 percent slopes
EvC	Everett very gravelly sandy loam, 8 to 15 percent slopes
Sk	Seattle muck

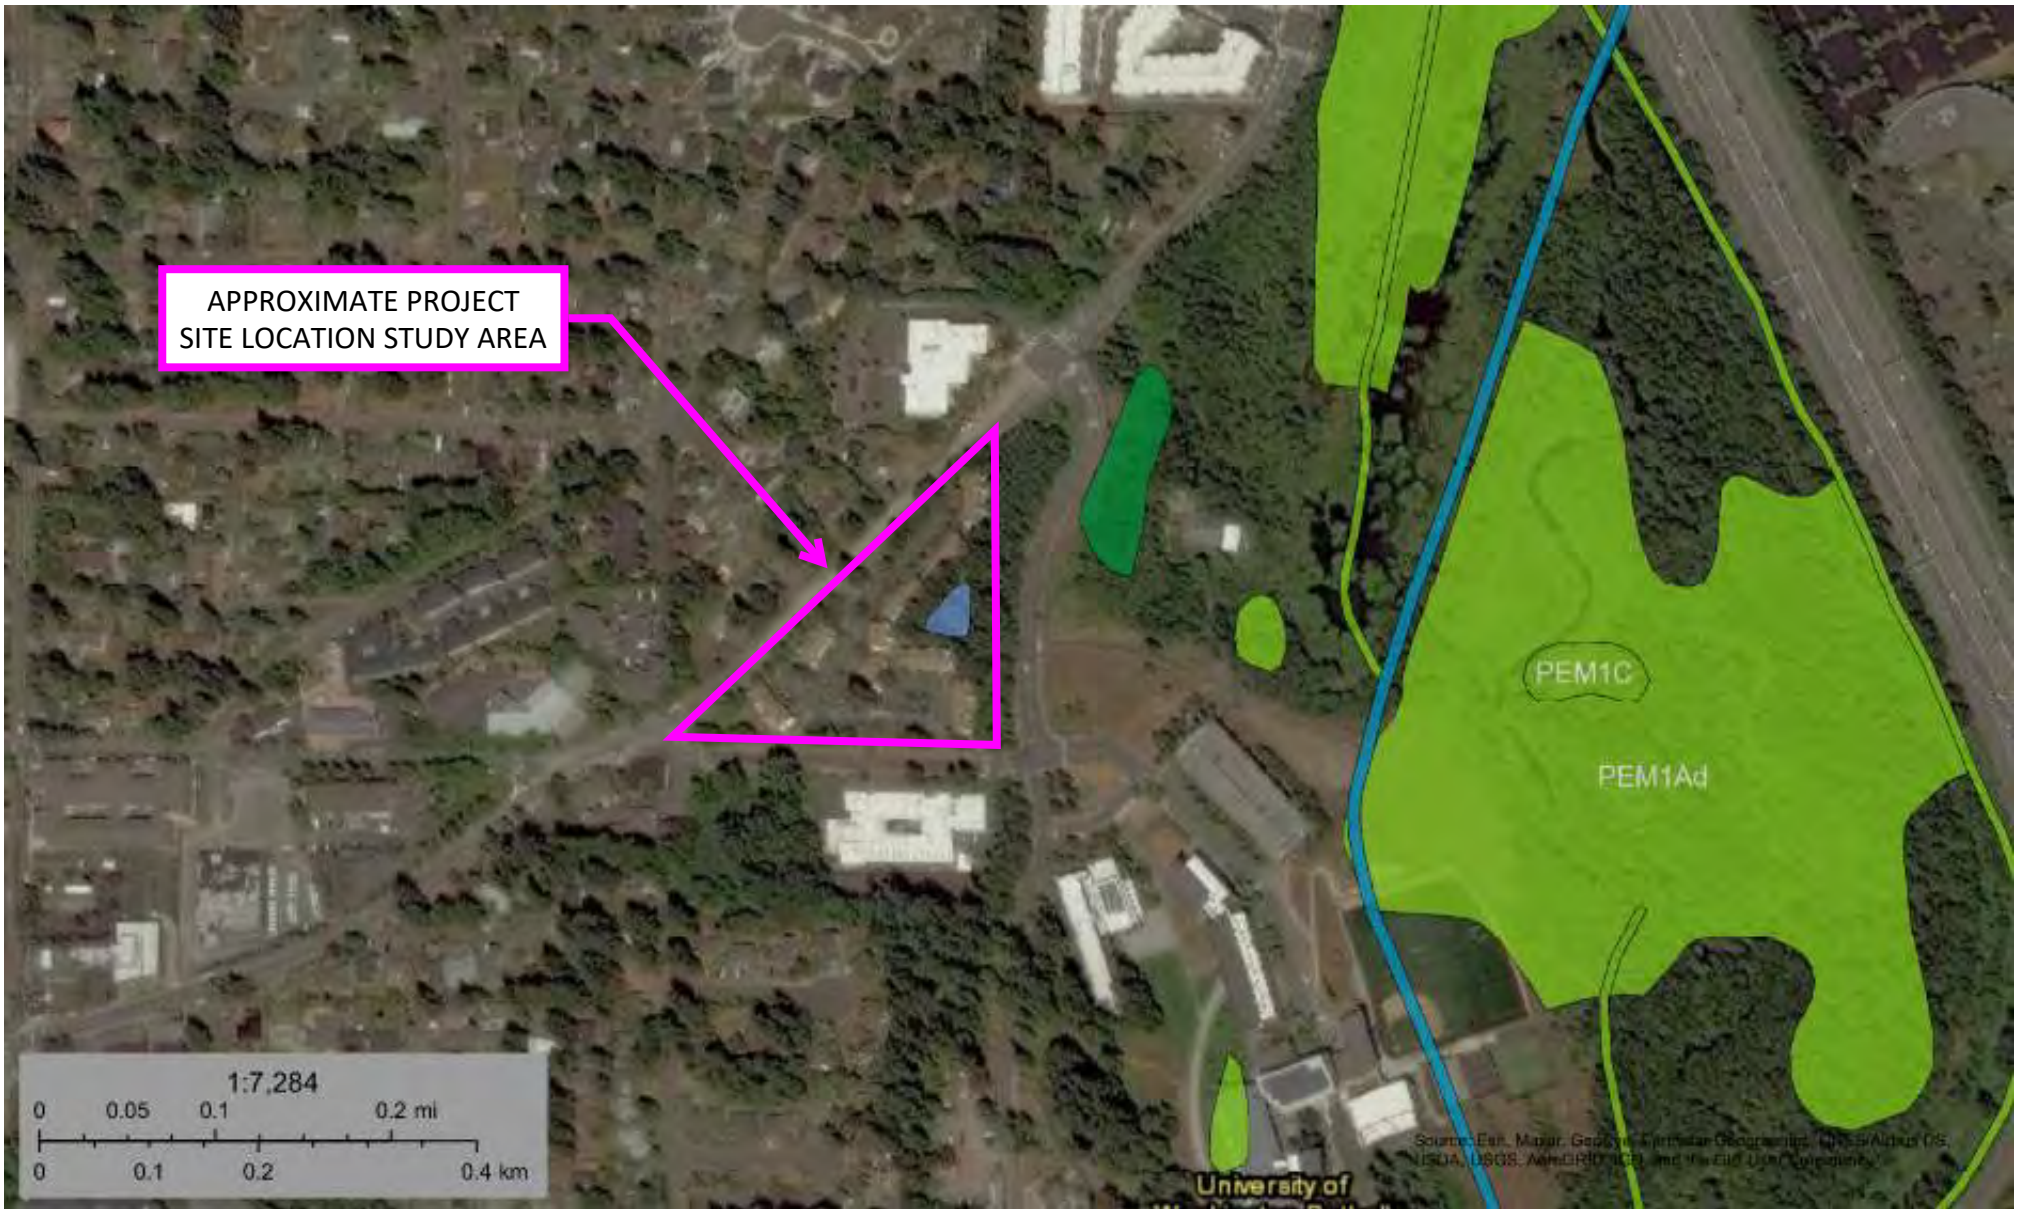
The USFWS (2020) NWI, (Figure 7), depicts the stormwater pond located in the central eastern area of the site as a freshwater pond. No wetlands, streams, or other bodies of water are depicted on site. Downslope from the project site and across 110th Avenue NE, two small off-site wetlands and a larger wetland complex associated with North Creek are depicted.

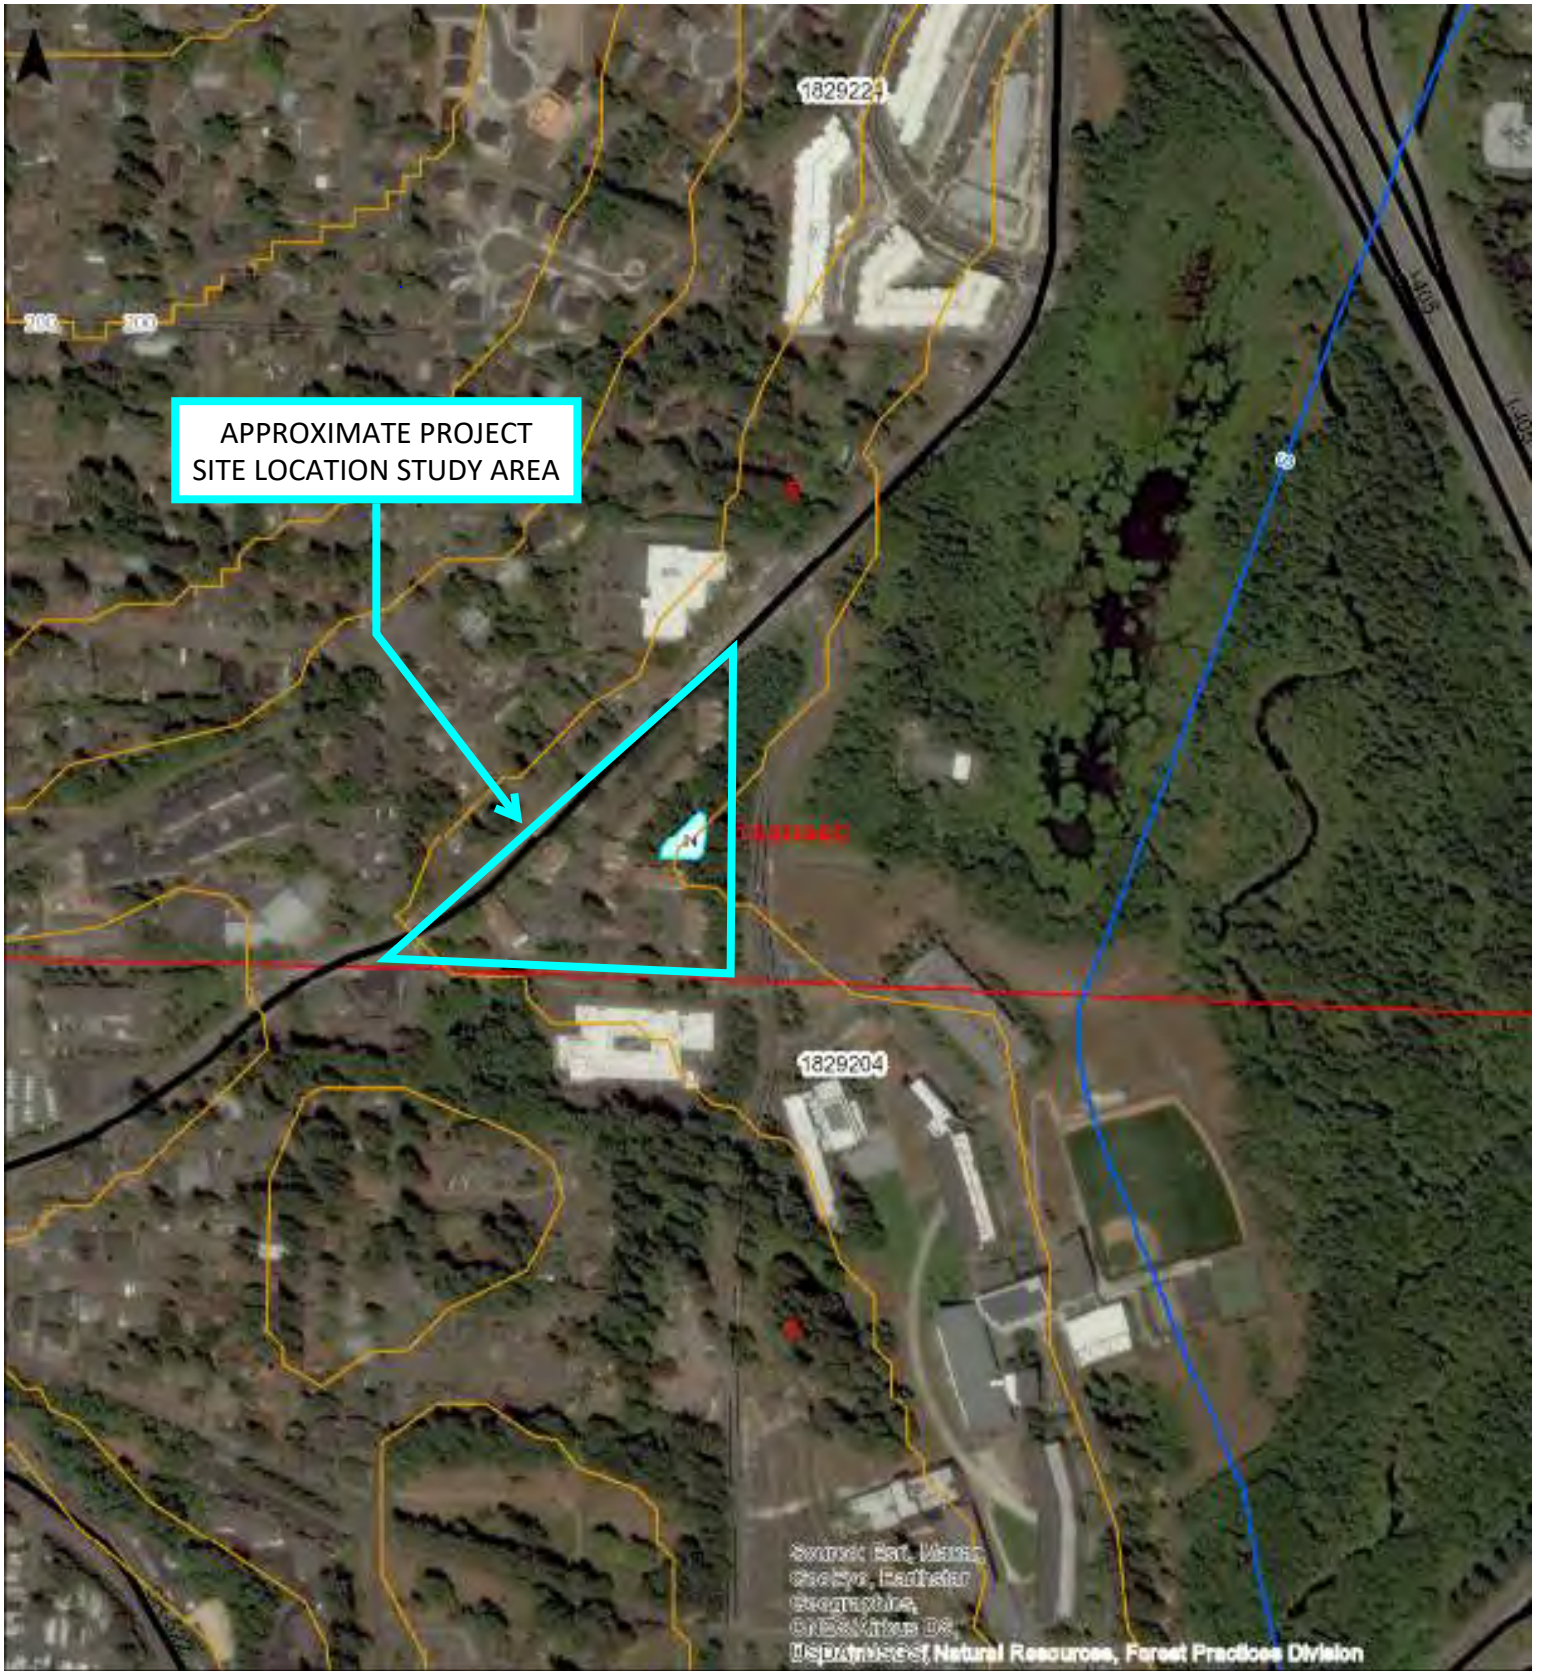
**FIGURE 7 - DNR WATER TYPE MAP
HUSKY VILLAGE REDEVELOPMENT
18612 Beardslee Blvd, Bothell, WA 98011**

The WDNR (2020) Forest Practice Activity Water Type Map for the study area depicts the stormwater pond in the central eastern area of the site as a Type N body of water. Approximately 500 feet east of the site, North Creek is depicted as a Type S stream (Figure 7). Type N streams are defined as non-fish bearing streams, Type S streams are designated as “shorelines of the state” defined in chapter 90.58.030 RCW.

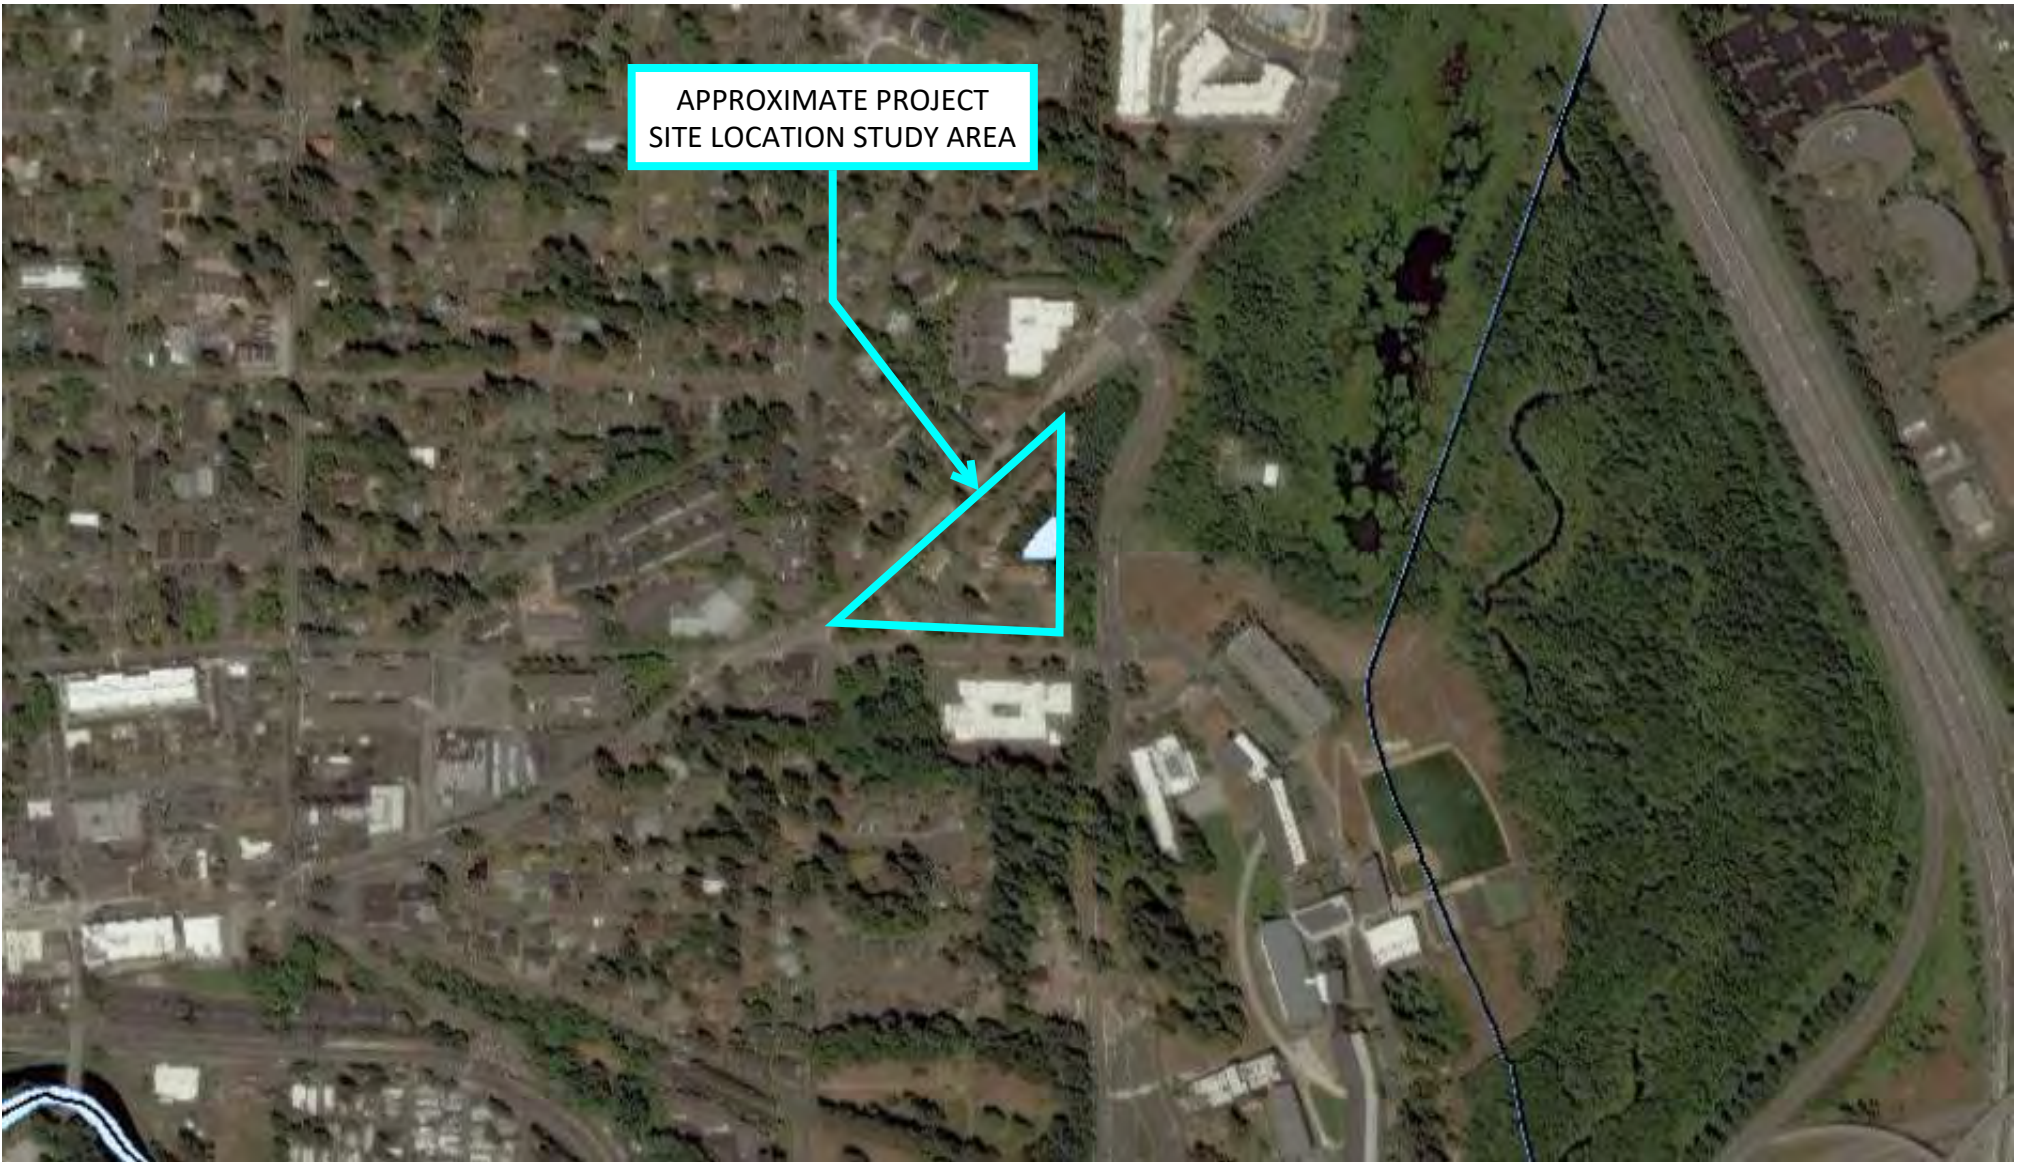
FIGURE 8 - SALMONSCAPE MAP
HUSKY VILLAGE REDEVELOPMENT
 18612 Beardslee Blvd, Bothell, WA 98011
 RAI PROJECT: 2016-087-102

The WDFW (2020) PHS database map does not depict any State or Federal listed species (threatened, endangered, or sensitive) within the project site or its immediate vicinity (Appendix C). The PHS database does map the North Creek and adjacent wetlands off-site, to the east side. These wetlands are depicted in similar locations as the NWI and City of Bothell maps. Upon review of the PHS database maps, Salmonscape, and Fish Passage maps, no streams are mapped onsite or in the immediate vicinity within 300 feet. The nearest creek and/or assessed and prioritized blockages or structures associated with fish are located more than 500 feet away from the project site similar to the WDNR map described in the previous section of this report (Figures 8 and 9).

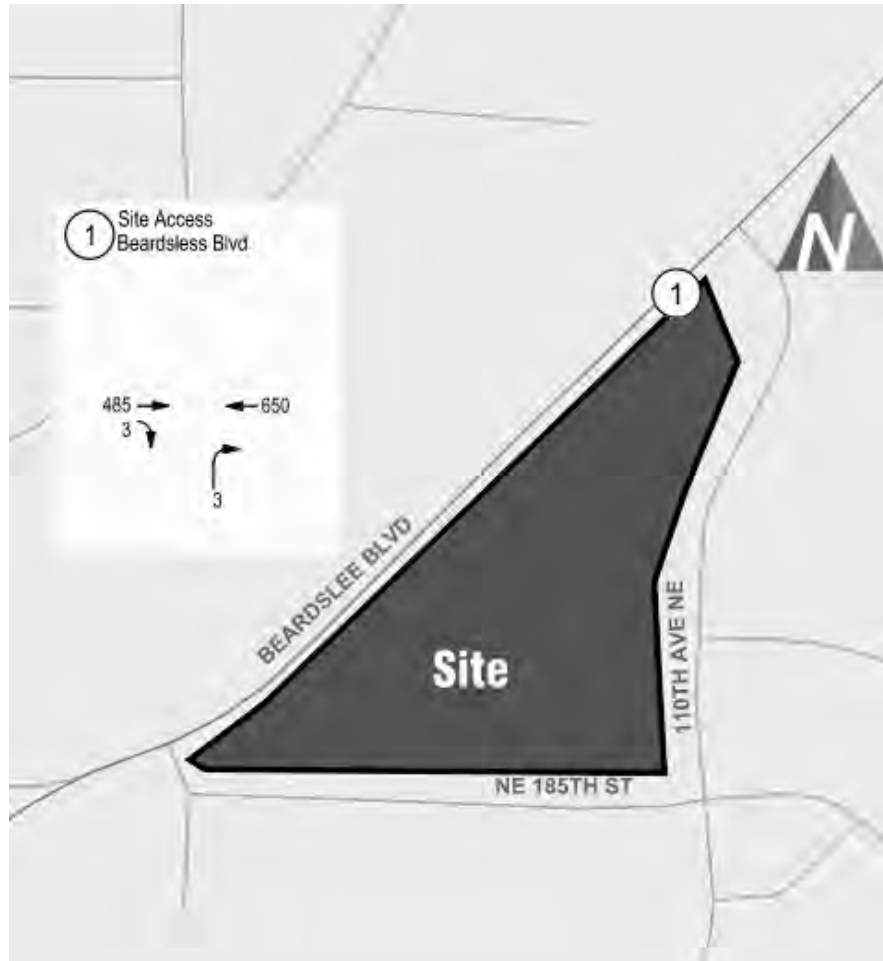
Figure 2. Future (2024) With-Project PM Peak Hour Site Access Volumes
