UW Anderson Hall HRA

Project Number 204675

February 27, 2014

Hoshide | Wanzer | Williams
architects

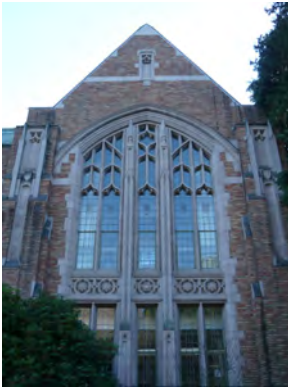
Gable End Windows

The elevations of Anderson hall are symmetrical around the vertical centerline with tall, pointed gables and pointed arch windows on either end. The windows use stone tracery with buttressed pilasters that create a series of strong and richly decorated vertical elements. Anderson Hall is constructed as a load-bearing concrete frame with masonry infill and brick and cast stone facing at the exterior walls. The roof material is slate shingles. Operable windows are steel-sash; fixed windows within the stone tracery have leaded lights.⁶

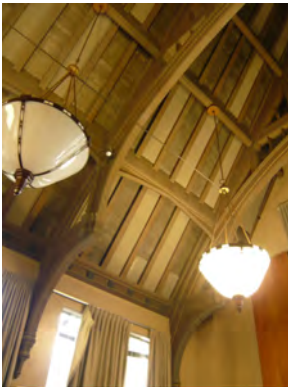
Auditorium

The most important interior spaces in Anderson Hall are on the second floor in each end wing. The Classroom (now named Auditorium, Room 223) is located at the west end and features a tiered floor with fixed seating and a high-peaked ceiling with timber trusses at a spacing of 10'-11". Acoustical ceiling panels were added between every other pair of rafters in the 1978 Renovation-Room 223 plans.

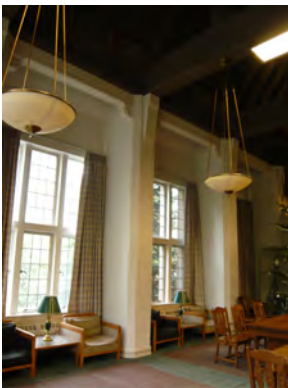
Forest Club Room

The Reading Room (now named Forest Club Room, Room 207) is located at the east end and features a fireplace with a balcony above, and a double-height wood timber ceiling. Both rooms retain their historic character with large, leaded windows and elaborate woodwork throughout. The light fixtures are not original (they do not match historic photographs), but they are appropriate to the historic character of the rooms. Unfortunately, the Reading Room has had new fluorescent light fixtures added to the underside of the main beams.

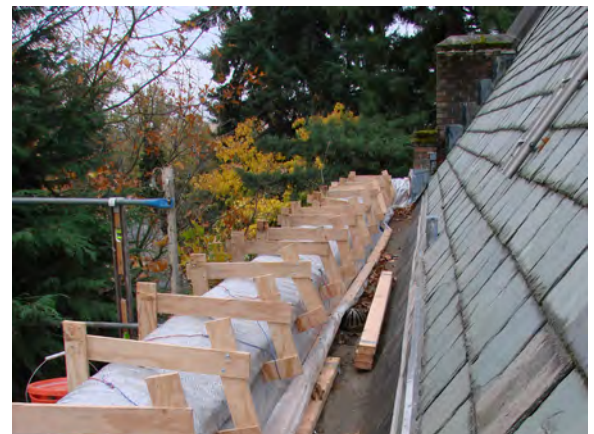
Water Penetration Investigation

Anderson Hall is well maintained and the slate roof, gutters and upper roof appear to be in good condition. There is currently some evidence of water penetration through the roof gutter or parapet wall on the west wall. Access to investigate this issue is difficult and has required a lift.

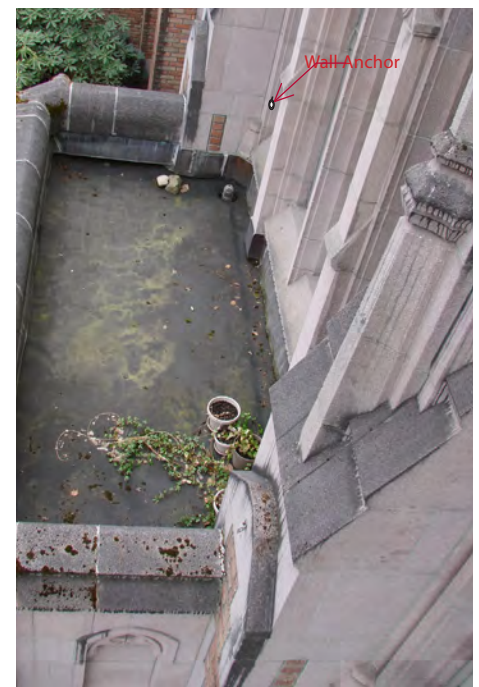
Entry Porch

There is one wall anchor proposed at the entry porch, mounted on the inside (east) face of the adjacent buttress, approximately 4" above the roof parapet. This anchor consists of an eye bolt with a galvanized steel plate.

From the primary view of Anderson Hall from the north, the wall anchor above the entry porch would be hidden by the porch parapet wall and coping from any point on grade closer than 190 feet from the face of the entry. This would make the wall anchor visible from Island Lane NE about 75 feet north of Stevens Way NE and from the Garfield Lane NE crosswalk at Stevens Way NE. At this distance the wall anchor will be insignificant.

- Fall Arrest Wall Anchor at the Entry Porch**
 The fall arrest wall anchor will not be visible except at a distance (190 feet or more). No mitigation is needed.

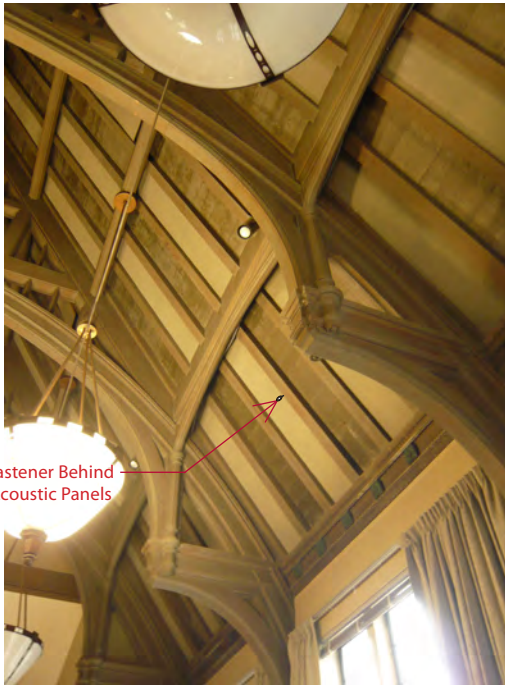
Fastener Behind Acoustic Panels

Each of the proposed anchors at the roof gutter have four 4/8" bolts through the concrete structure, as well as washers and nuts that could be visible on the interior. On the north and south sides these fasteners will be above suspended ceilings and will not be visible. In the Reading Room the fasteners will occur behind a false beam at the top of the wall and will not penetrate the interior. The Auditorium is the only interior space where the fasteners could be visible.

The Auditorium on the second floor is the only interior space affected by the proposed anchor fasteners. The bolts, washers and nuts would penetrate the sloped concrete ceiling at 5 locations on the west sloping ceiling, and one location each on the east sloping ceiling near the NE and SE corners. These fasteners would be about 4 feet above the break between the top of the wall and the sloping ceiling.

- Fasteners Affecting Interior Spaces**
 The Auditorium was renovated in 1978 and acoustic ceiling panels were installed in every other rafter space. The locations of the anchors should be adjusted to fall within the rafter bays containing the acoustic panels. The panels should be removed, the back side hollowed out to allow a cavity for the fasteners, and replaced on the ceiling. This will allow the fasteners to be hidden from view. However, if the 1978 acoustic panels are ever removed and the ceiling restored to its original condition, these fasteners will become visible and some form of mitigation will have to be employed at that time.

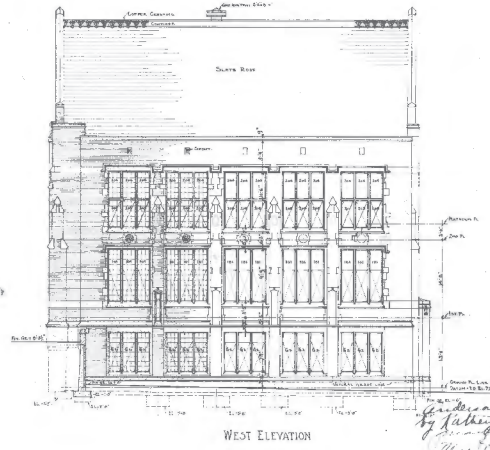
ALFRED H. ANDERSON HALL
 COLLEGE OF FORESTRY UNIVERSITY OF WASHINGTON

Drawn By	ELEVATIONS	DATE
Traced By	SCALE - 3/8" = 1'-0"	NOV 1914
Checked By		SHEET NO
Approved	CHAS. H. BEED & CARL GOULD	58
DATE	ARCHITECTS	REVISED
	110-15 3RD BLDG. SEATTLE, WASH.
