ADA

Transition Plan

UW Bothell & Cascadia College Campus

November 2020

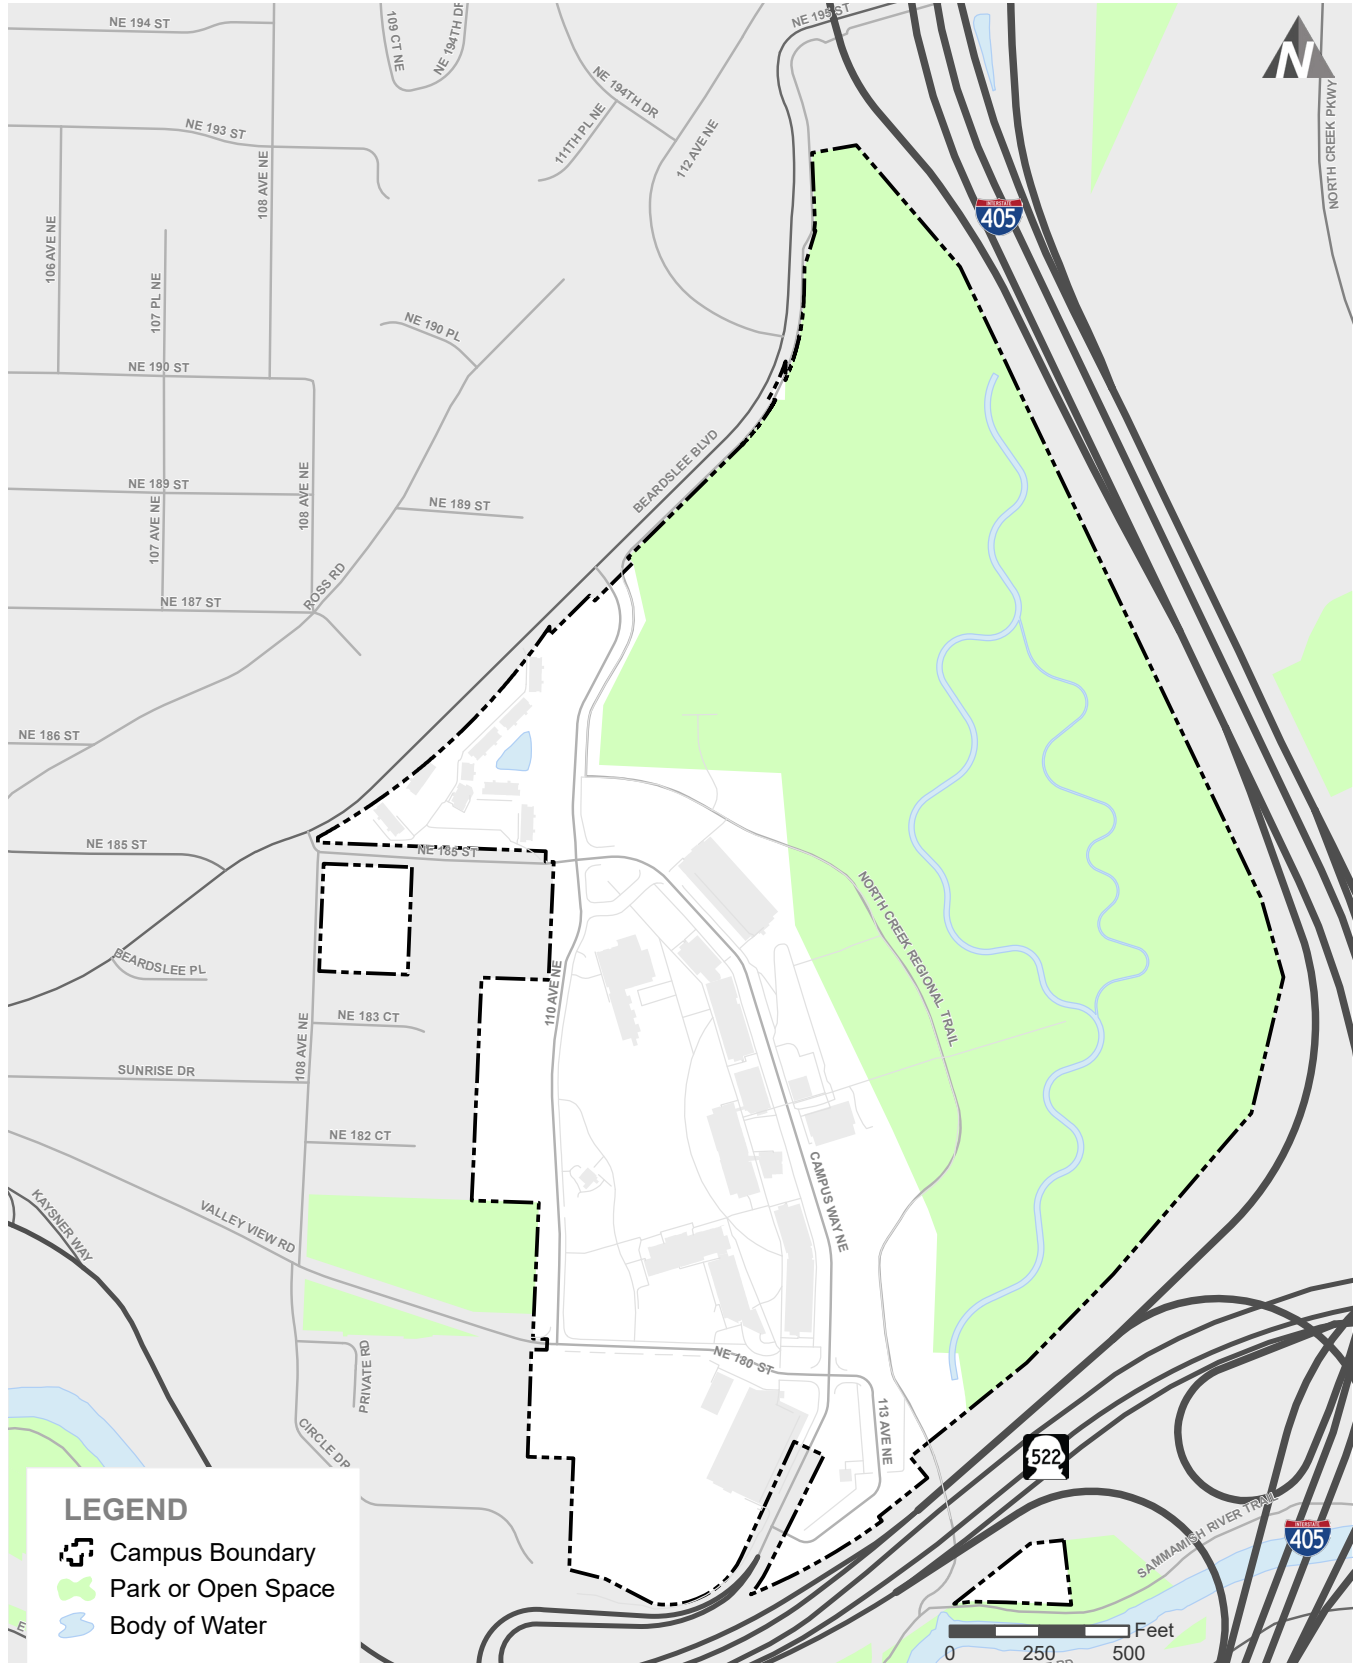
Figure 2-1 Data Collection Boundary

Barriers were documented along these pathways, including pictures of many of the barriers found. Employee-only areas were not assessed in this scope of work. Figure 2-1 shows the boundary extents of the data collection. The following sections describe the methodology for collecting data for the self-evaluation.

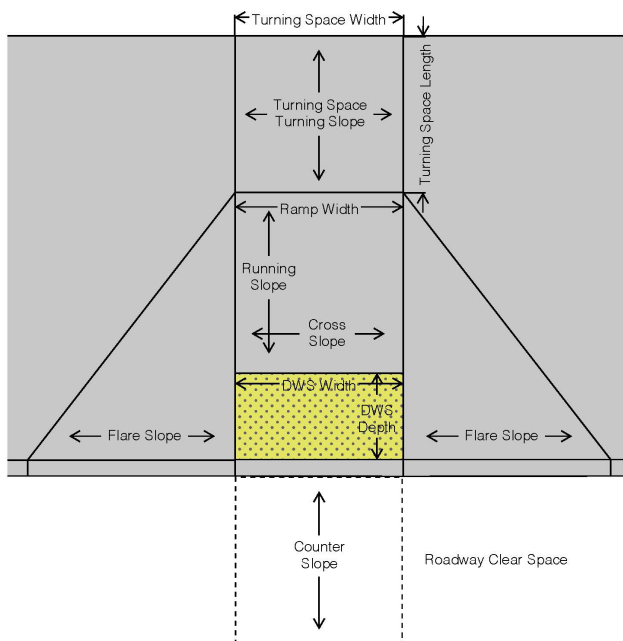
Figure 2-2 Perpendicular Curb Ramp Attributes

the non-compliant category. Non-compliant curb ramps are existing/missing curb ramps given an accessibility score of 30. Minor non-compliant curb ramps received an accessibility score of 1-29. For further detailing on scoring, see Section 5.2.1. Non-compliance is primarily attributable to the following core criteria:

- ▶ The ramp width is too narrow. Six curb ramp widths are less than 48 inches.
- ▶ The ramp running and cross slope are too steep. Seventeen curb ramps have a running slope greater than 8.3%. Eight curb ramps have a cross slope greater than 2%, three of which are greater than 3%.
- ▶ Curb ramp is missing, 27 curb ramps.

For some of the high scoring curb ramps, the non-compliance is caused by the necessity to tie into the existing terrain around the curb ramp. Due to the majority of campus residing on a hillside (greater than 140 feet elevation gain from east to west), meeting compliant grades becomes a challenge. In curb ramp design, a key goal is to limit the ramp slopes,

Maximum extent feasible (MEF) documentation may be necessary in certain cases where it is found to be infeasible to remove all of a curb ramp's barriers. Where some barriers can still be reduced or removed, the improvement will need to be completed along with the MEF documentation. At locations where curb ramps are missing, different solutions could be applied such as installing a new curb ramp, adding signage to prevent crossings, or raising the crossing to the elevation of the curb.

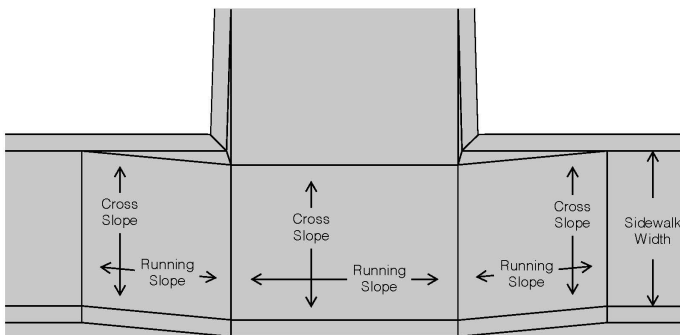
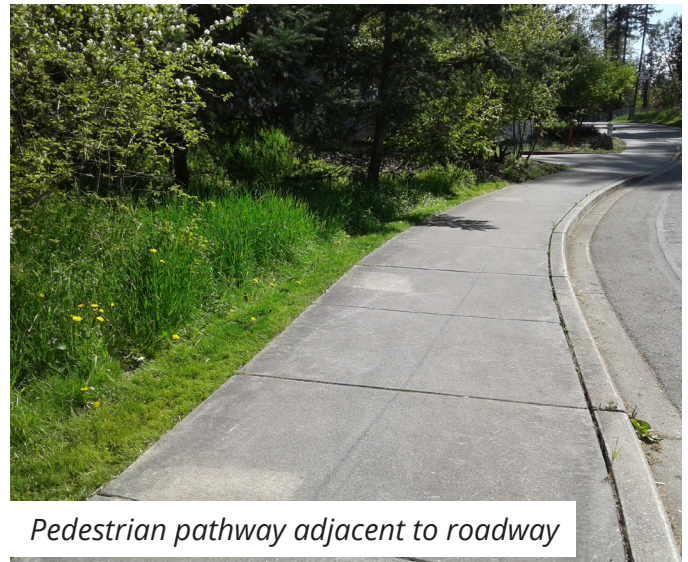
Figure 2-4 Driveway and Sidewalk Attributes

Several miles of sidewalks and pathways on campus are non-compliant based on ADA requirements. Common attributes for sidewalks and driveways are shown in Figure 2-4. Sidewalk segment that earned an accessibility score of 16-30 were categorized as non-compliant. Sidewalks that received an accessibility score of 1-15 were considered minor non-compliant. See Section 5.2.1 for details on accessibility scores. The most common hazards along the pathways

are gaps between concrete panels and utility boxes. Gaps between panels often come from concrete shrinkage and wear on gap sealant.

- ▶ The sidewalk width is too narrow (0.24 miles of pathways have a width less than 48 inches. 0.14 miles of pathways have widths less than 60 inches and have no pullouts. Some of these pathways have alternate routes and can be noted as such during the barrier removal process.
- ▶ The cross slope or running slope of the sidewalk is too steep. About 93% of sidewalk segments have at least one location where the cross slope is greater than 2% and about 52% of sidewalk segments have at least one location where the running slope is greater than 5%.
- ▶ The sidewalk has fixed/non-fixed barriers and other discontinuities that impede required usable pedestrian space. Obstacles including utility boxes without

- ▶ Non-compliant driveways intersect the sidewalk. Of the seven driveways identified as non-compliant, most are related to the cross slopes exceeding the ADA 2% threshold.

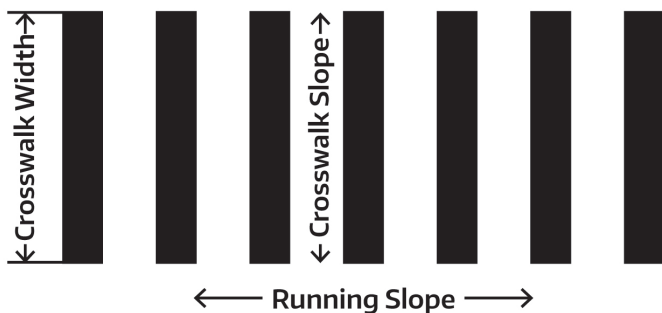
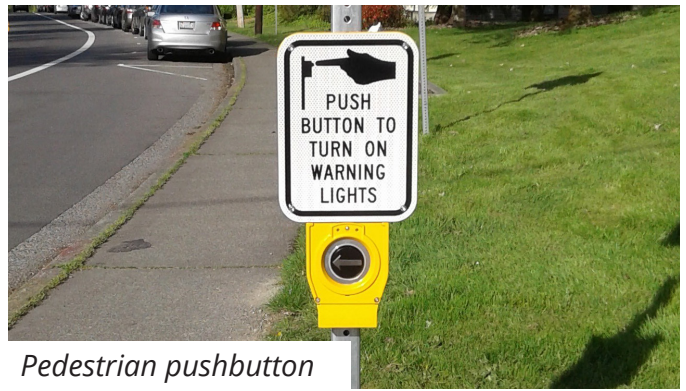
Figure 2-5 Crosswalk Attributes

Both marked and unmarked crosswalks must comply with ADA standards. All intersection crosswalks are legal crosswalks unless signed to prohibit pedestrian crossings. All but one of the marked crosswalks observed complied with the standard width requirement and 88% of crosswalks have compliant running slopes. The most common non-compliant element of crosswalks is the cross slope with around half with non-compliant cross slopes. Figure 2-5 shows the major attributes measured for crosswalks.

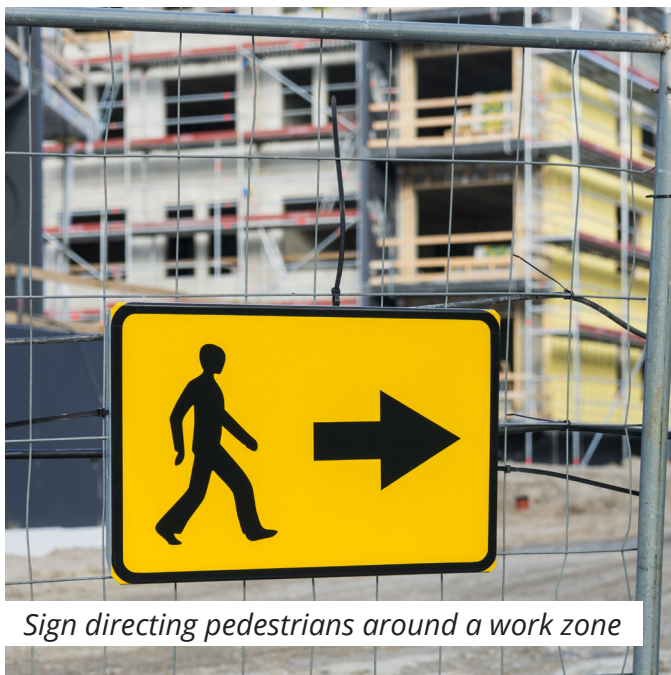
Sign directing pedestrians around a work zone
