UW Roberts Hall HRA

November 29, 2012

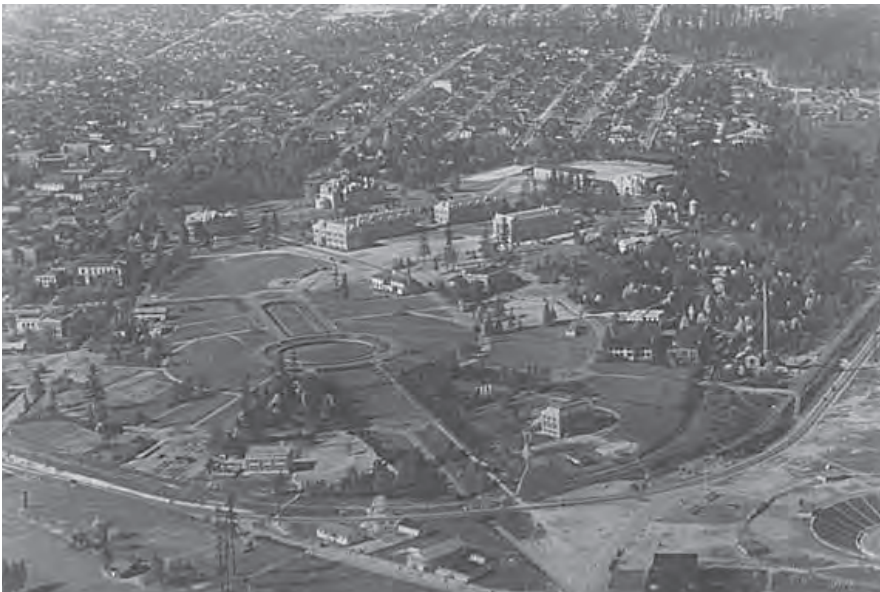
Mines Building First Phase, 1923

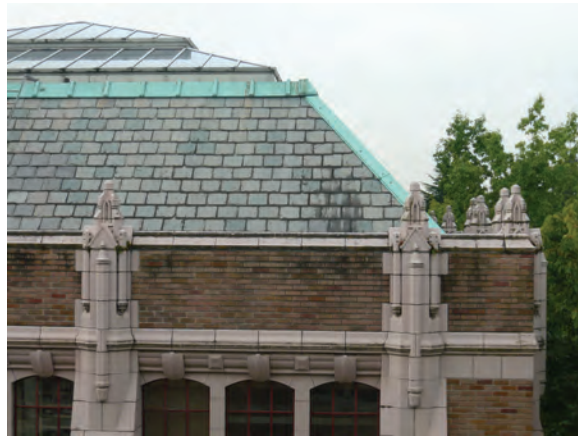
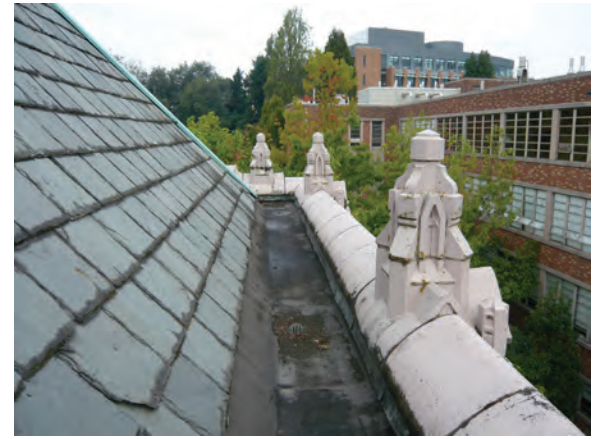
Roberts Hall was designed by Bebb & Gould in the Collegiate Gothic style, which was the architectural form extensively used on the upper campus quadrangle. The typical characteristics of this style were all included in the exterior treatment of Roberts Hall, including arched window and door openings, buttresses, and masonry walls. In the engineering quadrangle Bebb & Gould made a few modifications to the Collegiate Gothic style, as noted by T. William Booth and William H. Wilson:

"The mines building (1921, now Roberts Hall), required a three-story space for a rock crusher. Gould capped the space with a large skylight, then continued the skylight over the laboratories on the top floor. The slender brick buttresses, minimal decoration, and expanses of industrial steel sash set within the buttresses make an appropriate envelope for the no-nonsense discipline taught within."

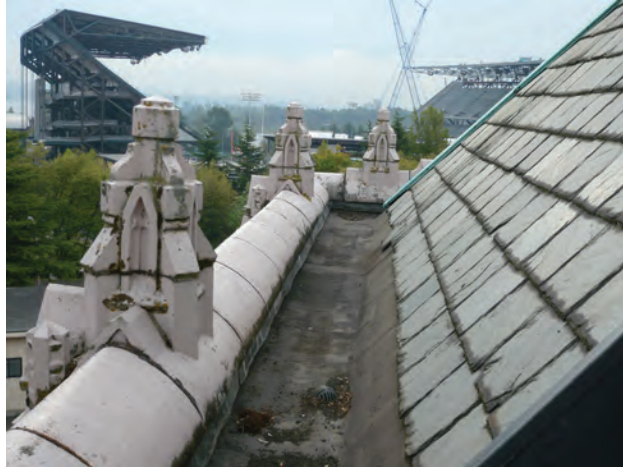
Recommendations will be made for the exterior of the building where the proposed safe access and roof anchor system will require additional elements to be added to the roof. Primary consideration will be given to the visibility of these changes to the public view of the structure from the main approach on Stevens Way as well as the pedestrian pathways along Mason Road. In addition, recommendations will be made for the interior of the building where the proposed roof anchor system requires fasteners through the concrete structure which will be visible to the building users.

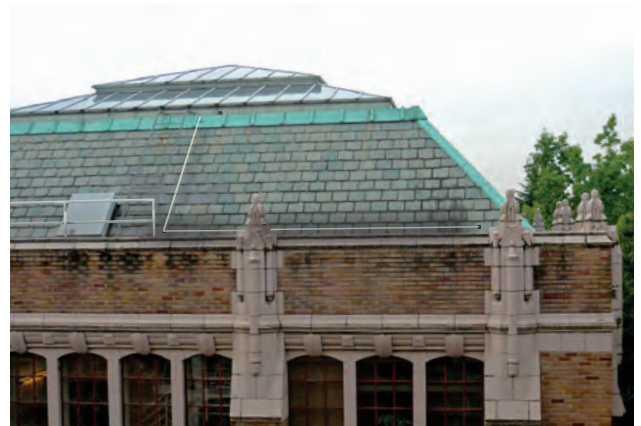
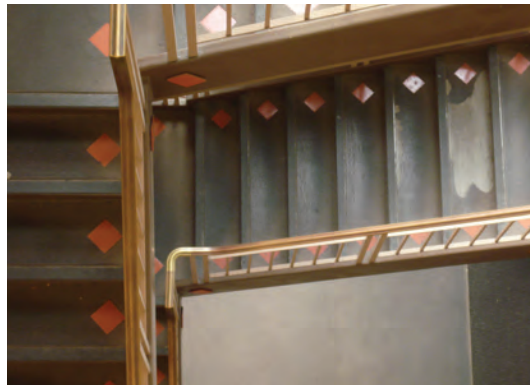
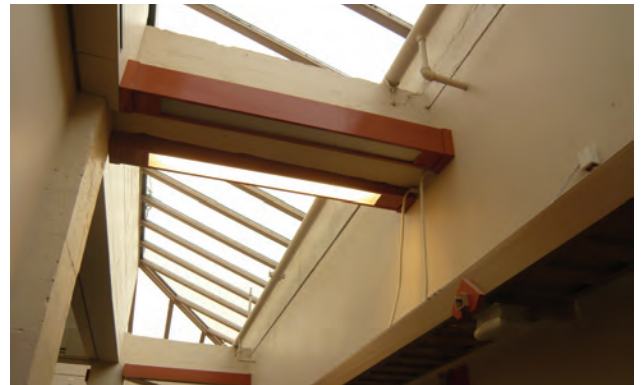
The fall arrest anchors and cables mounted to the slate roof will be approximately 9-1/2" higher than the raised coping on the outer edge of the gutter. The anchors and cable will be visible from the ground at a distance of approximately 130' from the face of the building. On the primary view side of Roberts Hall, the fall arrest system will be visible to about half way between Stevens Way and the building. When the anchors are fastened to the roof, some slate roof tiles will have to be replaced.

Both the eye bolts at the upper roof gutter and the eye brackets at the lower roof gutter have fasteners through the concrete structure that will be visible on the interior.

The guardrail is not visible from the main approach to the building, but can be seen from the parking area between Wilcox Hall and Roberts Annex and to a lesser extent from the Burke-Gilman Trail and Montlake Boulevard NE in front of Edmundson Pavilion. The guardrail and the roof hatch should be painted to match the slate roofing, and be finished with a satin sheen to reduce any reflections or glare.

The brackets holding the cables will project at least a few inches out from the face of the slate roofing and will cast a shadow. Our recommendation is to locate the brackets on the centerlines of the vertical pinnacles (approximately 17'6" on center) to hide the bracket when viewed from straight on, and to repeat the rhythm of the exterior bays when visible. The cables should be discontinuous at the building corners – workers can work around the interruption. The brackets should be painted to match the slate color. New slate roof tiles needed to replace damaged tiles in the installation of the brackets should match the color and size of the existing slate roof tiles.

On the interior of the building there is an original decorative motif of 4" square orange/red tiles, mounted in a diamond pattern. In a previous renovation similar tiles were used to hide connectors on the walls and at cable trays. Our recommendation is to utilize similar tiles to cover the thru fasteners for the fall restraint brackets.
