# Anderson Hall Renovation

University of Washington | UWAC

# Project Goals & Overview

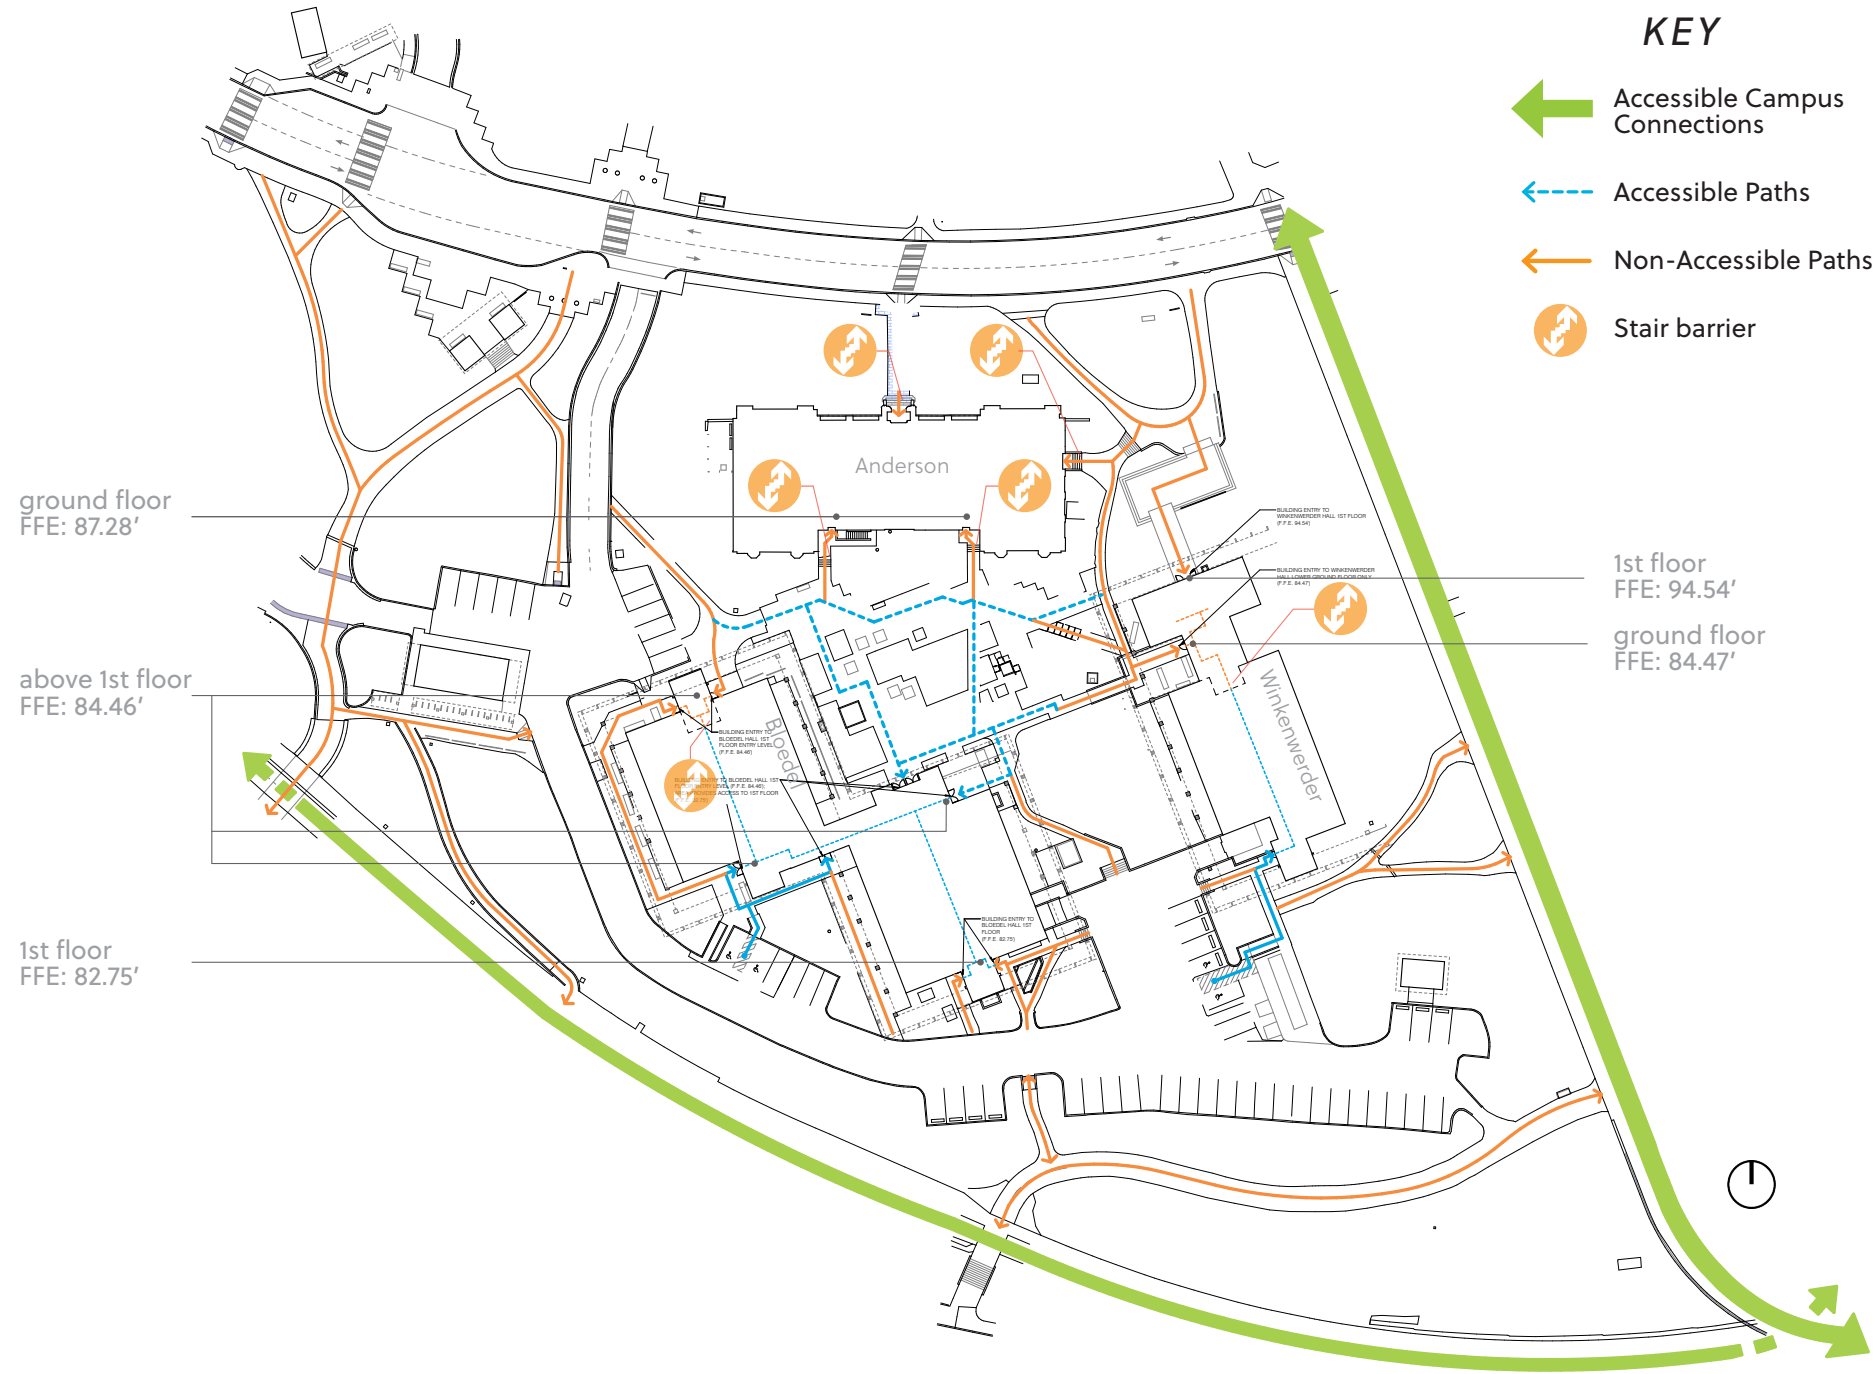
# EXISTING SITE ACCESSIBILITY CHALLENGES

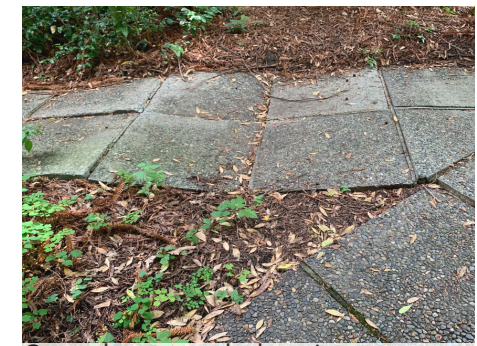
Central courtyard - heaving pavers

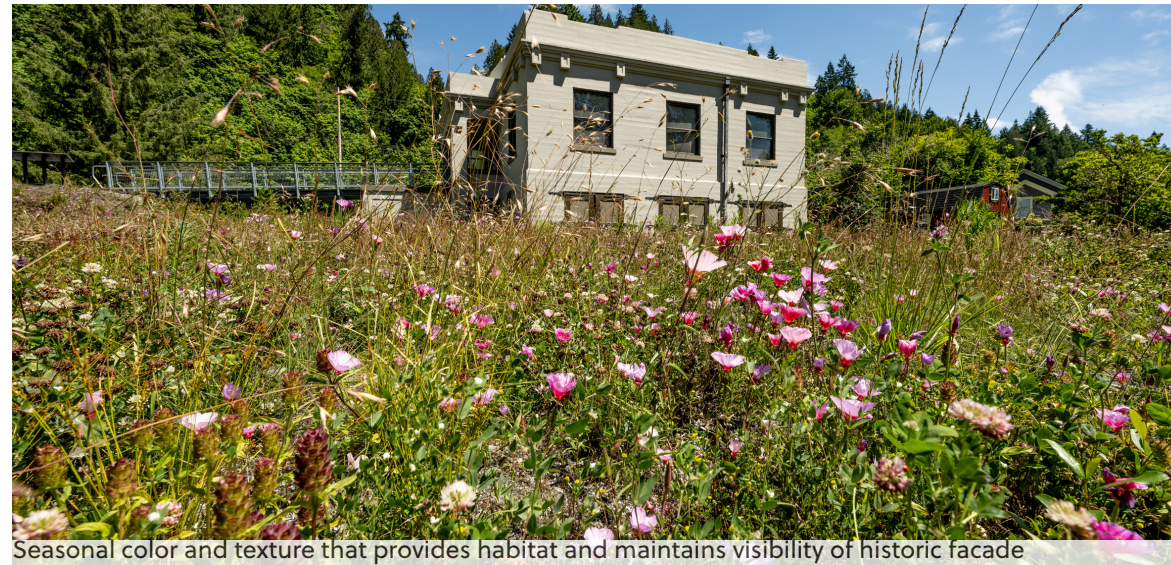
*Meadow*  
Demonstrate early forest succession and provide habitat and host plants for native species

Seasonal color and texture that provides habitat and maintains visibility of historic facade

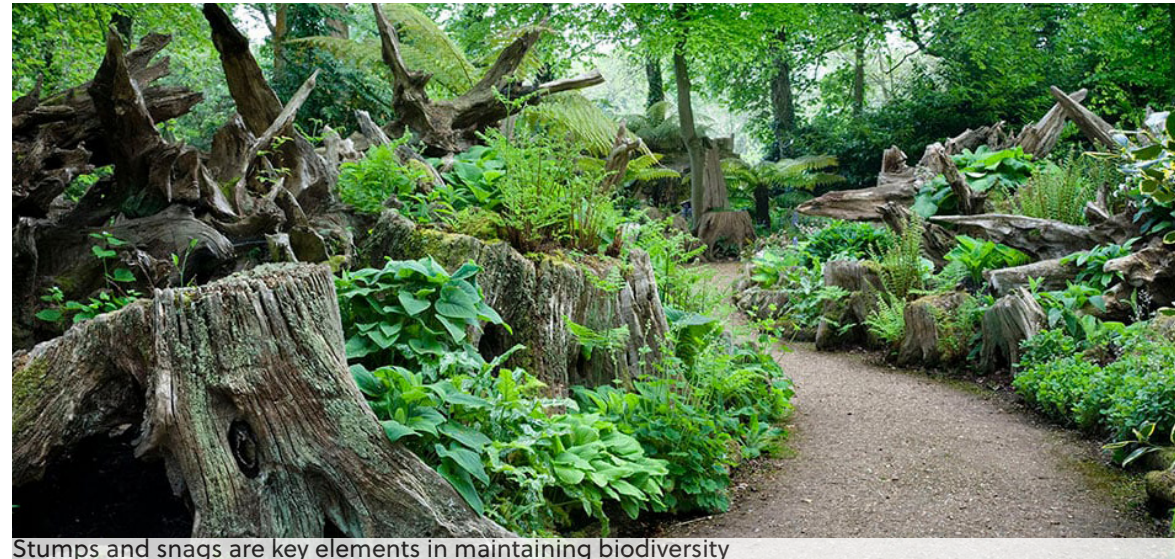
*Demonstration Garden*  
Create a unique landscape experience that supports a sense of discovery

Stumps and snags are key elements in maintaining biodiversity

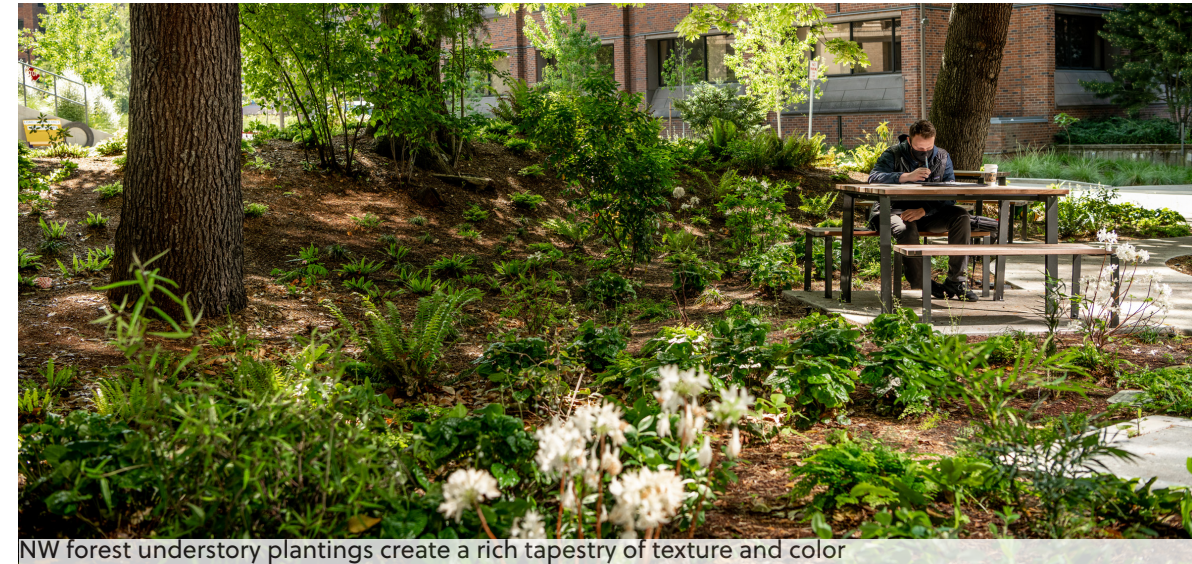
*Woodland*  
Multi-layered forest including a focus on a regenerative forest floor

NW forest understory plantings create a rich tapestry of texture and color

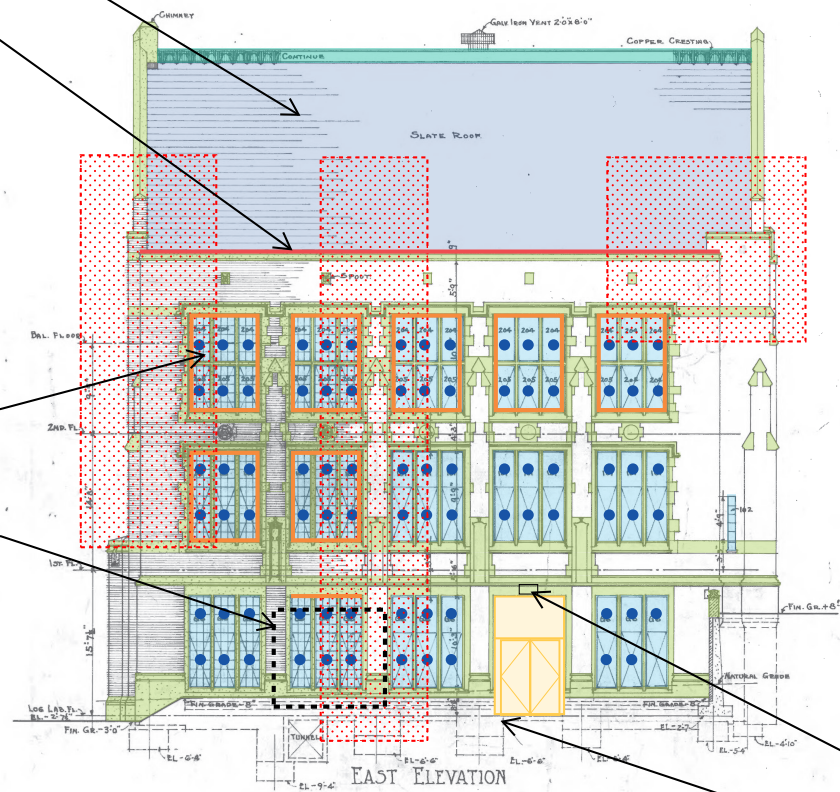
EAST ELEVATION

Resecure loose slates, do not disturb underlayment, maintain existing flashings, assume 5%

Replace existing membrane with new gutter liner and flashing system

Repair bowed window sash, typ this bay

Remove non-compatible plywood shed structure. If equipment requires an enclosure, the design will need to meet the Secretary of the Interior's Standards for compatible additions

Replace non-compatible security light fixture with compatible light

Prep & paint metal railings

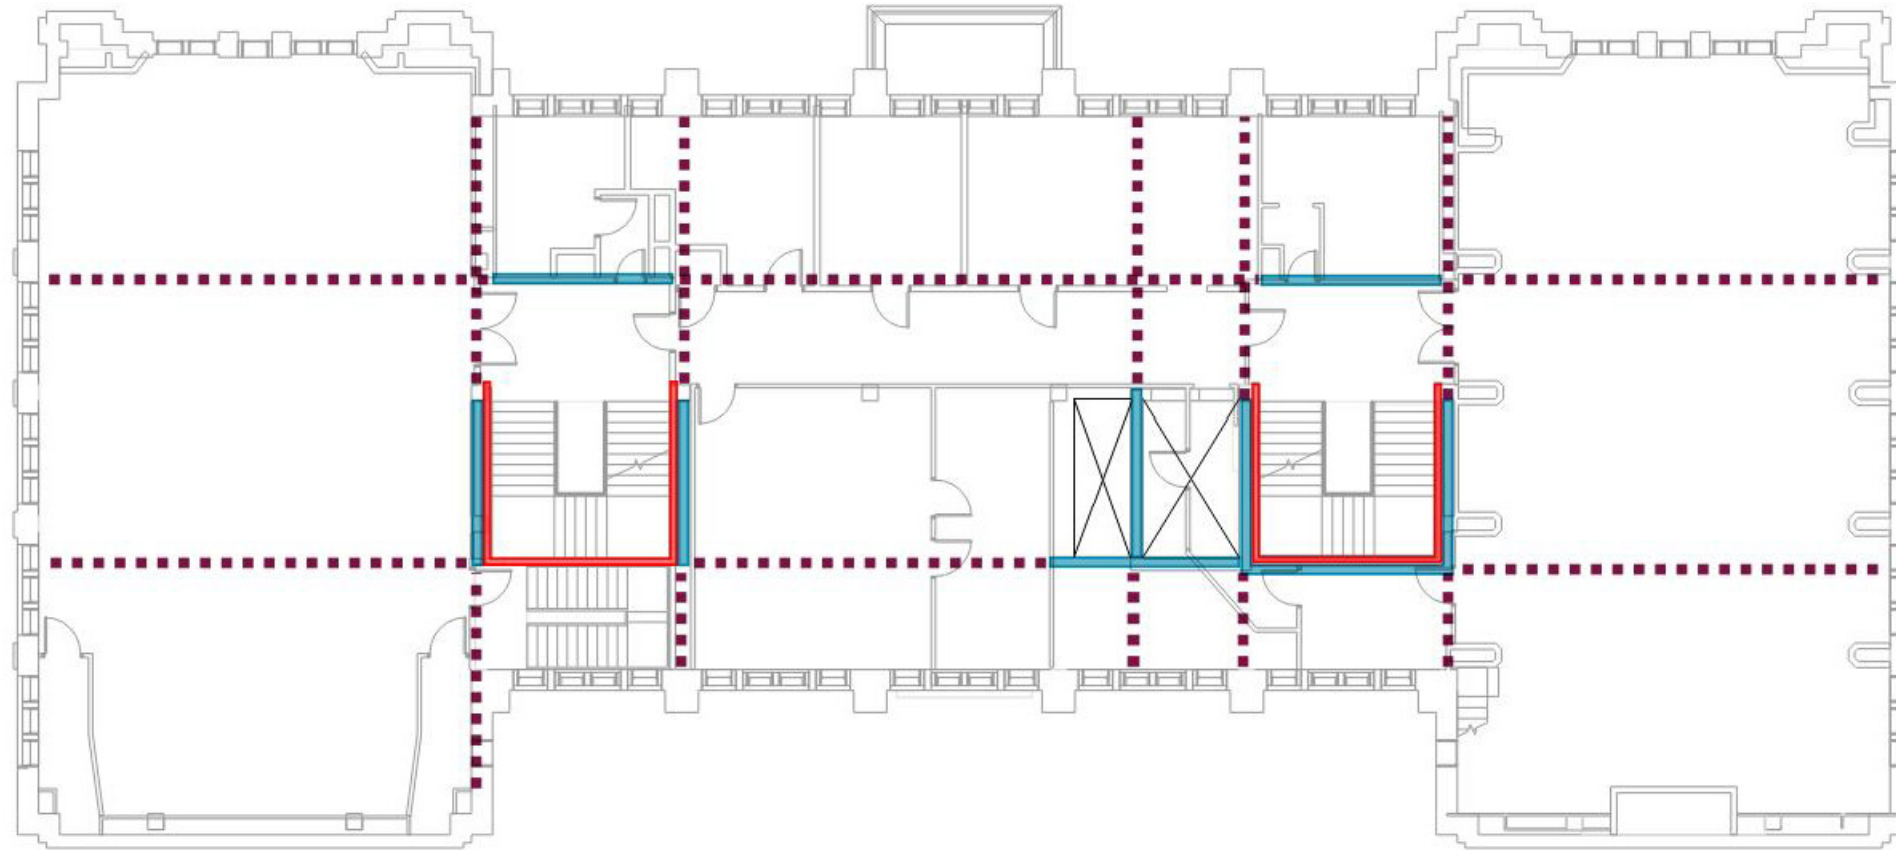
**Second Floor** ⊕  
NOT TO SCALE

- Improved Accessibility:
  - New elevator providing access from Ground Floor through the 3rd Floor
  - New ramp to access lower level of the Ground Floor
  - Gender neutral accessible restrooms
- HVAC system upgraded to meet Code
- New sprinkler system
- Seismic upgrade to building structure to meet Code

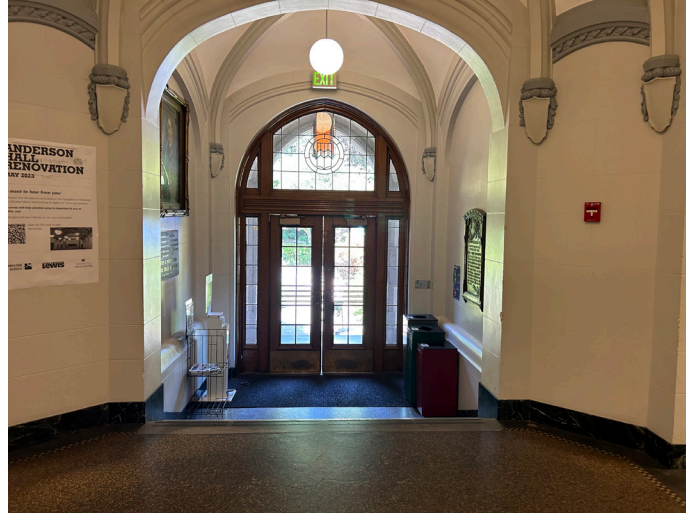
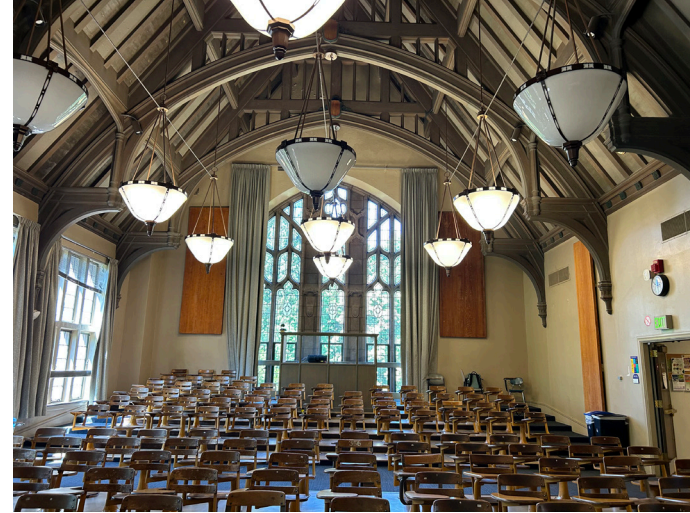
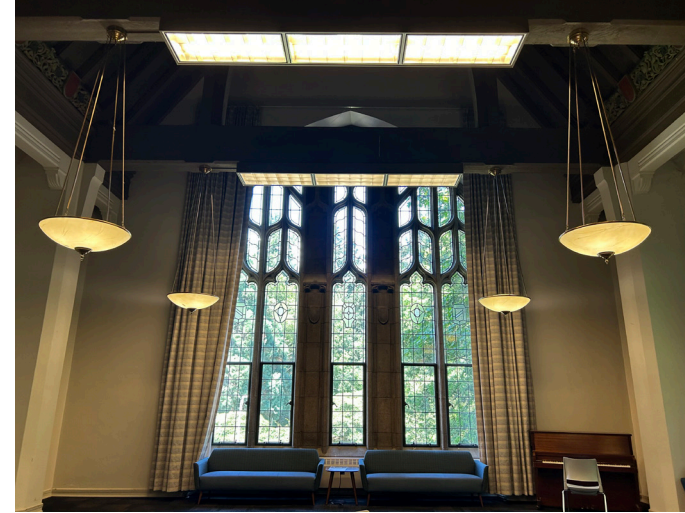
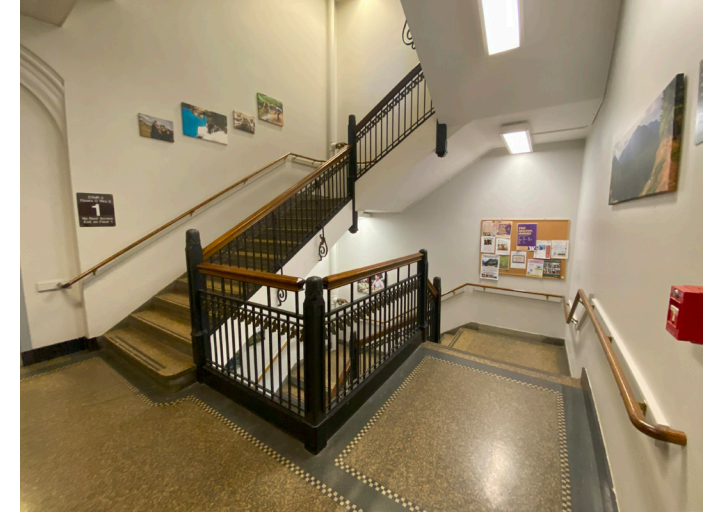
1st Floor Historic Entry Foyer and Central Corridor

- Retain groin vaults and shape of entry vestibule and central corridor
- Repair plaster and repaint decorative plaster groin vaults
- Replace lighting
- Clean/buff historic terrazzo floors

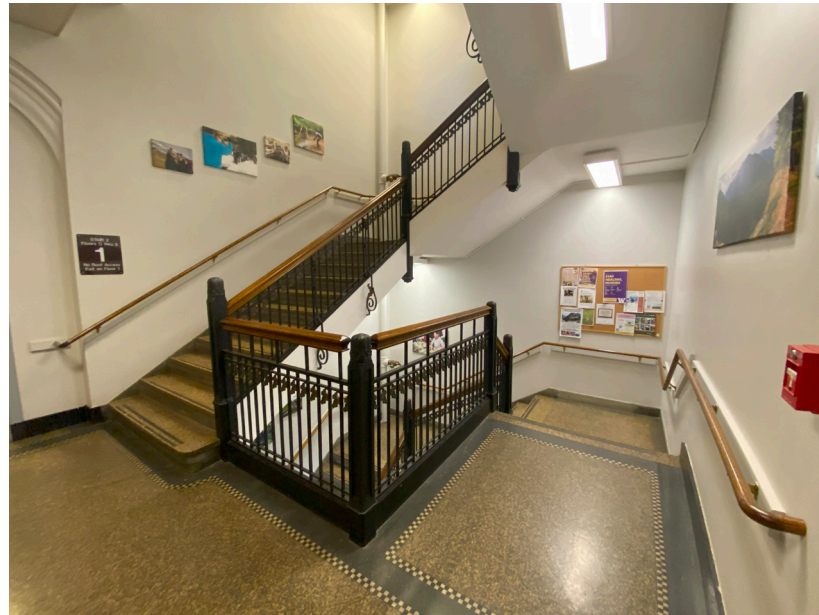
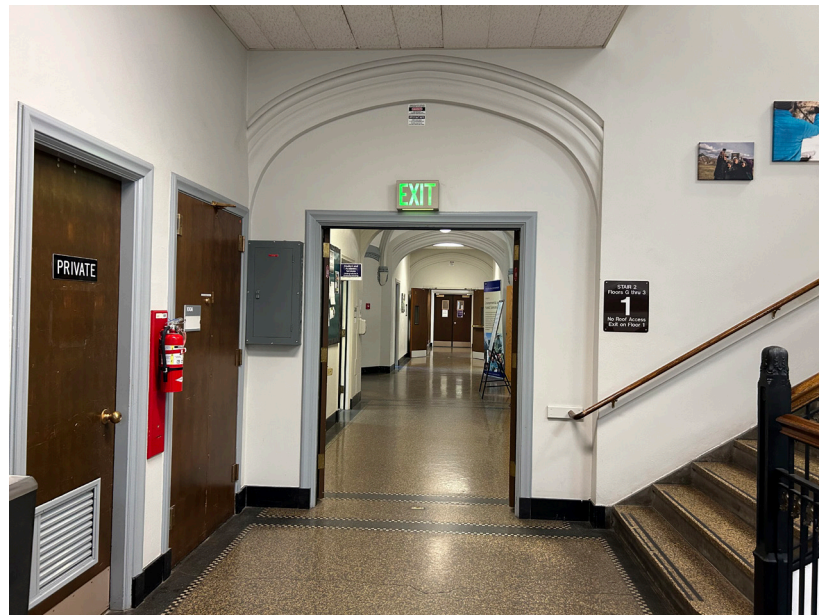
# HISTORIC STAIRS

- Retain historic stair
- Address non-compliant handrail/guardrail
- Replace lighting
- Replace ceiling soffits

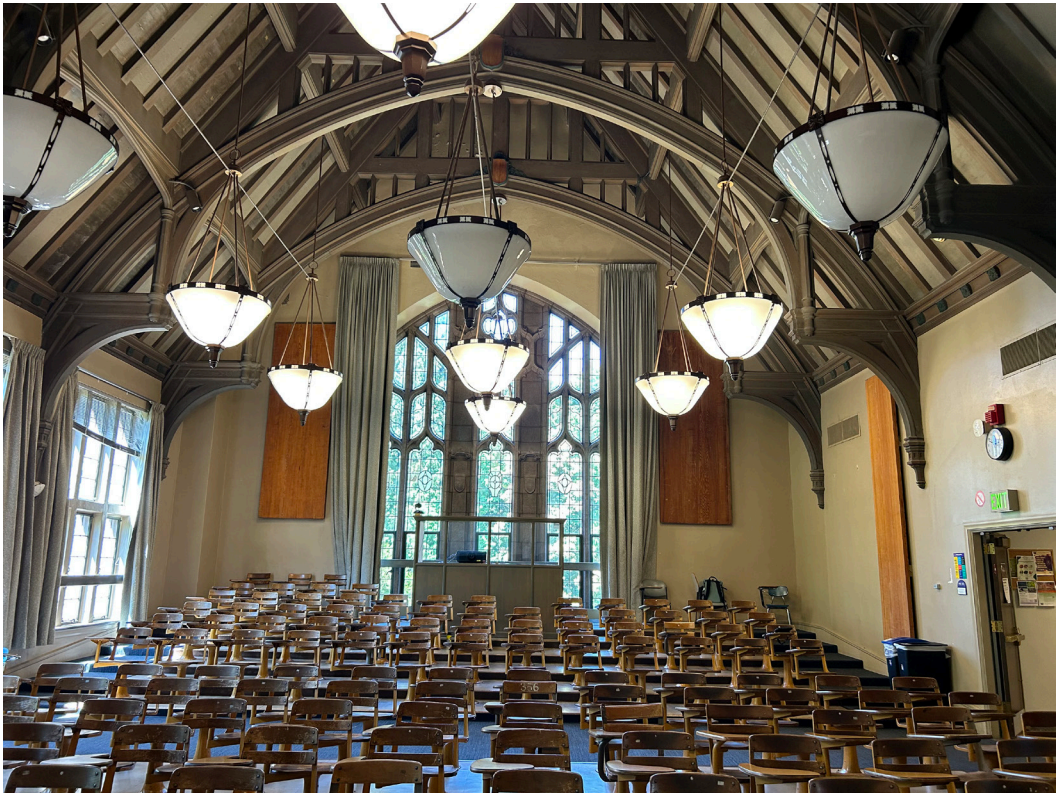
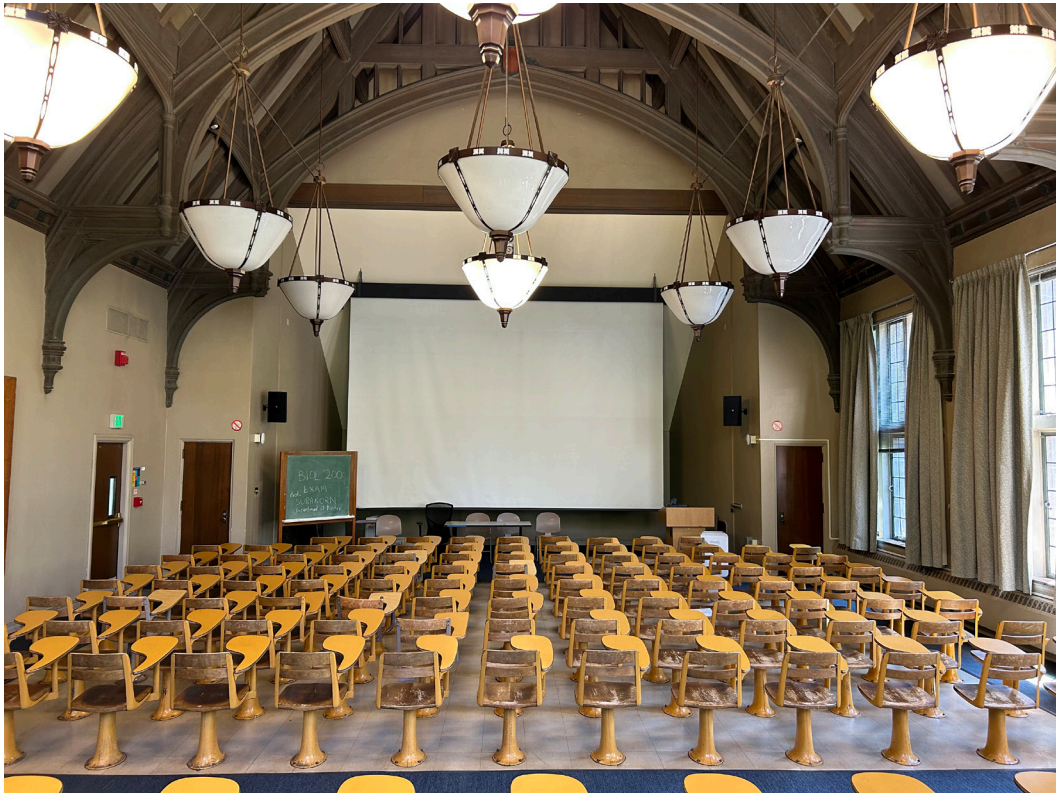
# HISTORIC AUDITORIUM

- Maintain existing volume, wall locations and historic elements
- Refresh of all finishes
- Repair of historic finishes
- Modify instructional area to meet UW requirements
- Reinforcement of original hollow clay tile walls & exterior masonry/stone anchorage

- Replace non-historic light fixtures with simple, contemporary light fixture
- Consider uplight component to highlight decorative wood ceiling

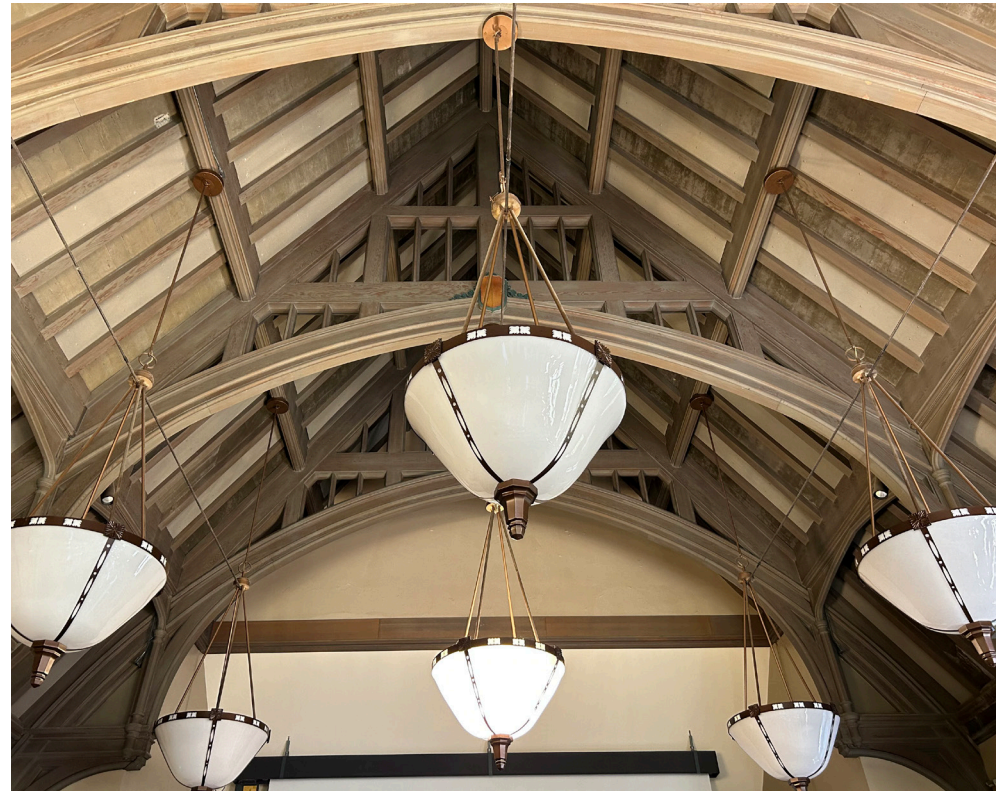
Existing Pendant Light Fixture

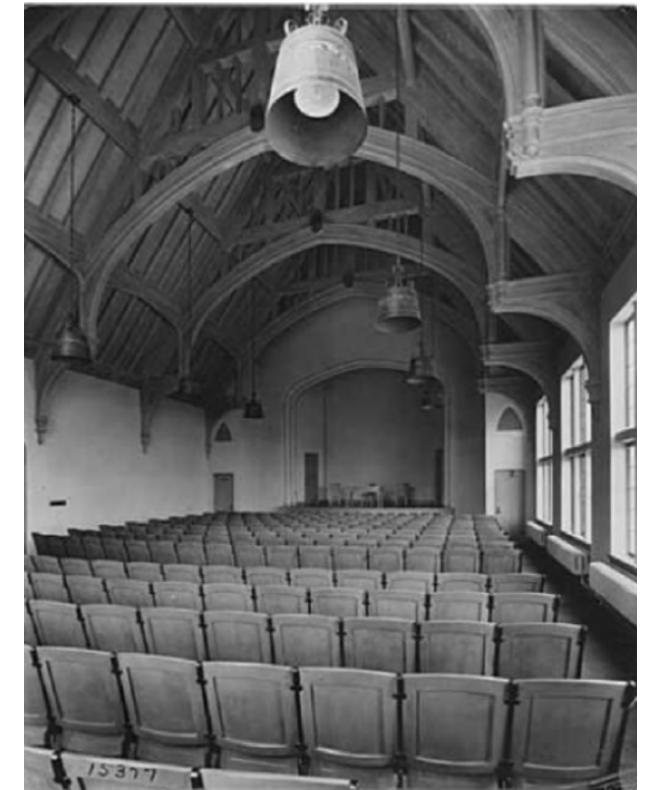
Original Light Fixture c. 1930 to 1952

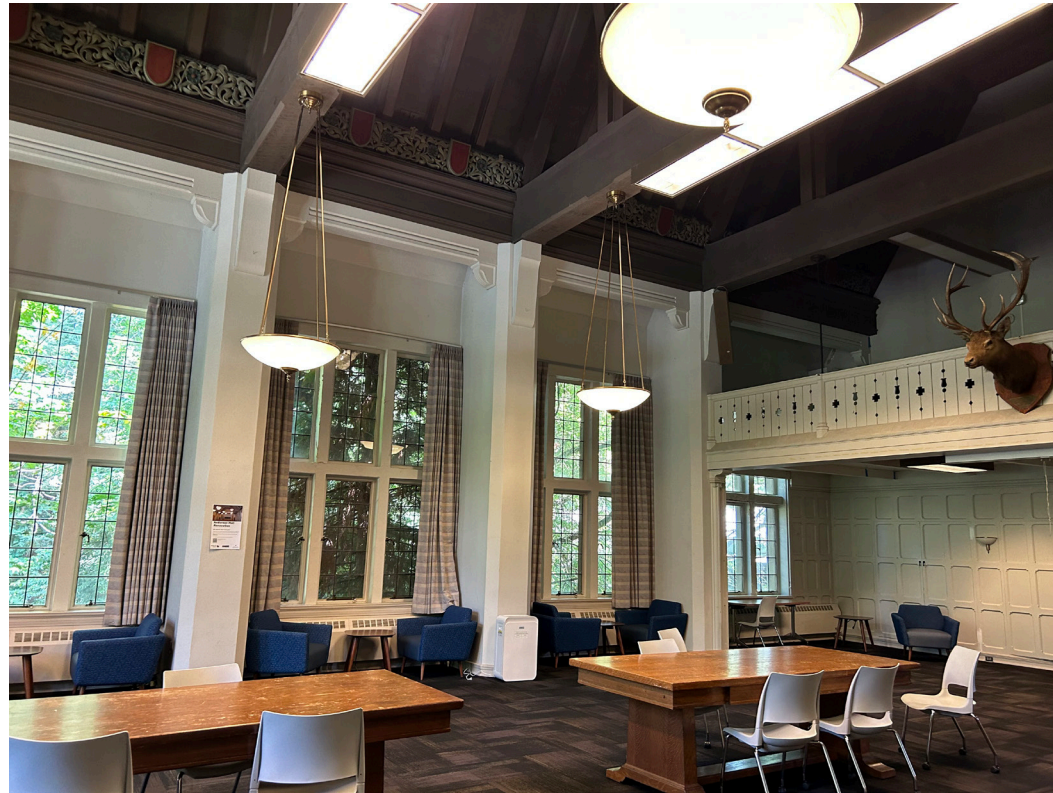
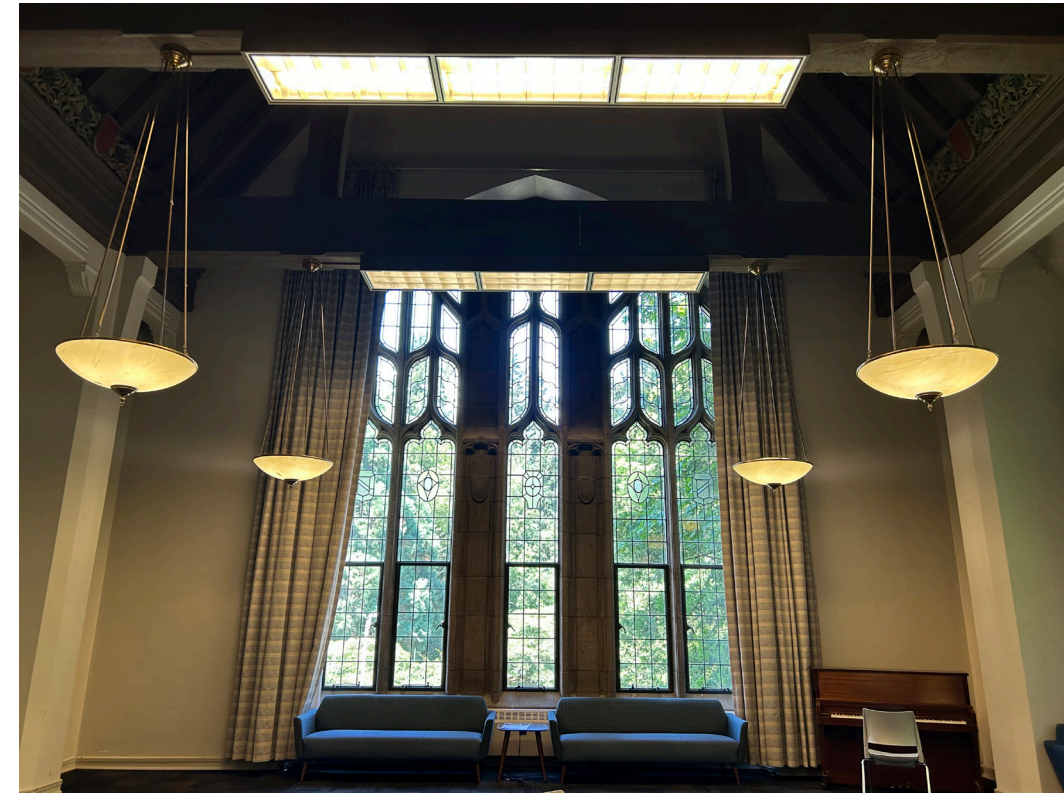
# HISTORIC FOREST CLUB ROOM

- Maintain existing volume, wall locations and historic elements
- Refresh of all finishes
- Repair of historic finishes
- Reinforcement of original hollow clay tile walls & exterior masonry/stone anchorage
