Hutchinson Hall

UW Historic Resources Addendum

BOLA Architecture + Planning
June 8, 2012

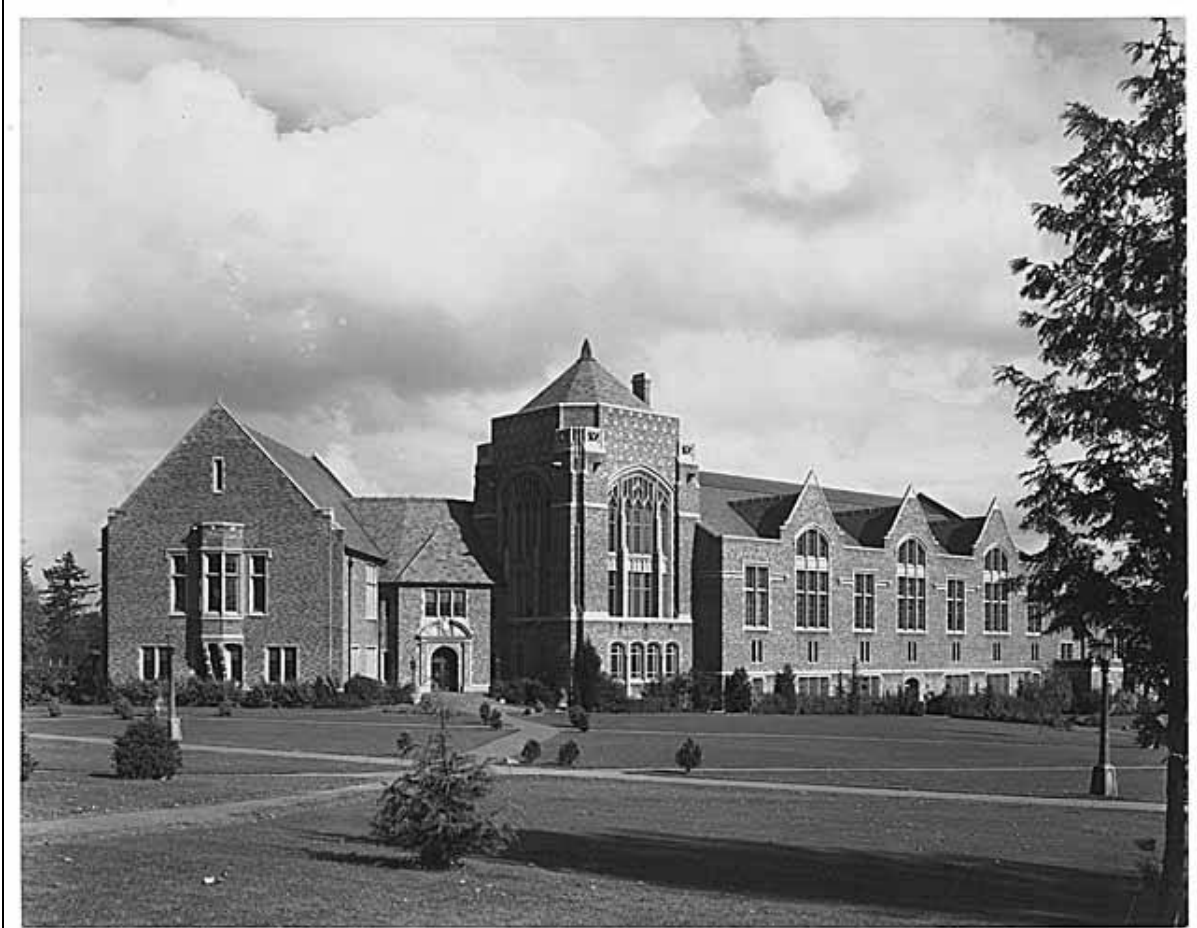
Above, a view of Hutchinson hall in 1931, prior to the realignment of Stevens Way in ca. 1938 (UW Libraries Special Collections, No. CFT0125).

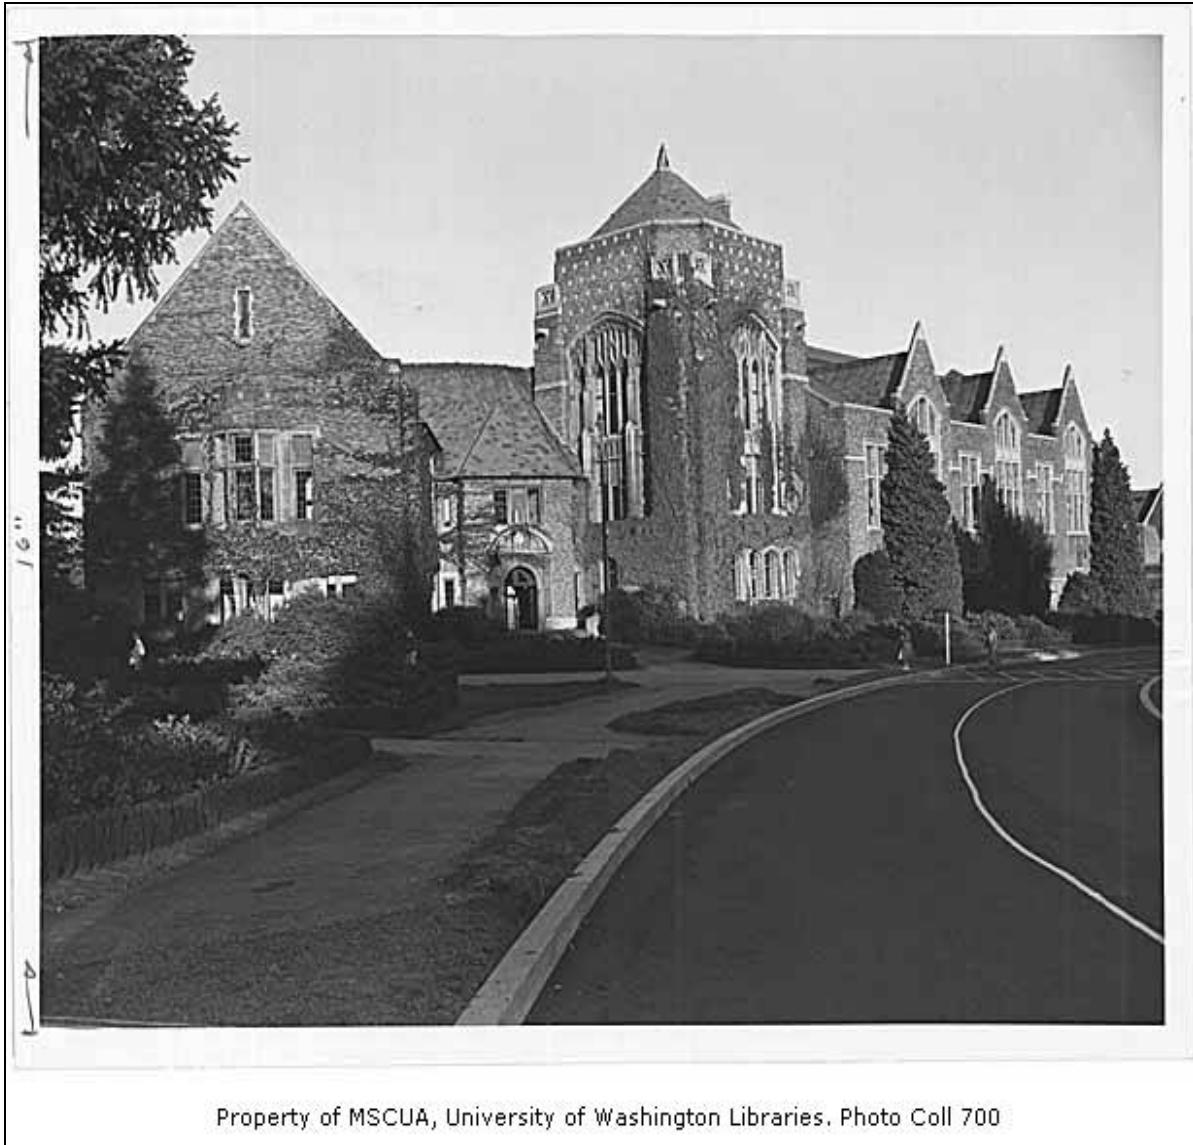
The 1954 photo of Hutchinson Hall above shows the roadbed of Stevens Way, which was widened in 1938. It currently appears wider. The sidewalk was widened after 1954. (UW Libraries Special Collections, No. 1983z).
