Copies of original Bebb & Gould plans and elevation drawings, dated November 1926, are shown on this page and on the following three pages. These building designs did not include the swimming pool section. (All drawings are from the University of Washington Facility Records files.)

Diagrammatic floor plans of Hutchinson Hall from the University's 2004 "Building Restoration and Renewal, Prioritization Study Final Report," p. 51. The second-floor plan shows the division of the original large gymnasium space, in the center, into smaller drama program and performance spaces.

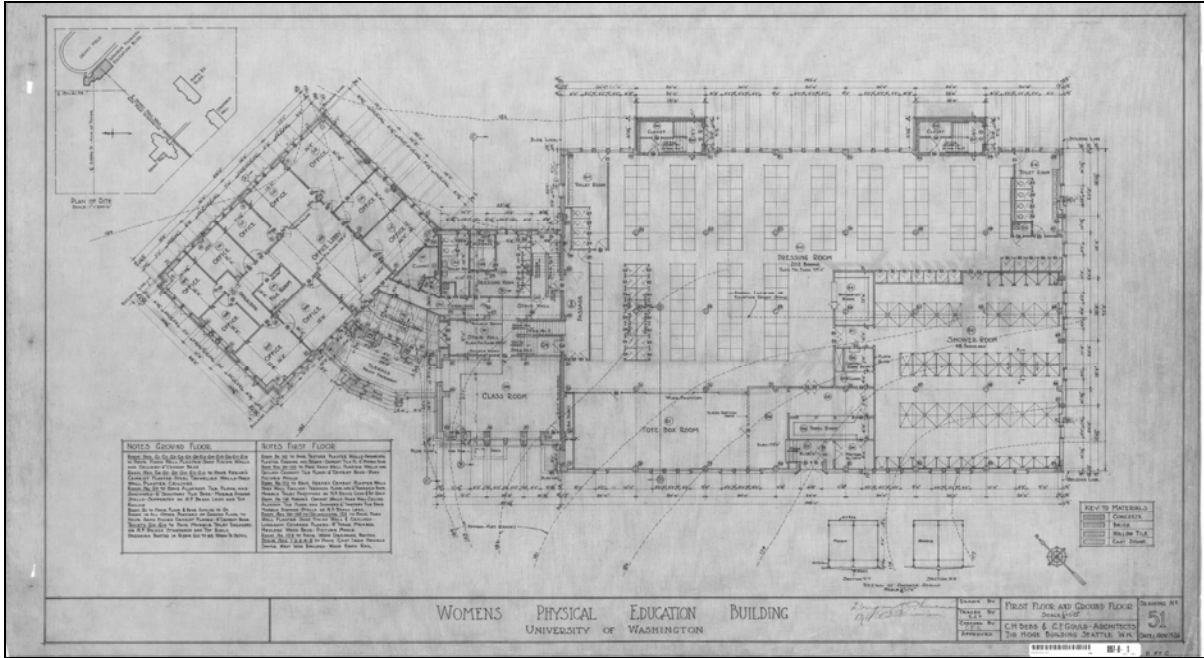
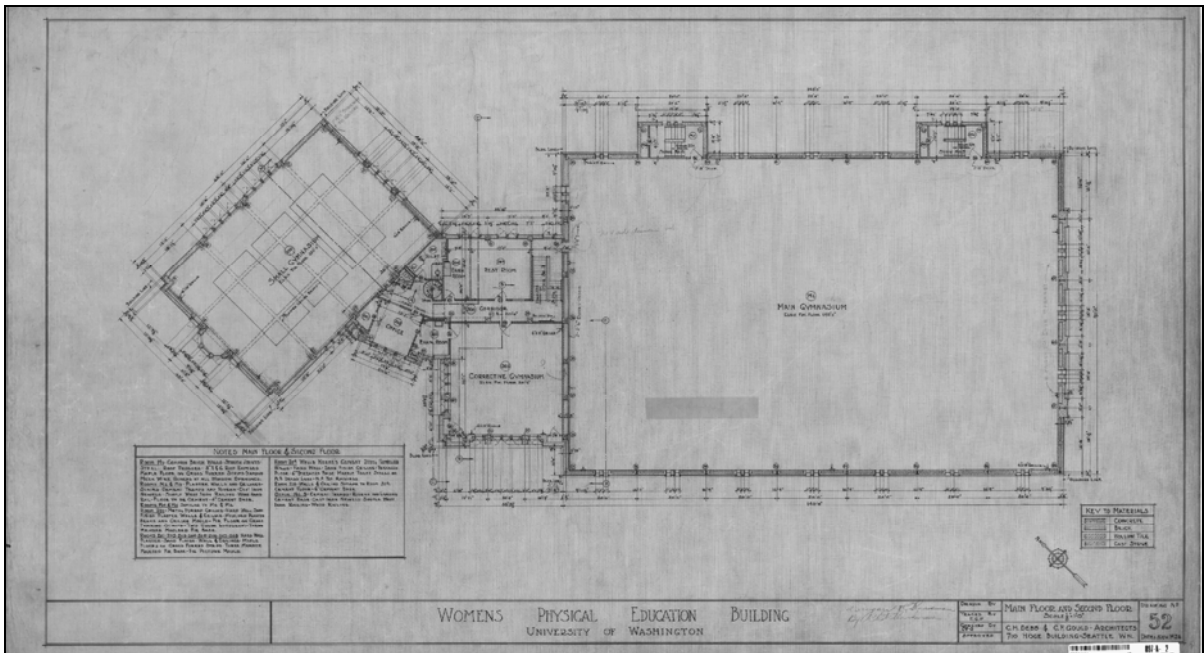
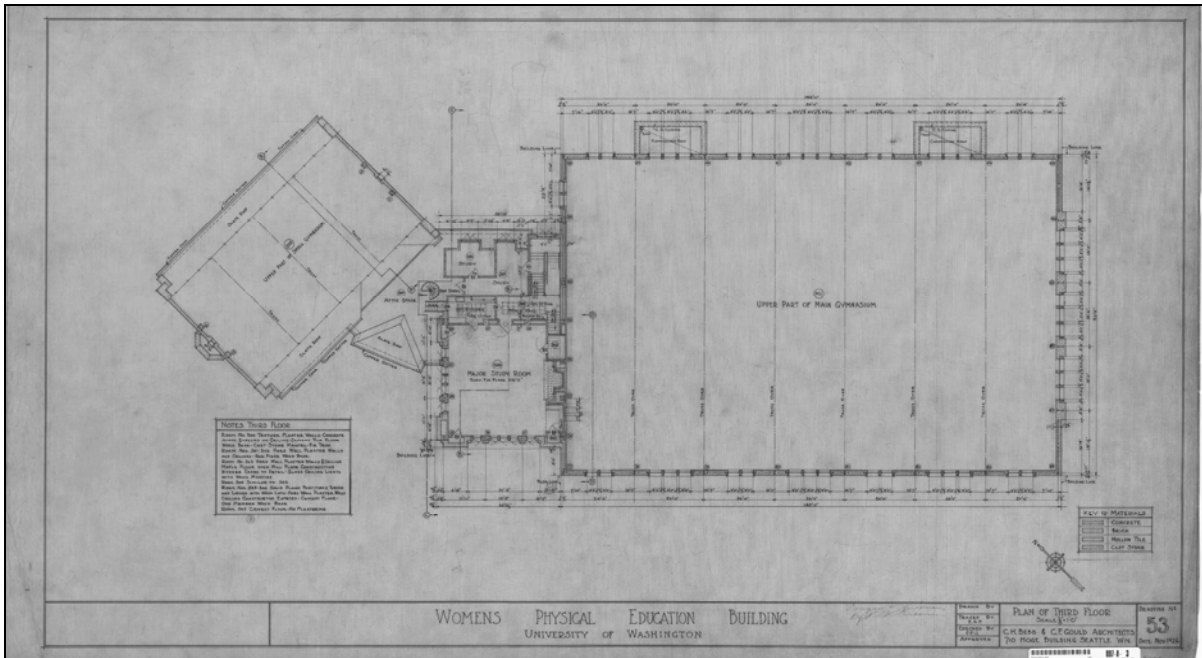
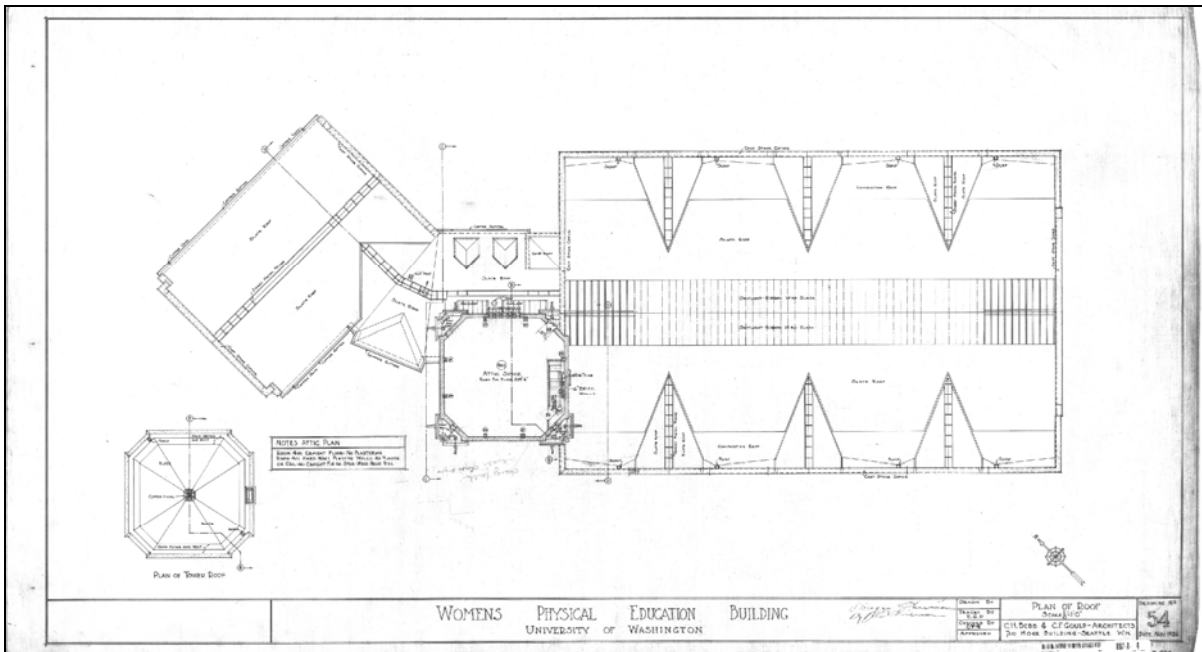
Directly below, the first floor and ground floor plan. Bottom, the main floor and second floor plan.

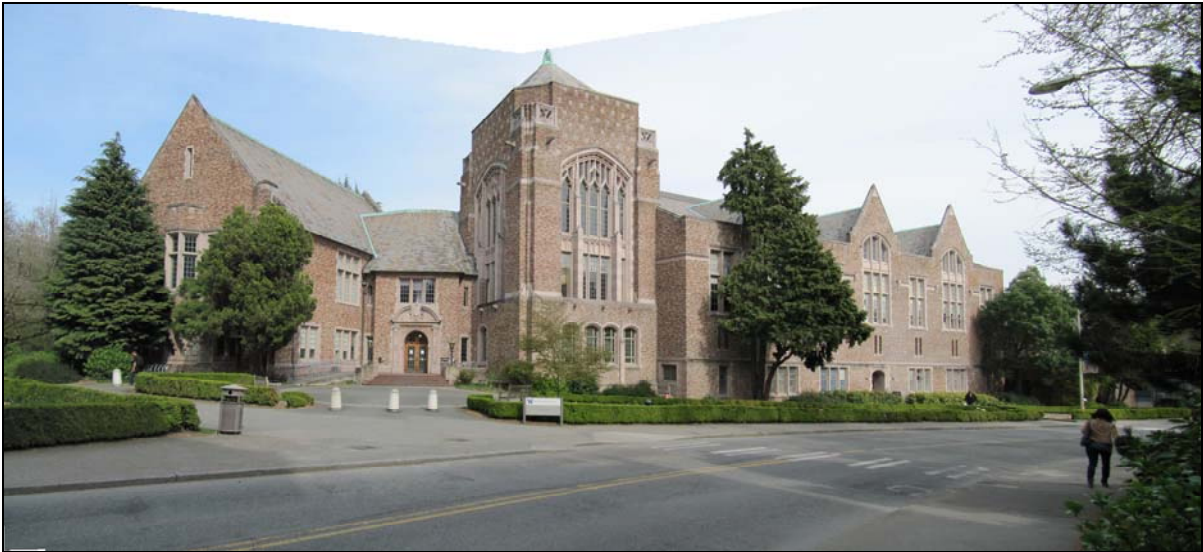
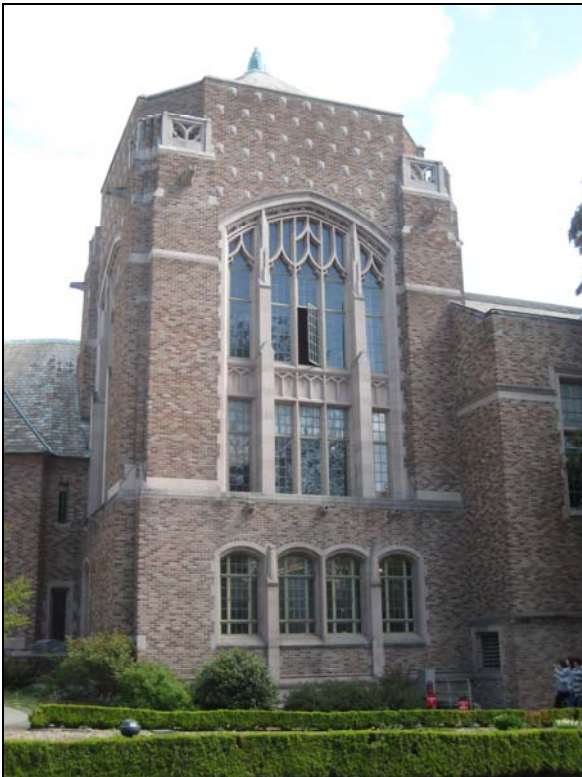
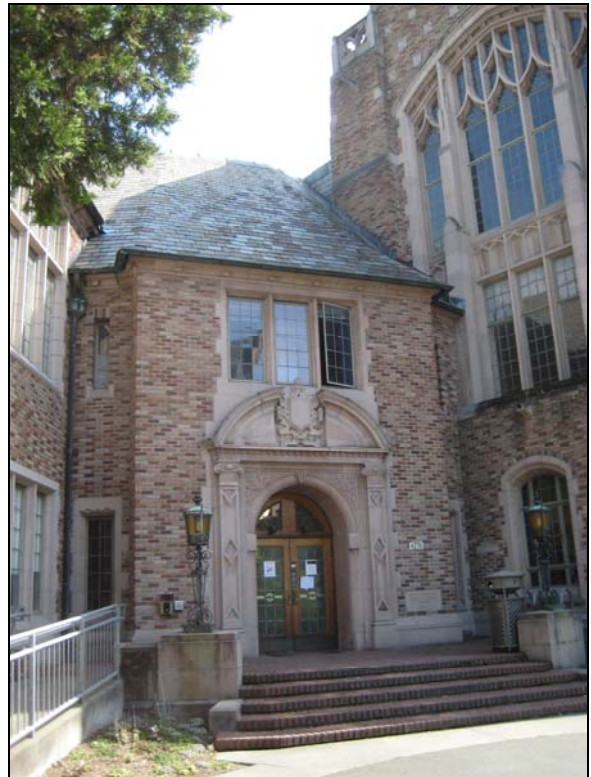
Top, a composite photo view of the north and west facades of the building. Above, detail views of the tower section and main entry. Note the steps and the accessible ramp, which arrives at the west side of the entry.

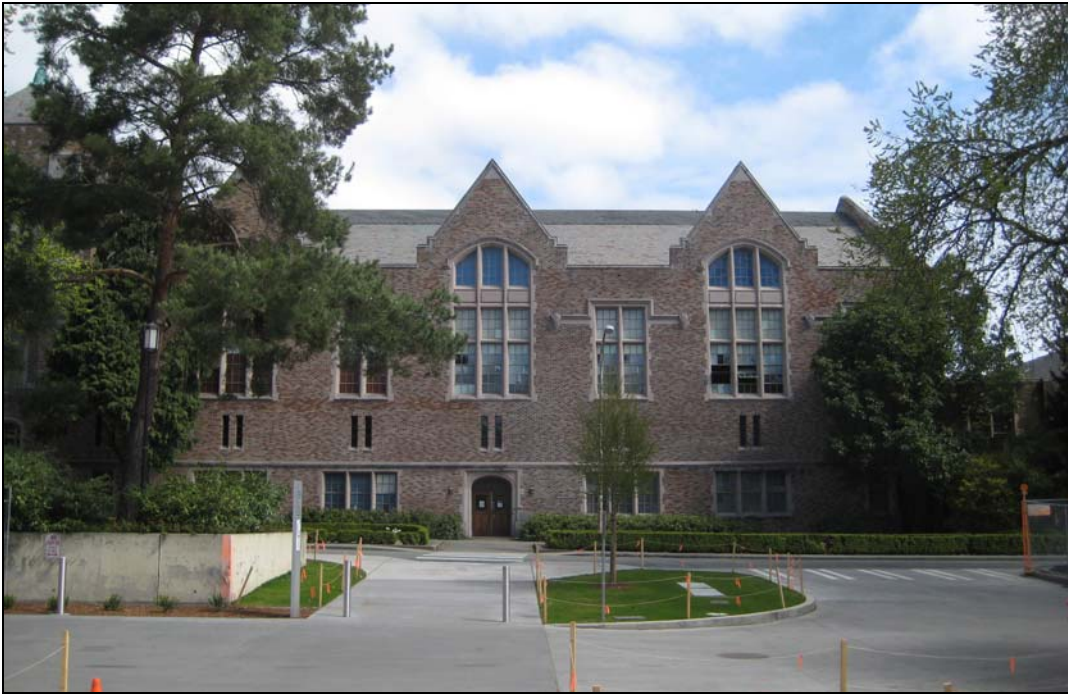
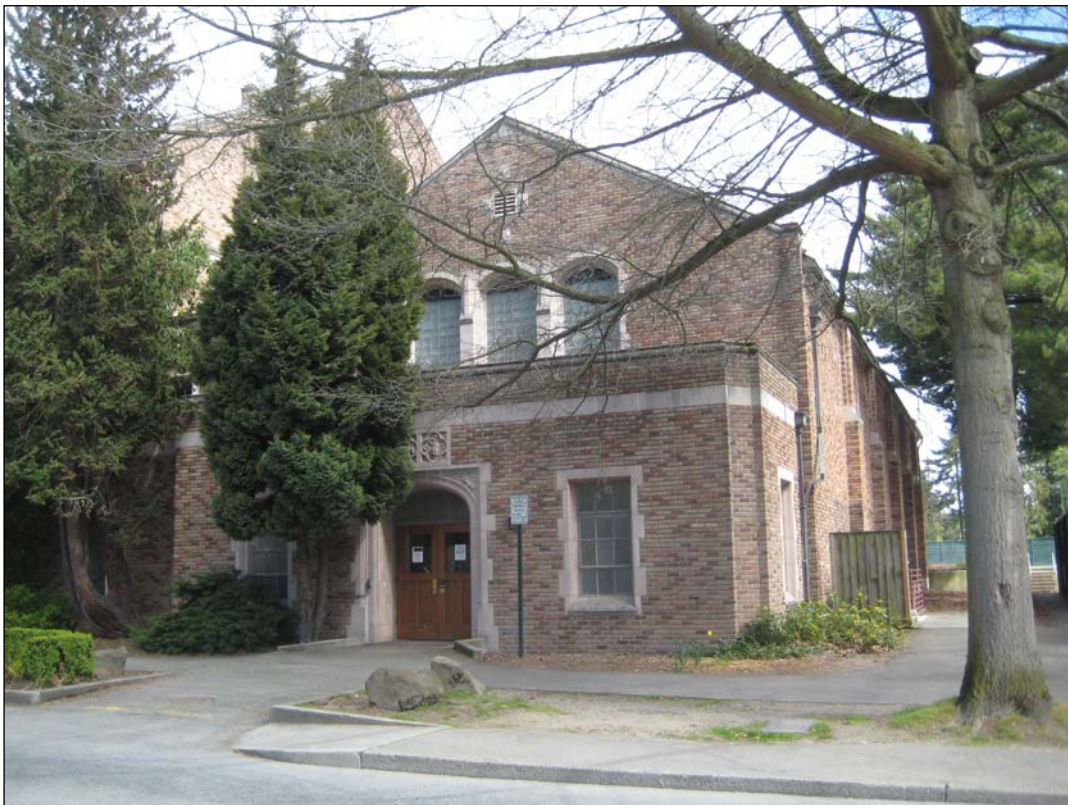
Top, partial view of the central part of the building's west facade. Above, oblique view of the entry and the west and south facades of the swimming pool wing. This wing currently contains Drama School studios and laboratory spaces. Note the close proximity of evergreen trees along the building's perimeter walls.

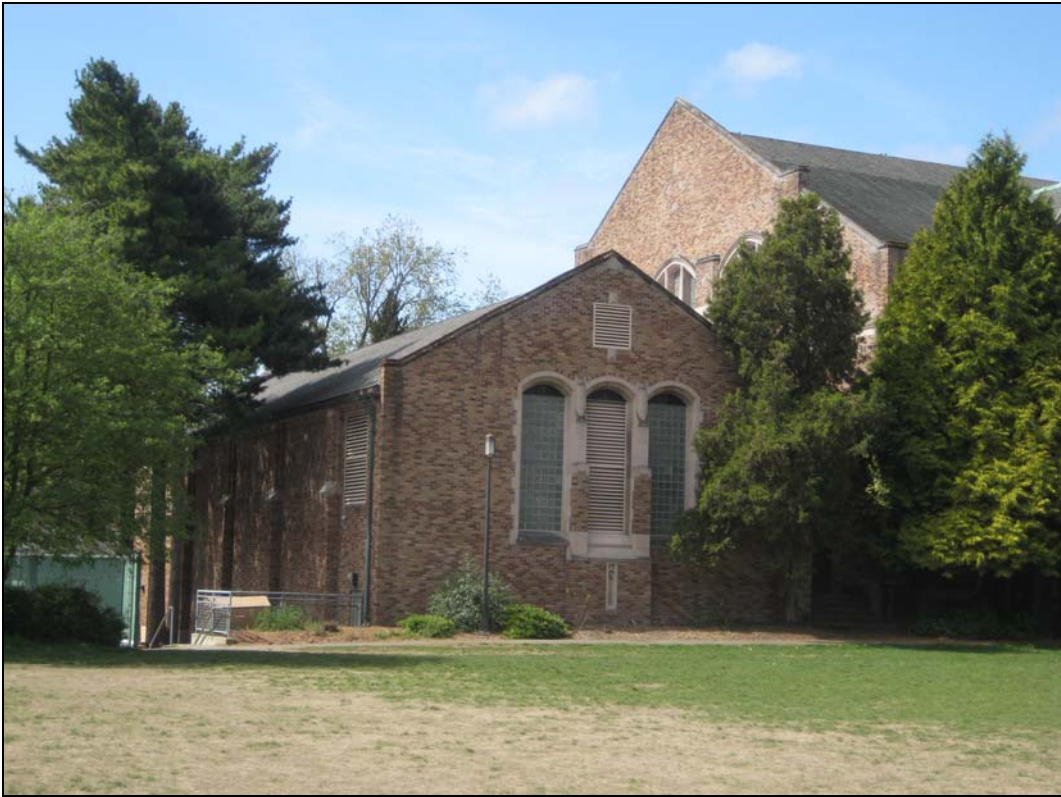
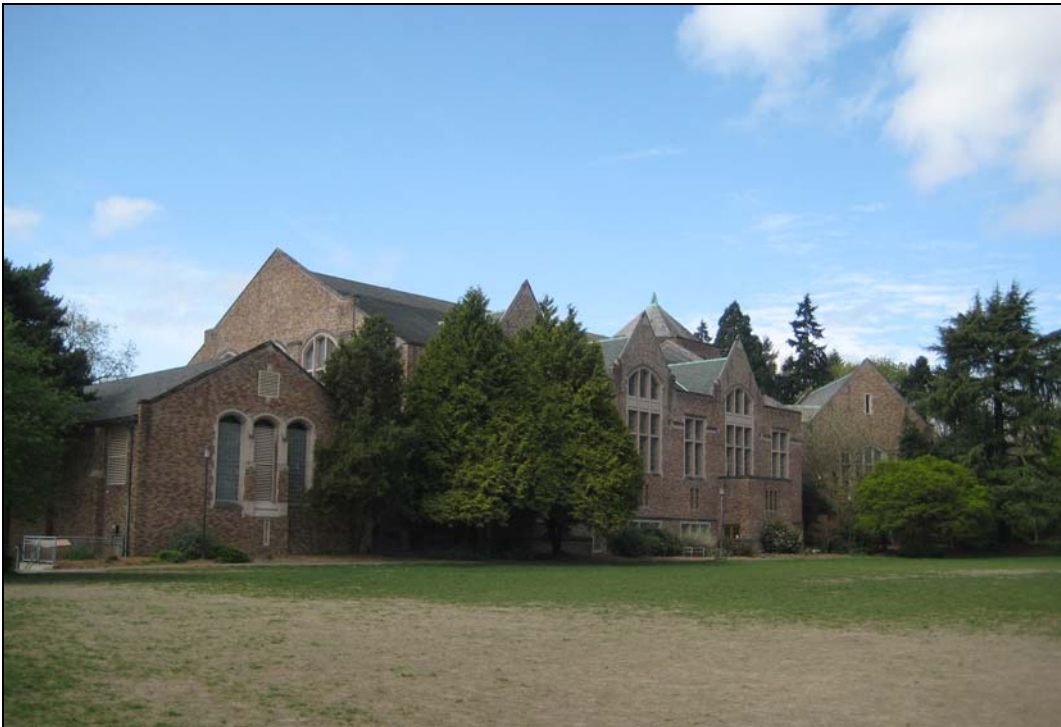
Top, oblique view of the back of the swimming pool wing building. Directly above, view from Denny Field looking at the building's back (east) facades. Note the proximity of trees.

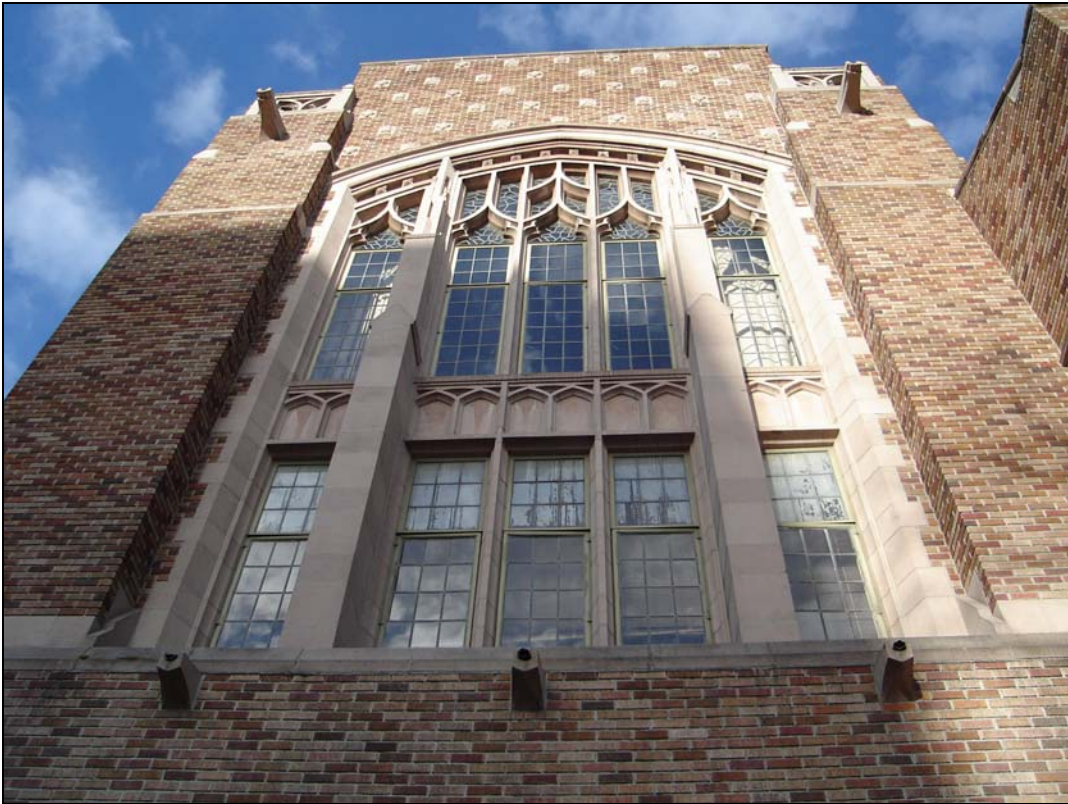
Top, the north facade. Directly above, view looking up at a large window assembly on the tower's west facade. The arched opening, tracery, cast stone surround and trim, and projecting scuppers are Gothic Revival features.

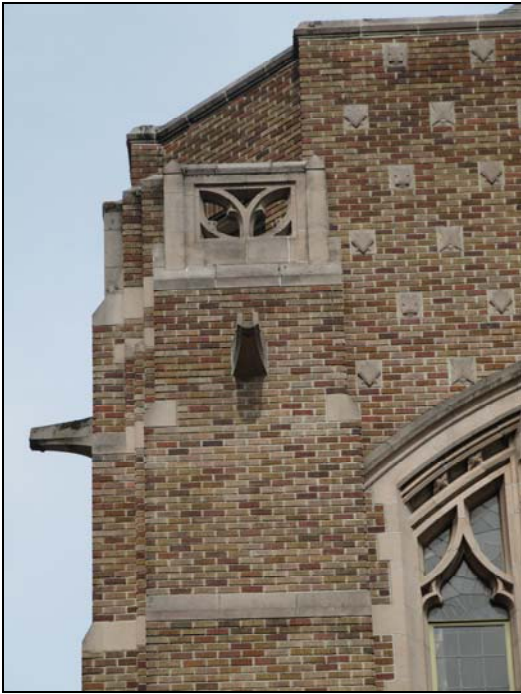
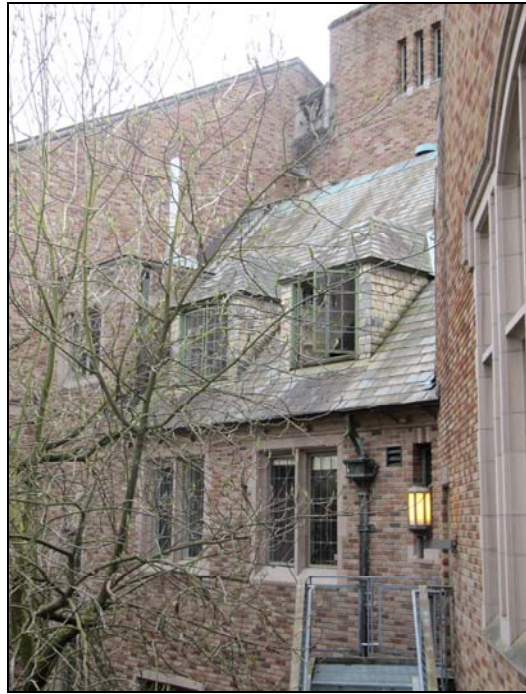
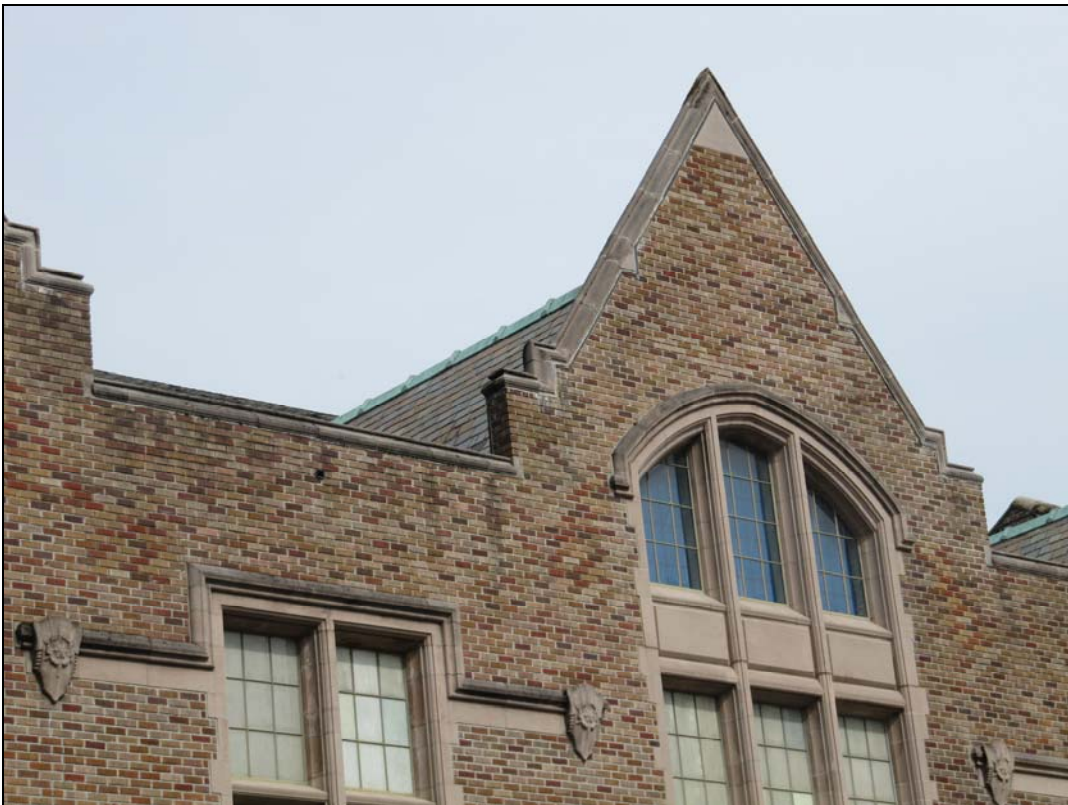
Detail views of perimeter walls, dormers, and roof features.

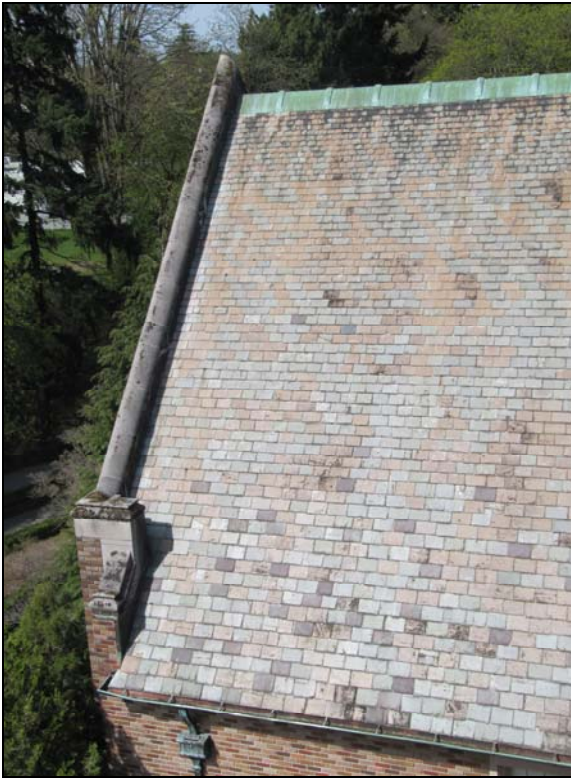
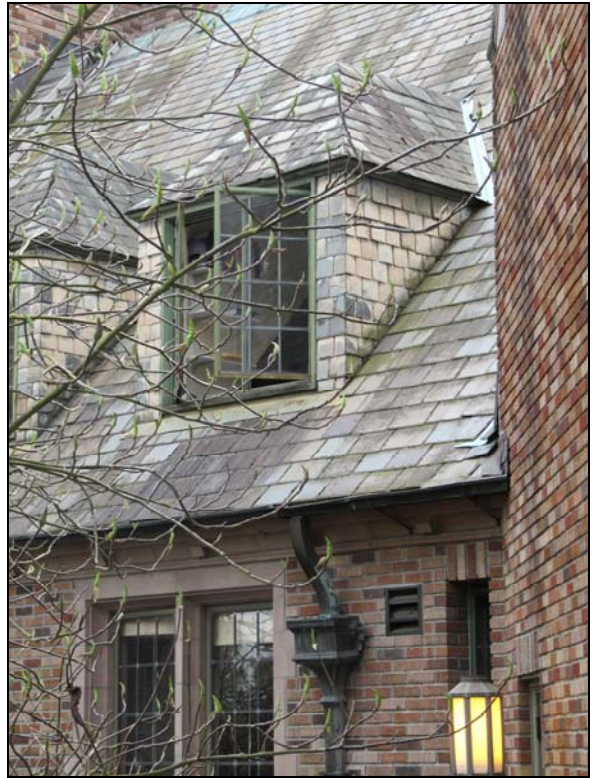
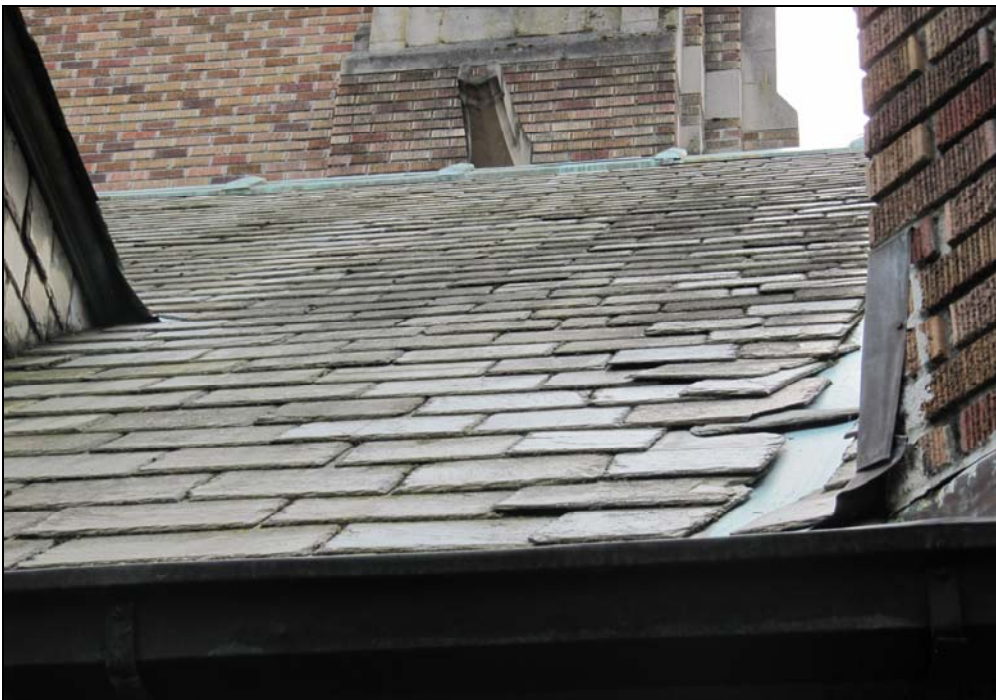
View of the gabled roof over the main mass from the tower. Note the combination of gray-colored composition shingles (over the former skylight area) and multi-colored slates, the multi-colored slates on the dormer roofs, copper cresting on the dormer ridges and copper flashing.

Above left, a view looking northwest at the south roof slope of the west wing of the building, showing the varied color, size and exposure of the original slates. Above right, views of two small slate-clad dormers on the back of the building, where the material was used for wall cladding as well as roofing. Note the copper gutters, downspouts, and scupper boxes in both views. Below, a detail view of the slate roofing near the small dormer.

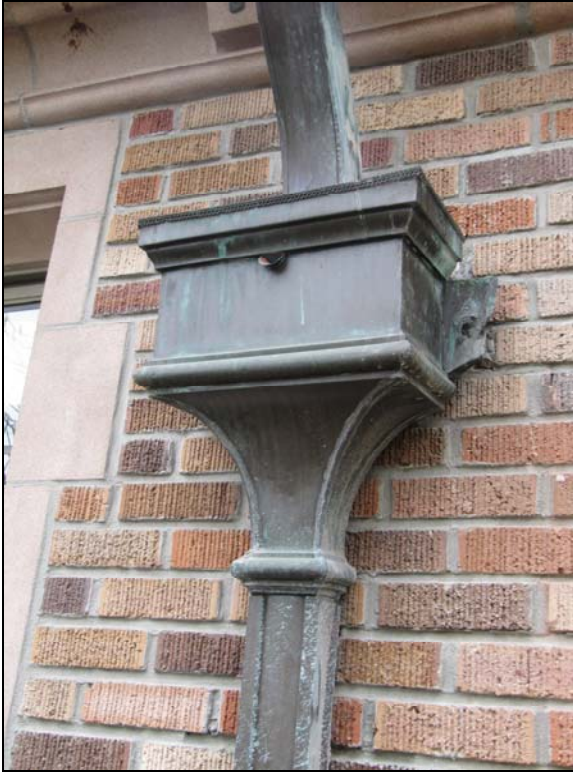
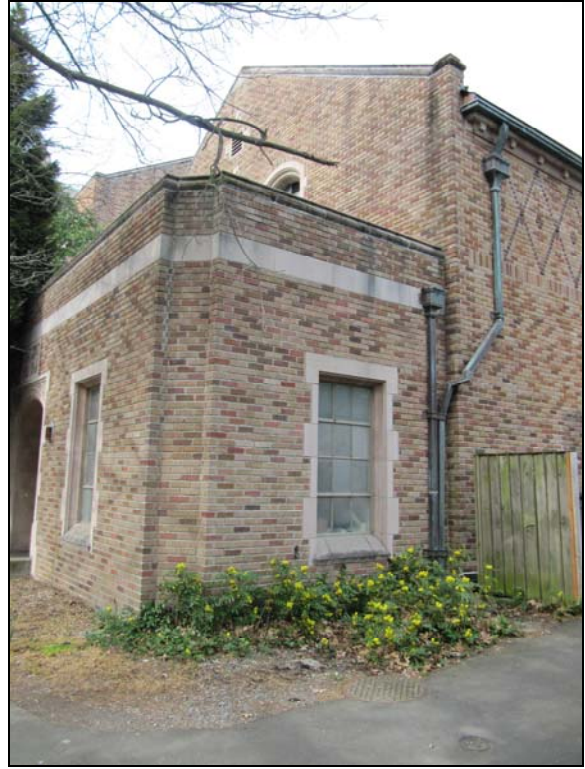
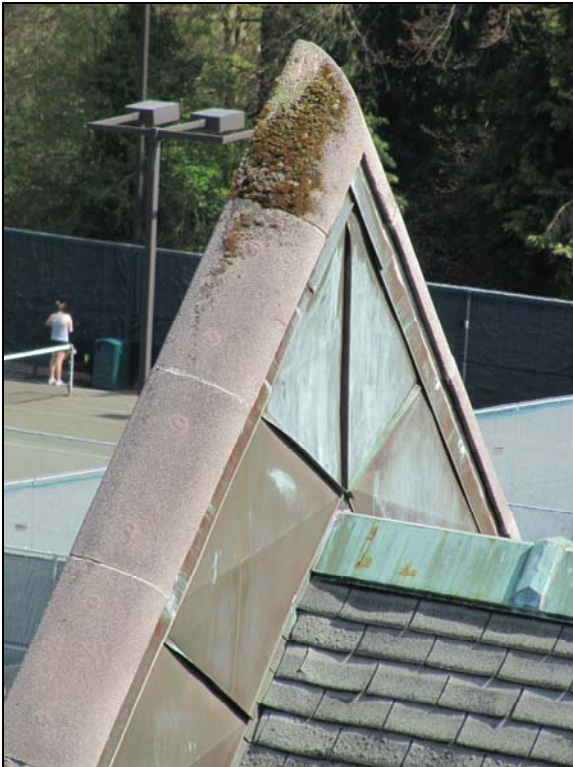
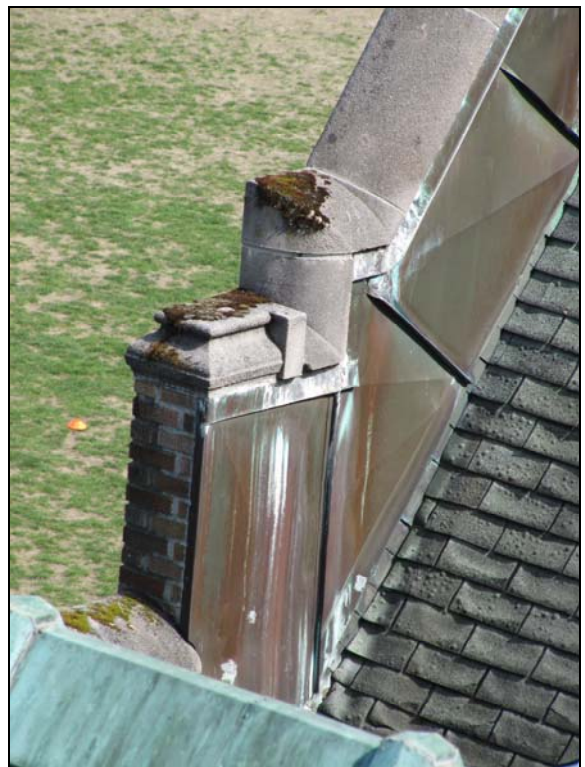
Above, views of copper downspouts and typical scupper boxes. Below, detail views of copper roof flashing, cast stone parapet cap, and copper ridge cresting.

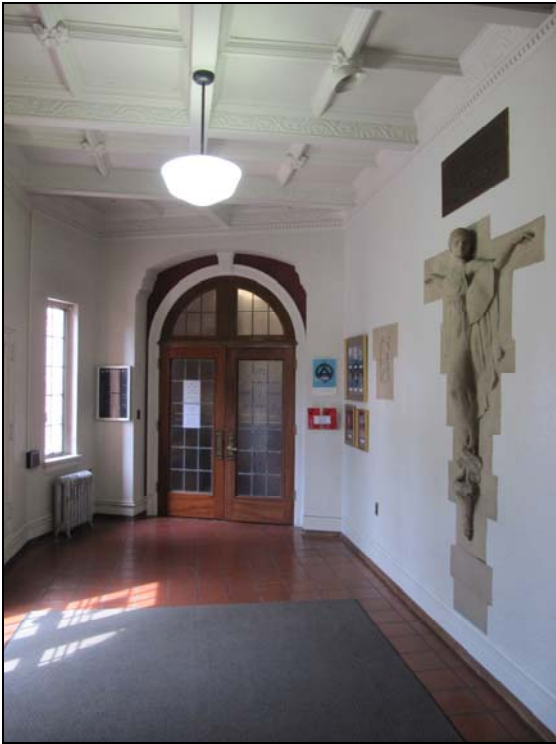
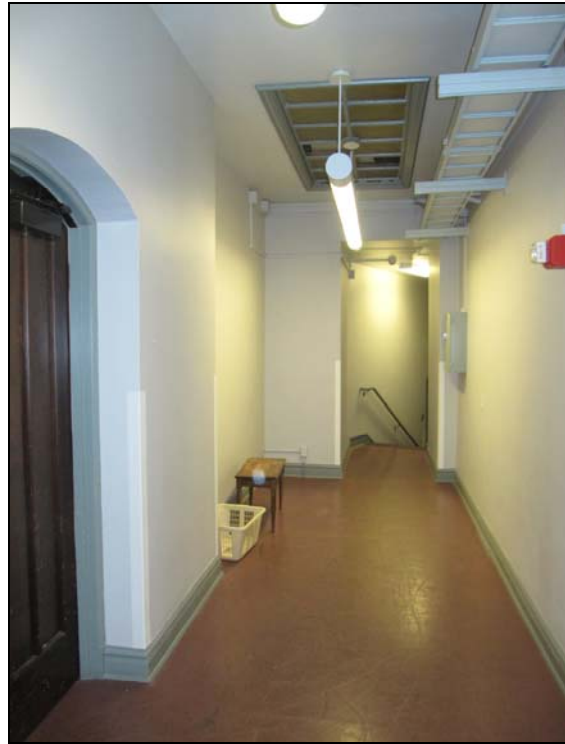
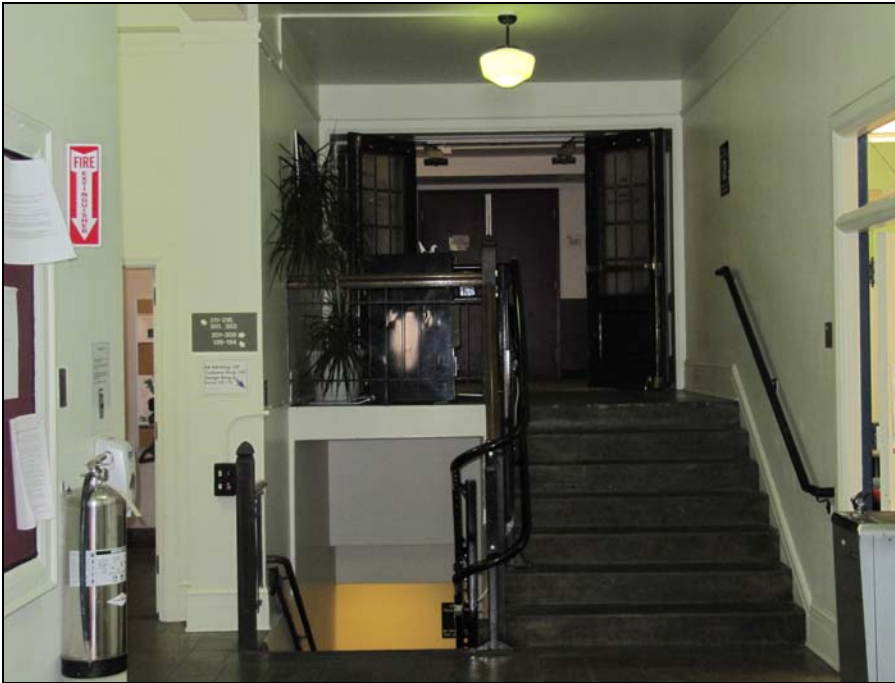
Above left, view of the main lobby space, which is characterized by a coffered ceiling, quarry tile flooring, stained wood doors with leaded windows and arched transoms, painted wood base and picture rail trim, plaster walls, and bas-relief wall sculpture. The relatively simple upper floor corridor, above right, is typical. Bottom, view of the open stair and stair lift from the first floor lobby area to the second floor. Multiple floor levels within Hutchinson Hall make universal access solutions difficult.

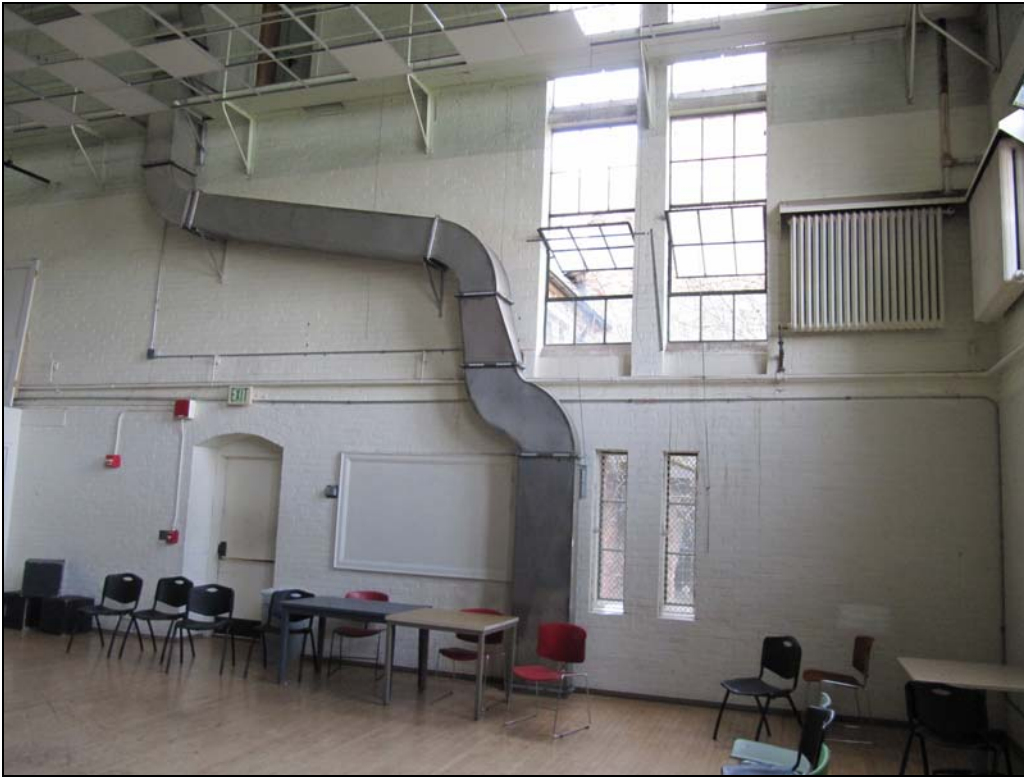
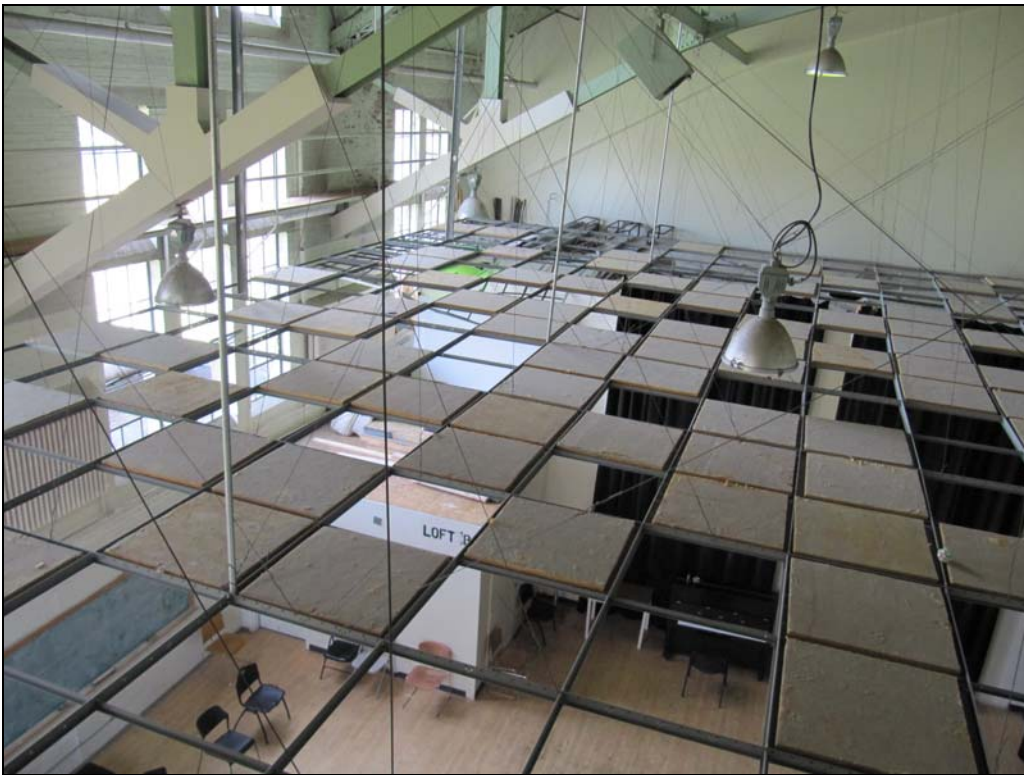
Views of two large spaces on the back (east side) of the former Main Gymnasium space, showing the tall windows, exposed mechanical and ceiling systems, and fire-resistant cladding on the roof trusses.

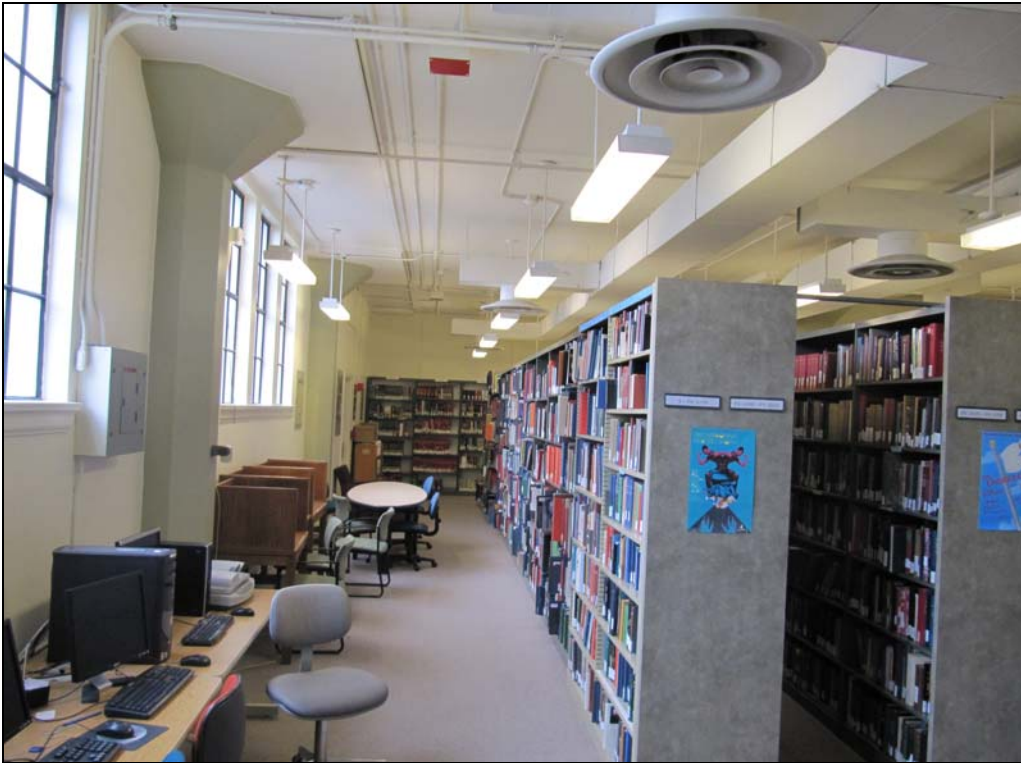
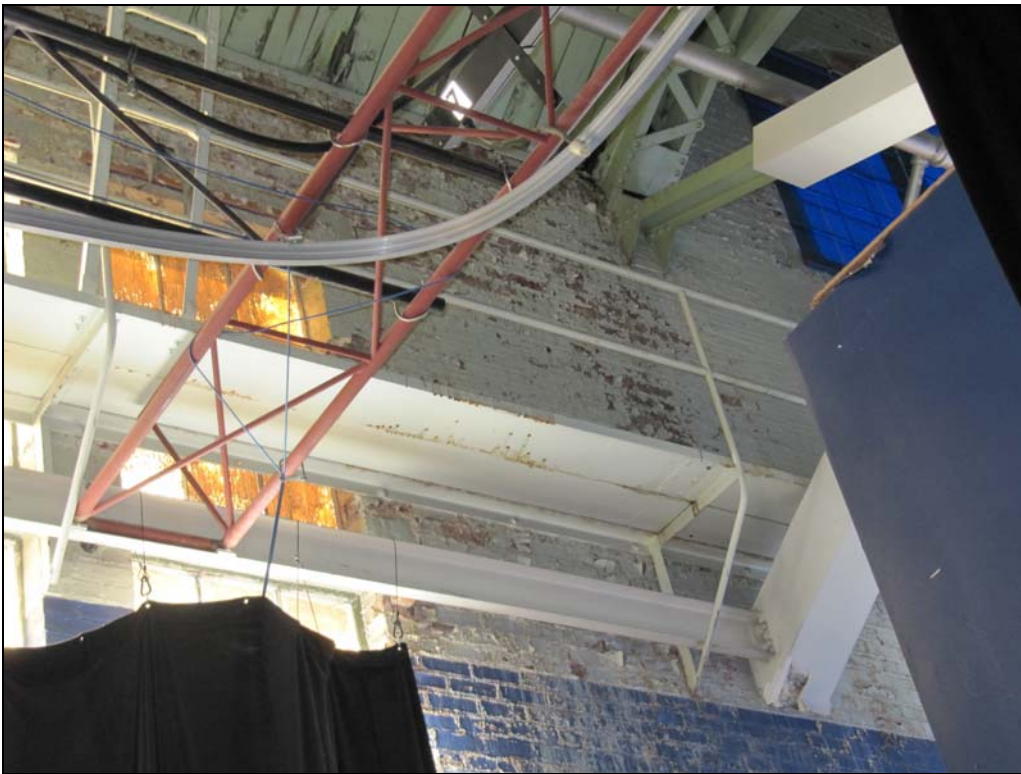
Top, finishes in the basement library space are relatively new. Directly above, a view of the perimeter masonry and spalled paint on the steel framing in Room 200, evidence of water infiltration from the roof and walls. Some of the wood roof decking appears to be damaged also.
