Historical Resources Addendum

McDonald Smith, Russell T. Joy, Tioga, and Tacoma
Biscuit and Candy Company buildings

September 2007

Prepared by
Artifacts Consulting, Inc.
201 North Yakima Avenue
Tacoma, WA 98403

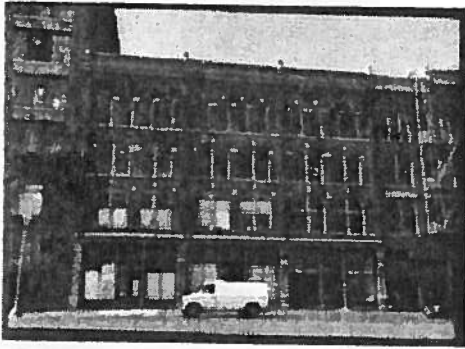
JUNE 24, 1941 VIEW LOOKING NORTH DOWN PACIFIC AVENUE. EAST (FRONT) FACADE OF McDONALD-SMITH BUILDING SECOND ONE IN. OUTDOOR PAINTED ADVERTISEMENTS FOR PARAMOUNT SUPPLY CO (OCCUPIED 1936 PACIFIC AVE. FROM 1923-1960) AND CONSOLIDATED DAIRY PRODUCTS (OCCUPIED 1934 PACIFIC FROM 1923-1937). STORE NAME FOR FAMILTON CO. (OCCUPIED 1934 PACIFIC AVE. FROM 1941-1944) CAN BE SEEN ABOVE STOREFRONT OF 1934 PACIFIC. NOTICE FIRE ESCAPE STAIRS ALONG SOUTHEAST STOREFRONT. SOURCE: TACOMA PUBLIC LIBRARY.

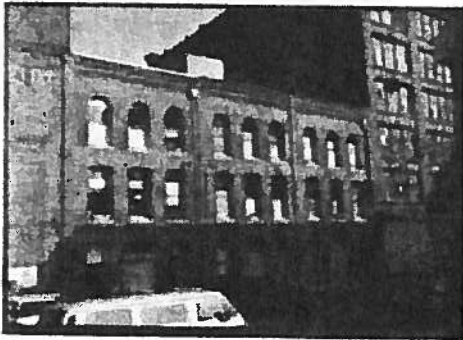
CA. 1970 VIEW OF THE EAST (FRONT) FACADE. FAINT REMNANTS OF OUTDOOR ADVERTISING FOR PARAMOUNT SUPPLY CO. MATCHING ORIGINAL STOREFRONTS LINE PACIFIC AVE. FIRE ESCAPE STAIRS HAVE SINCE BEEN REMOVED FROM BUILDING. SOURCE: TACOMA PUBLIC LIBRARY. TACOMA ECONOMIC DEVELOPMENT DEPARTMENT PHOTOGRAPH COLLECTION.

As the restoration of the McDonald Smith Building continued, the design team discovered that all of the original pilasters along the storefronts were in ruins. Fiberglass replicas were cast from the iron detailing on the neighboring buildings, and the McDonald Smith Building storefronts were restored.²¹

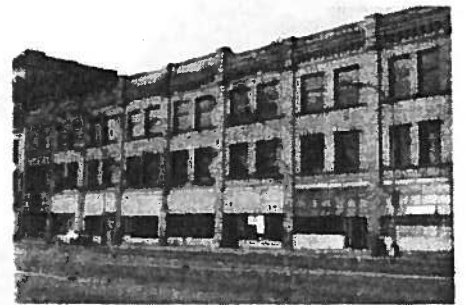
CA. 1970 VIEW OF THE EAST (FRONT) FACADE. THE ALTERED AND MODIFIED STOREFRONTS APPEAR NEARLY VACANT. SOURCE: TACOMA PUBLIC LIBRARY, TACOMA ECONOMIC DEVELOPMENT DEPARTMENT PHOTOGRAPH COLLECTION.

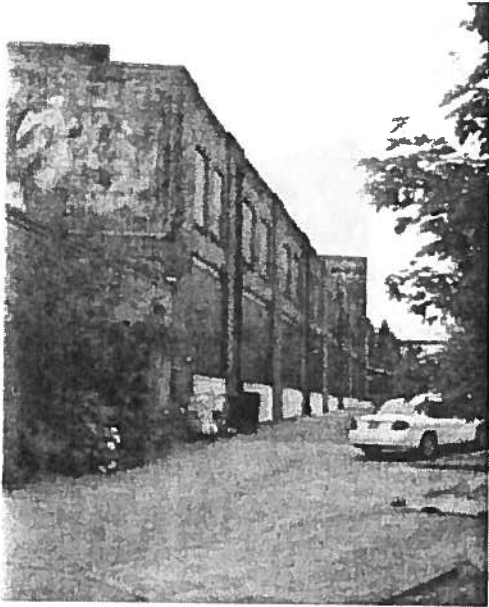
AUGUST 2007 view of the West (rear) facade. The rear bays once used for loading and unloading goods from the train are now completely boarded up in the vacant building. Source: Artifacts Consulting, Inc.

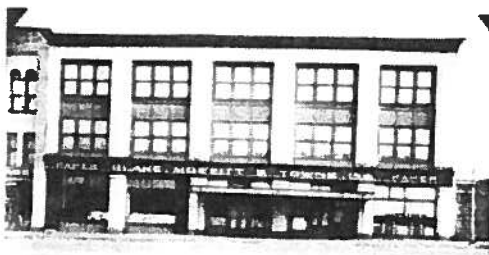
CA. LATE 1940S VIEW OF THE WEST (FRONT) AND SOUTH FACADES. OUTDOOR ADVERTISING FOR BLAKE, MOFFITT & TOWNE, INC. ADDITION OF FLAT ROOF CANOPY OVER TWO OF THE STOREFRONTS. SOURCE: TACOMA PUBLIC LIBRARY, RICHARDS STUDIO PHOTOGRAPHY COLLECTION.

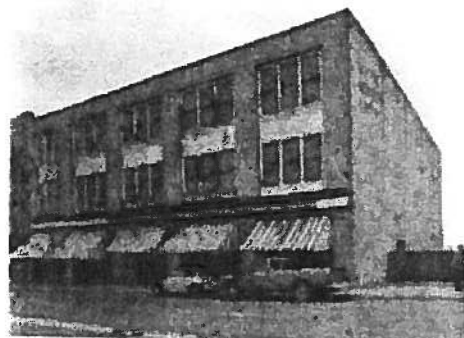
CA. 1970 VIEW OF THE WEST (FRONT) AND SOUTH FACADES. FLAT ROOF CANOPY HAS BEEN REMOVED. FIVE INDIVIDUAL CANOPIES OVER EACH STOREFRONT HAVE BEEN ADDED. WEST FACADE OVERHANG EXTENDING OUT FROM ROOF HAS BEEN REMOVED. BUILDING HAS RECEIVED A FRESH NEW PAINT JOB OF MUSTARD YELLOW. OUTDOOR ADVERTISING HAS BEEN PAINTED OVER, WITH A NEW ADVERTISEMENT FOR THE OLD SPAGHETTI FACTORY NOW ADORNING THE SOUTH FACADE. SOURCE: TACOMA PUBLIC LIBRARY. RICHARDS STUDIO PHOTOGRAPHY COLLECTION

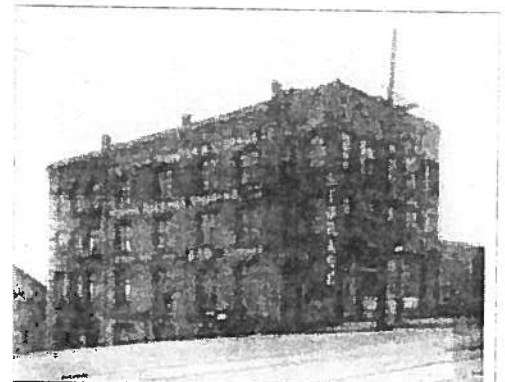
CA. MID 1920S VIEW OF THE NORTH AND WEST FACADES. THE VIEW SHOWS THE ENTIRE OUTDOOR PAINTED ADVERTISING FOR THE WHITWORTH TRANSFER & STORAGE CO. (1920-1927). SOURCE: TACOMA PUBLIC LIBRARY, CHAPIN BOWEN PHOTOGRAPH COLLECTION #BU 10791.

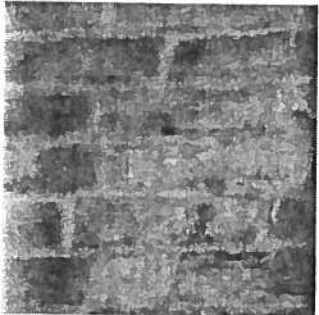
WALLS, BRICK, PACIFIC	Dense, dark red brick with slightly rounded arrises comprises the exterior wall along Pacific Avenue. The bricks exhibit a well-fired face and uniformity of hues. Bricks are laid up in a running bond as a veneer. Mortar joints are narrow. Mortar is tinted red to match the brick. Joints are struck flush. Arched, three-course headers run above window openings. Stepped, angled, and corbelled brickwork provides accents to either side of window openings and a base for the sheet-metal cornice.	<ul style="list-style-type: none"> Signs painted over some brick, see Signage. Holes for fasteners and other attachments through the brick face and mortar joints. 	Primary

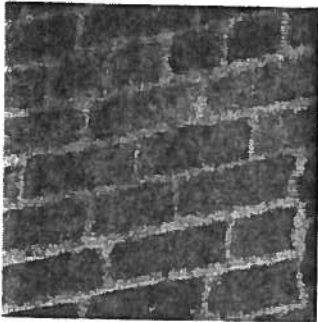
WALLS, SANDSTONE DETAILING	<p>A continuous rubbed-faced sandstone sill runs beneath the second-, third-, and fourth-story windows on the east (Pacific) facade. The sill projects from the wall plane. The top face is tooled. Mortar joints separate the stones. Window openings on all three stories feature sandstone keystones and springers at the brick arches over each window opening.</p>	<ul style="list-style-type: none"> • No known alterations. 	Primary

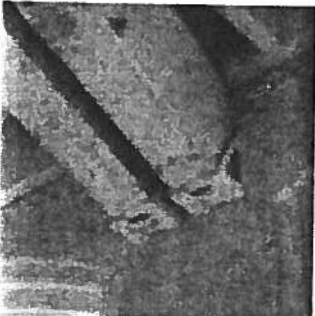
FRAMING, BEAMS	<p>Douglas fir beams support the floor joists and associated floor assemblies. Beams differ according to load capacity needs, with both single and paired examples. Beam ends rest on Douglas fir columns. All beam ends terminate in masonry set within a pocket and rest on a metal plate. Corbels project from the first- and second-floor beam pockets to provide additional bearing surface.</p>	<ul style="list-style-type: none"> • Multiple paint coatings. • Holes from previous fasteners and attachments. • Cutting beams in the south bay to allow insertion of the stairwell. 	Primary

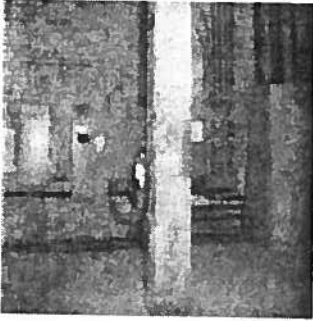
FEATURE	DESCRIPTION	ALTERATIONS	LEVEL	IMAGE
FRAMING, COLUMNS	Douglas fir columns carry floor loads. Columns differ according to load capacity needs. A row of east/west columns is centered within each bay. The first-floor columns stand on sandstone bases, rising above the surrounding concrete slab.	<ul style="list-style-type: none"> • Multiple paint coatings. • Holes from previous fasteners and attachments. • Removal of a column on each floor in the south bay to allow insertion of the stairwell. 	Primary

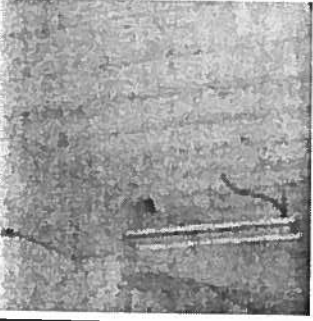
WINDOWS, TYPE 1	One-over-one lites in a double-hung wood sash characterize this window type. Original sash feature stile extensions on the upper sash, which extend beyond the meeting rail. Type 1 windows exist along the second and third stories of the east facade. The curvature of the upper sash changes due to the arch form on the second and third stories. All sash feature a wood sill over the continuous sandstone sill.	<ul style="list-style-type: none"> • Holes from previous fasteners and attachments. • Selective replacement with wood sash windows. These sash do not have the same stile extensions on the upper sash. 	Primary

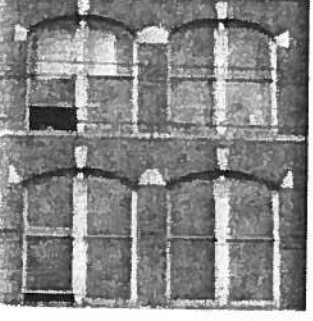
WINDOWS, TYPE 2	One-over-one lites in a double-hung wood sash characterize this window type. Original sash feature stile extensions on the upper sash, which extend beyond the meeting rail. Type 2 windows exist along the fourth story of the east facade. The upper sash features a half-round curvature to fit within the arch over the window opening. All sash feature a wood sill over the continuous sandstone sill.	<ul style="list-style-type: none"> • Holes from previous fasteners and attachments. • Selective replacement with wood sash windows. These sash do not have the same stile extensions on the upper sash. 	Primary

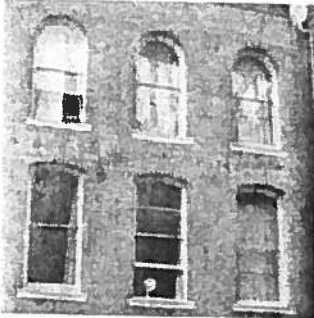
FEATURE	DESCRIPTION	ALTERATIONS	LEVEL	IMAGE
WINDOWS, TYPE 3	<p>One-over-one lites in a double-hung wood sash characterize this window type. Original sash feature stile extensions on the upper sash, which extend beyond the meeting rail. Type 3 windows exist along all four stories on the west facade. The curvature of the upper sash changes at the fourth story to the arch form. All sash feature a wood sill over the cast-iron lug sill. These notable sills slip into the window openings and feature an exterior apron beneath the projecting sill.</p>	<ul style="list-style-type: none"> • Holes from previous fasteners and attachments. • Selective replacement with wood sash windows. These sash do not have the same stile extensions on the upper sash. • Selective removal of first-story cast-iron sills. • Selective replacement of windows with doorways on the second story. This involved cutting out the lower section of masonry to street level. 	Primary

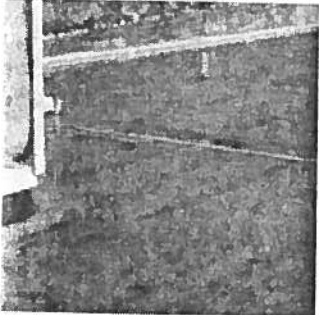
ROOF, FLASHING	<p>Contemporary metal flashing caps the parapets. Metal flashing protects the interface between the contemporary roofing and the adjacent building, the rooftop elevator, and mechanical elements.</p>	<ul style="list-style-type: none"> • Replacement of original flashing with contemporary flashing. 	None

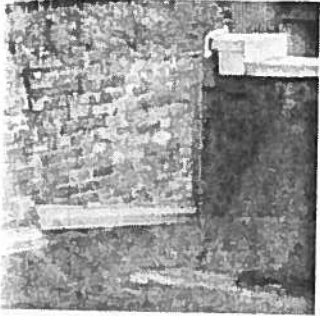
ENTRANCES, AREAWAY	<p>First-floor entrances on the west facade access the areaway beneath the sidewalk along Commerce Street. These tall, arched doorways align with the second-story doorways at street level along Commerce.</p>	<ul style="list-style-type: none"> • No known alterations. 	Secondary

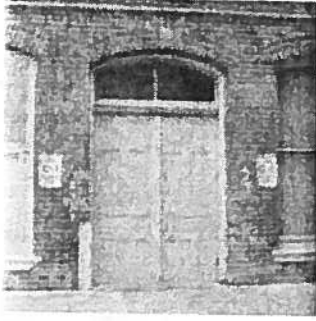
FEATURE	DESCRIPTION	ALTERATIONS	LEVEL	IMAGE
ENTRANCES, COMMERCE	<p>The Commerce Street level consists of three bays. Each bay features an original, central doorway, which measures over two feet wider than the building's window openings. The doorways enter the building at the second story. Three courses of brick headers arch over the doorway. A two-lite, hopper-type arched transom spans a pair of wood panel doors providing entry to the interior spaces. Cast-iron threshold runs beneath the doors. Heavy wood brick molding runs around the inner face of the doorway between the doorframe and masonry wall.</p>	<ul style="list-style-type: none"> • Replacement of the north bay doors with contemporary materials. • Addition of personnel doorways at former window locations in the north and south bays. • Repainting the doors. 	Primary

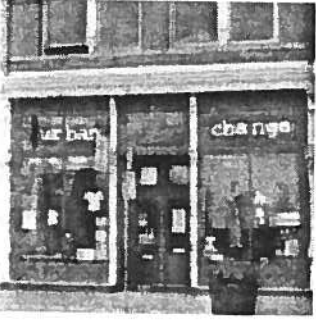
ENTRANCES, PACIFIC	<p>The Pacific Avenue level consists of three bays. Each bay features a cast-iron storefront assembly made by Cherry & Parkes of Tacoma. Principal cast-iron columns align with the building's main structural masonry piers. These structural divisions form the bays. Within each bay, slender cast-iron columns flank a central doorway. Double doors lead to the interior below a two-lite transom. The doorway is flanked by large display windows over a low bulkhead. A band of fixed lites extends the full width of the bay above the doorway and display windows.</p>	<ul style="list-style-type: none"> • Restoration of the storefront done during the 1980s utilizes fiberglass replicas of iron detailing from adjacent buildings. 	Primary

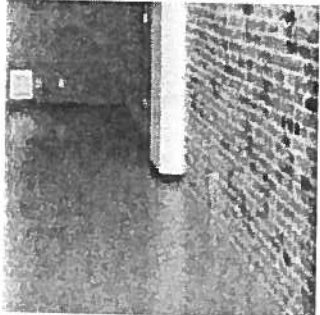
INTERIOR (McDONALD SMITH BUILDING)				
FEATURE	DESCRIPTION	ALTERATIONS	LEVEL	IMAGE
FLOOR PLAN	Each floor features an identical open floor plan. Load-bearing, multiple-wythe brick walls divide each floor into four bays. Openings cut through these walls provide access between spaces. Stairways and an elevator provide vertical access between the floors.	<ul style="list-style-type: none"> • Addition of contemporary partitions on all floors during 1980s conversion: for the first floor into commercial space and the upper three floors into residential space. The stairway in the south bay of each floor was added at this same time. • Addition of the elevator in 1931. 	Primary	
FLOORING	Douglas fir flooring runs east/west across the floor joists within each bay of the second through fourth floors. The first floor features a poured-in-place concrete slab.	<ul style="list-style-type: none"> • Holes cut for the added stairways and the elevator. • Paint layers added. • Concrete slab poured throughout the first floor and on the upper floors. Upper-floor work done as part of the 1980s rehabilitation. 	Secondary

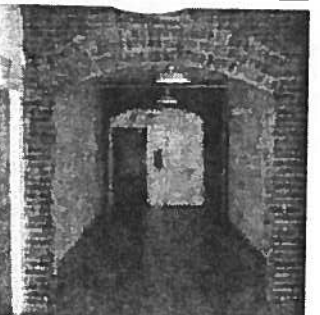
DOORWAYS	Doorways between interior spaces consist of openings through the masonry walls that segment each floor into bays. Door openings range in width. Openings feature three-course arched headers. A series of broad, centrally located openings on each floor allows north/south movement between each of the bays.	<ul style="list-style-type: none"> • Cutting additional doorways. • Infilling former doorways. 	Secondary

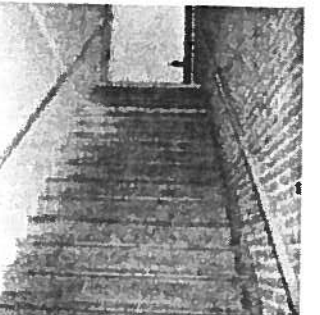
STAIRWAYS	An open stairway provides personnel access between the first and second floors in the northwest corner. The stairway features a Douglas fir carriage, tread, and risers, with a heavy wood handrail.	<ul style="list-style-type: none"> • The addition of a main stairway in the central portion of the building's south bay. 	Minimal

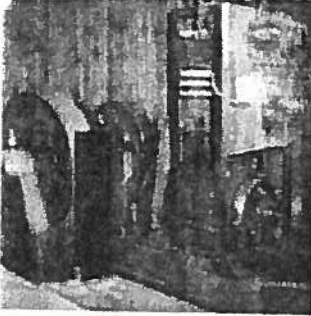
FEATURE	DESCRIPTION	ALTERATIONS	LEVEL	IMAGE
ELEVATOR	The building did not originally feature an elevator.	<ul style="list-style-type: none"> The 1931 addition of an elevator shaft and pit to service a freight elevator. The mechanical equipment is located in a shed roof, rooftop enclosure. Elevator enclosures on each floor consist of painted vertical board. The elevator is located in the north-west portion of the building. 	Minimal

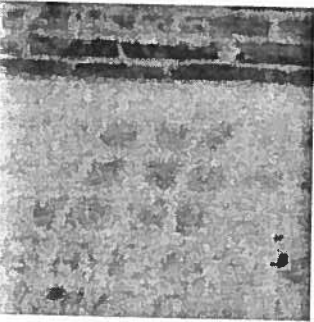
SIGNAGE	The building's east and west facades feature remnants of signs painted onto the brick. These occur on the west facade above the third- and fourth-story windows in each bay and above the second-story windows in the northernmost bay. On the east facade, signs occur above the third- and fourth-story windows in the southernmost bay.	<ul style="list-style-type: none"> • No known alterations. 	Primary

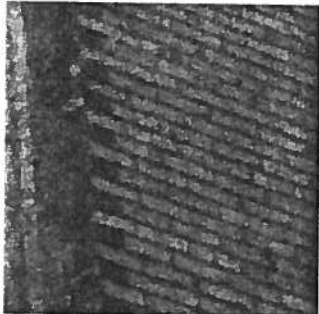
WALLS, BRICK CORE	Exterior and interior load-bearing walls are at least four wythes thick. Bricks are laid up in a common bond with headers every sixth course. Interior brick types are predominantly lighter red and interspersed with burnt brick. The lower brick quality (relative to the exterior) reflects the utilitarian character of interior spaces and indicates the cost of higher quality brick. Mortar joints range from 1/4-inch to 3/8-inch in width. Mortar is soft and light gray in color. Three-course, arched, rowlock headers span above each window opening to transfer loads to the sides. Load-bearing interior walls, aligned east/west, form four bays within the building.	<ul style="list-style-type: none"> Third story addition. Holes for fasteners and other attachments through the brick face and mortar joints. Painting the majority of interior brick wall surfaces with a variety of mediums. Infilling former doorways. Cutting additional doorways. 	Secondary

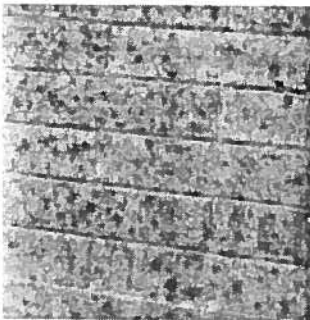
FEATURE	DESCRIPTION	ALTERATIONS	LEVEL	IMAGE
WALLS, BRICK VENEER	<p>Two brick types clad the Pacific (east) facade. The veneer is one wythe thick. The first two stories, pilasters between the third story windows, and cornice (between pilasters) feature a dense, hard-fired Roman brick with crisp arrises from the building's original construction. The third story and upper pilaster section additions feature a similar, dense, hard-fired Roman brick. Both areas exhibit tan-to-brown coloring in a range of hues, though the newer brick is slightly darker with more red tones. Both brick sections are laid up in a running bond. Metal inclusions melted during firing left pockets and spots of metal fused with the clay on the brick face. Thin (1/8-inch) mortar joints tinted brown and struck flush with the brick faces impart a monolithic character to the wall surface. Stepped bricks serve as accents—offsetting pilasters, spandrels, corbels, and the cornice from the broader wall surface.</p>	<ul style="list-style-type: none"> • Third story addition. • Holes for fasteners and other attachments through the brick face and mortar joints. 	Primary

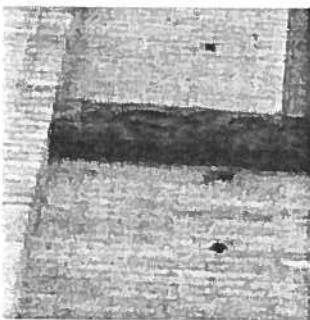
WALLS, SANDSTONE	<p>A continuous pitched-faced sandstone sill runs beneath the third story east facade windows. The sill projects from the wall plane. The top face is tooled. Stone lengths range from three to five feet. Narrow joints separate the stones, as well as the stones from the brick. The upper west facade windows feature sandstone lug sills. Each sill projects from the wall plane and features a pitched face.</p>	<ul style="list-style-type: none"> • No known alterations. 	Primary

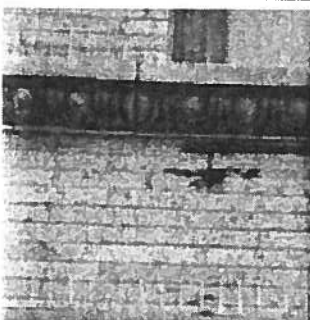
WALLS, TERRA COTTA	<p>A continuous terra cotta sill runs beneath the second story windows facing Pacific Avenue. This sill features an egg-and-dart ornamental motif. Narrow mortar joints separate the terra cotta sections.</p>	<ul style="list-style-type: none"> • No known alterations. 	Primary

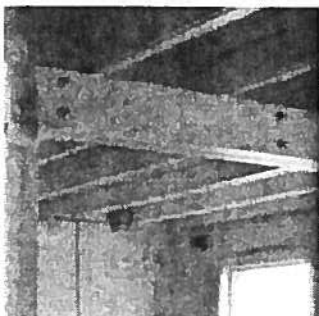
FEATURE	DESCRIPTION	ALTERATIONS	LEVEL	IMAGE
FRAMING, COLUMNS	<p>Three types of Douglas fir columns carry floor loads. Columns differ according to load capacity needs. Type 1 columns, occurring on the third floor, are 7-1/4 inches square. Type 2 columns are found in the northern two bays of the second floor and are 11-1/4 inches square. Type 3 columns, located in the remainder of the second floor and throughout the first floor, are 15-1/2 inches square.</p> <p>Each column type features a different bearing plate for the beam ends (see Framing, Beams). A row of columns aligned east/west is centered within each bay. All columns extend through the flooring at each level to rest on the column below for continuous vertical bearing. The first-floor columns stand on sandstone bases, rising above the surrounding concrete slab.</p>	<ul style="list-style-type: none"> • Multiple paint coatings. • Holes from previous fasteners and attachments. • Replacement of one portion of a column in the south bay of the first floor with poured-in-place concrete. • Addition of contemporary columns between existing columns in the two southernmost second-floor bays and the south-middle third-floor bay. These added columns typically exist between split beam sections. 	Primary

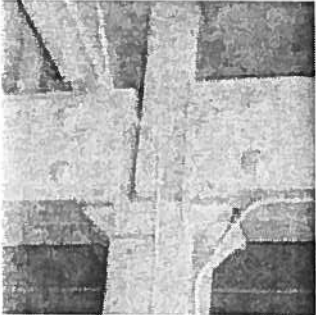
FRAMING, JOISTS	<p>Joists consist of two main types: those carrying the roof, and those supporting each floor. Joists carrying the roof are notched at the ends to rest on beams. These are the smallest joists. The larger joists carrying floor loads reach dimensions of 3-3/4 x 18 inches with approximately three-foot spacing. Joist ends at the masonry walls are set in pockets with metal strap ties attaching them to the walls. All joists run north/south. Wood corbels provide additional support beneath second-floor joists at the south end of the building.</p>	<ul style="list-style-type: none"> • Multiple paint coatings. • Holes from previous fasteners and attachments. 	Secondary

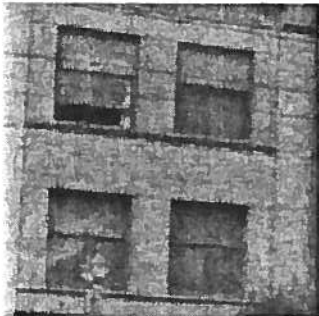
WINDOWS, TYPE 3	One-over-two lites in a double-hung wood sash characterize this window type. Overall window opening dimensions are approximately 6 feet 5 inches x 7 feet 9 inches. The two northernmost window openings on the west facade feature slightly narrower, 4 foot 5 inch openings. Original sash lifts and locks featuring decorative metal work remain on windows. Majority of sash feature original glass. These windows exist along the third story of both the east and west facades.	<ul style="list-style-type: none"> Holes from previous fasteners and attachments. Temporary plywood coverings at openings. 	Primary

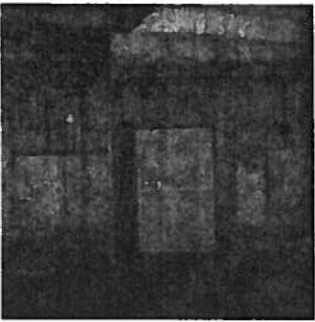
ENTRANCES, PACIFIC	The Pacific Avenue street-level facade features eight original bays. Each bay contains a contemporary storefront assembly.	<ul style="list-style-type: none"> • Replacement of the original storefronts with contemporary assemblies. 	None

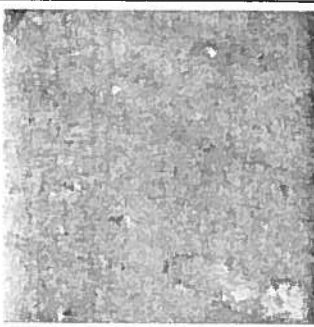
WALL AND CEILING FINISHES	Common bond brick walls provide interior wall finishes. Mortar joints are struck flush. Bricks typically range in color, though predominantly salmon-colored. Many lesser quality burnt bricks were employed on the interior of the masonry walls. The brick selection and roughness of mortar joints indicate the overall utilitarian character of these interior spaces. Holes for flues and doorways penetrate the walls. The ceiling consists of exposed joists, bracing, beams, and the underside of the upper floor's flooring.	<ul style="list-style-type: none"> • Paint and whitewash added over brick in various spaces depending upon past tenant needs. Stored materials were often organized according to markings painted on the walls. • Added doorways cut into the walls. 	Secondary

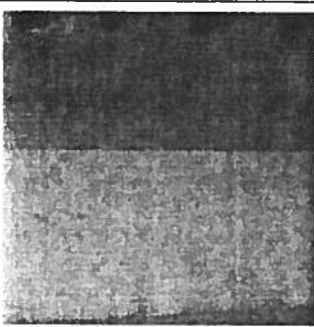
PARTITIONS	Vertical bead board over wood-stud frame partitions off restroom spaces on the second and first floors. Exterior surfaces are painted. Interior surfaces are unfinished. These restrooms feature remnant toilet connections.	<ul style="list-style-type: none"> • No known alterations. 	Minimal

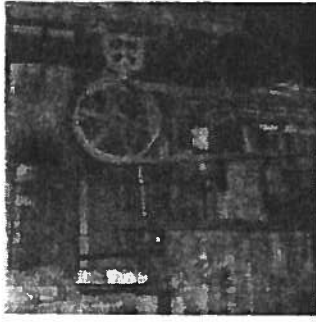
ELEVATORS	<p>Four belt-driven freight elevators service the building. These were added as part of the 1904 third-story addition. Located in the southwest corner of each bay, the elevator shaft runs from the first through third floors. Mechanical equipment for the elevators is located on the second floor. Posts and beams at the outer corners of each shaft reinforce the flooring above and provide a solid mount for rails. Rooftop units contain the upper set of sheaves for each elevator.</p>	<ul style="list-style-type: none"> • Closing off the northernmost elevator shaft at the second floor. 	Secondary

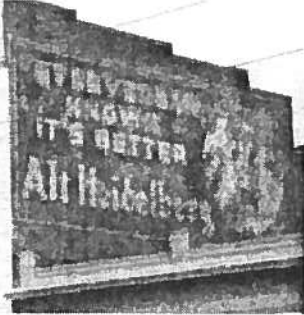
SITE (RUSSELL T. JOY BUILDING)				
FEATURE	DESCRIPTION	ALTERATIONS	LEVEL	IMAGE
AREAWAY	An areaway extends beneath the sidewalk along Commerce Street.	<ul style="list-style-type: none"> • Addition of partitions between this space and the first floor. 	Secondary	
SIGNAGE	The building's north facade features an Art Deco-style Alt Heidelberg advertisement painted onto the brick in 1933. Complete with the brewery's symbol of the 'student prince,' the Alt Heidelberg sign remains visible today, and is one of the last of its kind in existence. The sign covers the portion of this facade above the adjacent one-story building to the north.	<ul style="list-style-type: none"> • No known alterations. 	Primary

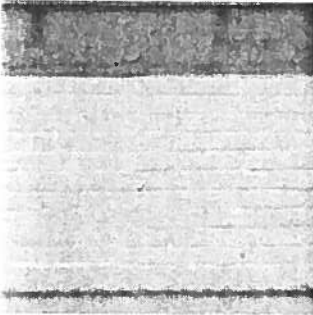
WALLS, BRICK, CORE	Exterior load-bearing walls are at least four wythes thick. Bricks are laid up in a common bond with headers every seventh course. Interior brick types are overall lighter in color, indicating lower quality and reflecting the utilitarian character of interior spaces versus the higher quality brick used on the exterior. Mortar joints range from 1/4-inch to 3/8-inch in width. Mortar is soft and light gray in color.	<ul style="list-style-type: none"> Holes for fasteners and other attachments through the brick face and mortar joints. Painting of the majority of interior brick wall surfaces with a variety of mediums. Cutting additional doorways to the adjacent building to the north. 	Secondary

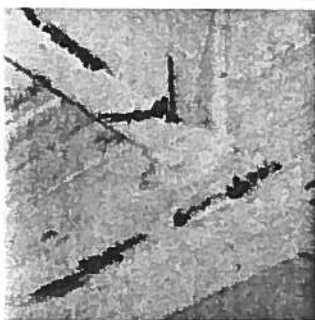
FRAMING, BEAMS	Douglas fir beams support floor joists and associated floor assemblies. Beams consist primarily of massive (approximately 1 x 2 foot) beams. Fourth-floor beams are smallest as they carry only the roof decking. Beam ends at columns rest on metal plates projecting on either side of the column. All beam ends terminating in masonry are set within a pocket and rest on a metal plate. Corbels project from the first- and second-floor beam pockets to provide additional bearing surface.	<ul style="list-style-type: none"> Multiple paint coatings. Holes from previous fasteners and attachments. Cutting beams in the south bay to allow insertion of the stairwell. Adding metal beams to provide additional reinforcement. 	Primary

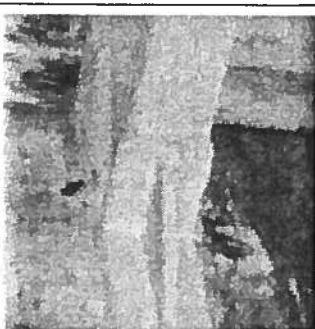
FRAMING, JOISTS	Joists carry the roof and each floor. All joists run north/south, spanning between the masonry walls and the central beam within each bay. Cast-metal brackets mounted to the north and south masonry walls carry the joist ends. Joist ends terminating at beams are carried by metal brackets.	<ul style="list-style-type: none"> Multiple paint coatings. Holes from previous fasteners and attachments. 	Secondary

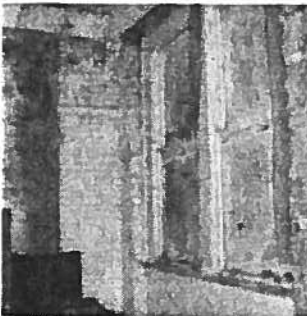
WALL AND CEILING FINISHES	Common bond brick walls make up interior wall finishes. Mortar joints are struck flush. Bricks typically range in color, though predominantly salmon-colored. The brick selection and roughness of mortar joints indicate the overall utilitarian character of these interior spaces. Holes for doorways penetrate the walls. The ceiling consists of exposed joists, bracing, beams, and the underside of the upper floor's flooring.	<ul style="list-style-type: none"> • Paint and whitewash added over brick in various spaces dependent upon past tenant needs. • Added doorways cut into the walls. 	Secondary

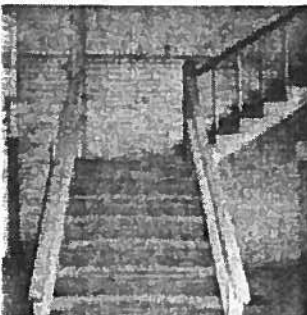
STAIRWAYS	An open wood stairway provides personnel access between the fourth and third floors along the north portion of the building. There is no stairway connection between the second and third floors. A second stairway provides access between the first and second floors.	<ul style="list-style-type: none"> • Removal of the stairway between the second and third floors. 	Minimal

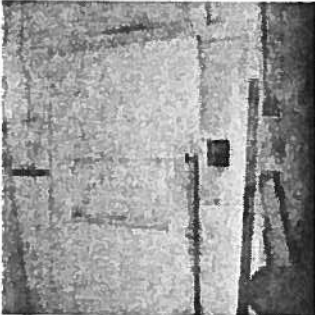
FEATURE	DESCRIPTION	ALTERATIONS	LEVEL	IMAGE
ELEVATOR	A wood frame enclosure on each floor provides access to the elevator shaft. A freight elevator operates within the shaft servicing each floor.	<ul style="list-style-type: none"> No known alterations. 	Minimal

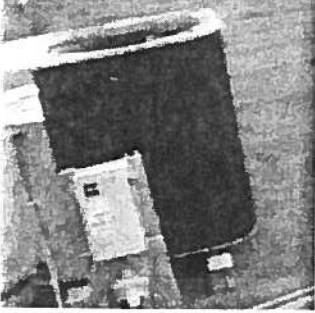
MECHANICAL EQUIPMENT	Extent of original mechanical equipment unknown.	<ul style="list-style-type: none"> Installation of rooftop mechanical equipment. 	None

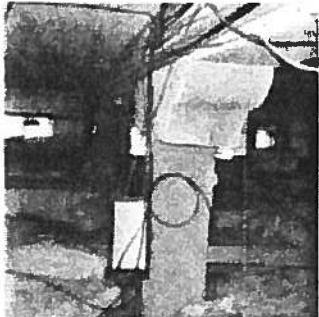
FRAMING, COLUMNS	Douglas fir columns carry floor loads. Column dimensions differ according to load capacity needs, with the lower floors exhibiting the largest column cross-sections. Columns run east/west.	<ul style="list-style-type: none"> Multiple paint coatings. Holes from previous fasteners and attachments. 	Primary

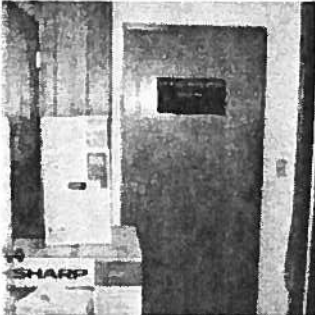
FEATURE	DESCRIPTION	ALTERATIONS	LEVEL	IMAGE
DOORWAYS	Doorways between interior spaces consist of contemporary openings in contemporary partitions. Door openings range in width.	<ul style="list-style-type: none"> Ongoing changing of partitions and door configurations according to tenant needs. 	None

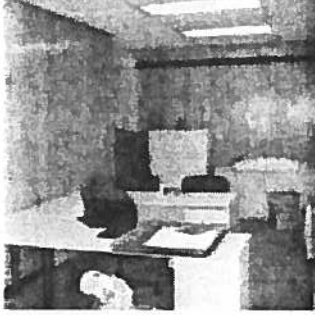
ELECTRIC LIGHT FIXTURES	Extent of original light fixtures unknown.	<ul style="list-style-type: none"> Replacement of original fixtures with existing, contemporary fixtures. 	None
