# University of Washington

Historic Resources Addendum

Magnuson Health Sciences Center and Certain Additions

Roof Replacement Projects

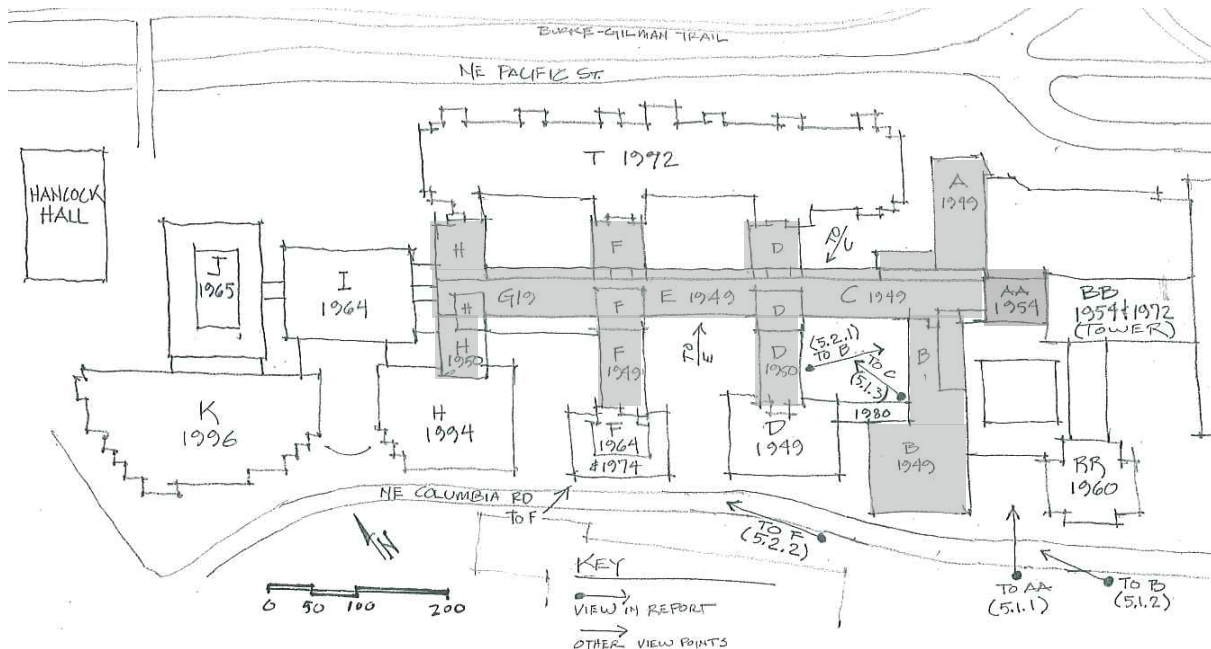
Recommendations will neither be made for portions of the building less than 45 years old, nor for conditions on the older portions of the building that cannot be seen from the adjacent streets and public courtyards. This includes roofs with parapets over 18 inches tall (high parapet), where the changes due to the roof replacement and upgrades are not visible. Those roofs are identified as B5, C1, C2, C5, D5, D6, F4, F5, F7, G1, J1, J2, and J6. The façade-to-roof transitions that cannot be seen from the street or courtyards have been identified as B3, B4 and E1. Those portions of the building that are less than fifty years old and may be more easily adapted to the proposed roofing system have been identified as B1, C3, C5, F6, F8, F10, F11, and F12.

Recommendations will be provided for the parts of the building that are older than 45 years of age, and where the proposed roof replacement and upgrades will require changes to the existing façade-to-roof transition that will be visible to the public viewing the structure from the street or other public courtyards. This includes roofs with a gravel stop edge condition as well as those roofs where the existing parapet is less than 18 inches tall (low parapet). Roofs with gravel stop conditions have been identified as AA, B6, C3, C4, D4, and E2. Roofs C4, D4, and E2 are all substantially the same condition and will be treated as one condition. Roofs with low parapet walls have been identified as B2, and F13.

Original buildings are shaded and additions dated. The visibility of various roofs are also indicated with specific views noted (Section 5).

If the proposed roofing system requires flashing over the top of any existing terra cotta parapet cap visible from below, an effort should be made to minimize the amount of terra cotta covered by flashing. If stainless steel is currently covering the terra cotta it should be removed and replaced with copper that only covers approximately 2" of the face of the terra cotta.

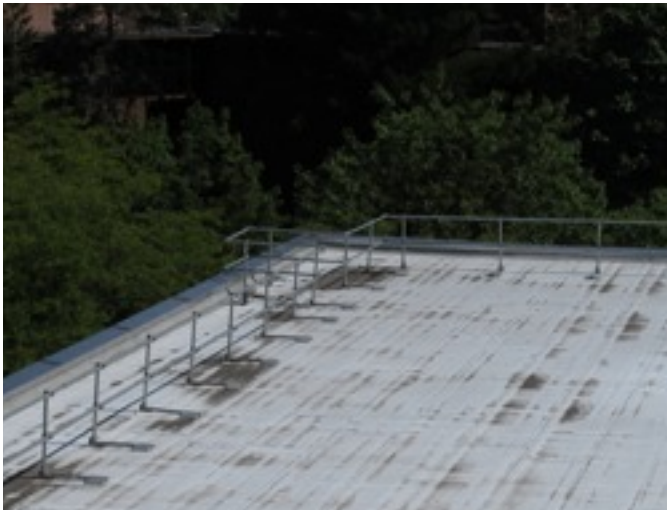
Safety railing on A wing.

Any roof access safety rails or attachments should be installed in such a manner as to be useful and minimize the visual impact from below. While safety harnesses and attachment points do minimize the visual impact, they may be less practical than guard rails for worker ease of access and range of activity and amount of time required to allow safe access. The safety railing system should be of the variety that has no roof penetrations minimizing the possibility of future roof leaks. The existing metal safety rails on the roof of A wing are an example of rails set back from the roof edge minimizing the visual impact while providing safe roof access. A 42-inch high guardrail should be set back from the edge about 60 inches to minimize visibility from below while still allowing adequate access to the majority of the roof area.

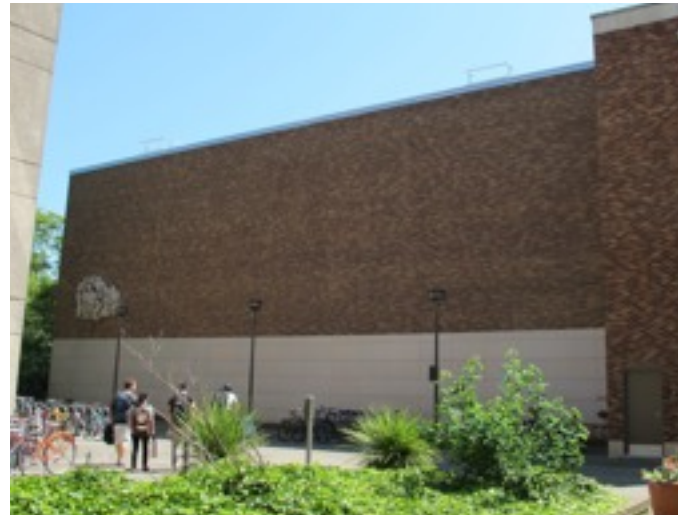
Minimal impact of metal railing set back from edge of roof.
