**ENVIRONMENTAL CHECKLIST**

**Anderson Hall Renovation**

**January 2024**

**SIGNATURE PAGE FOR**  
**GEOTECHNICAL REPORT ON**  
**ANDERSON HALL RENOVATION**  
**SEATTLE, WASHINGTON**

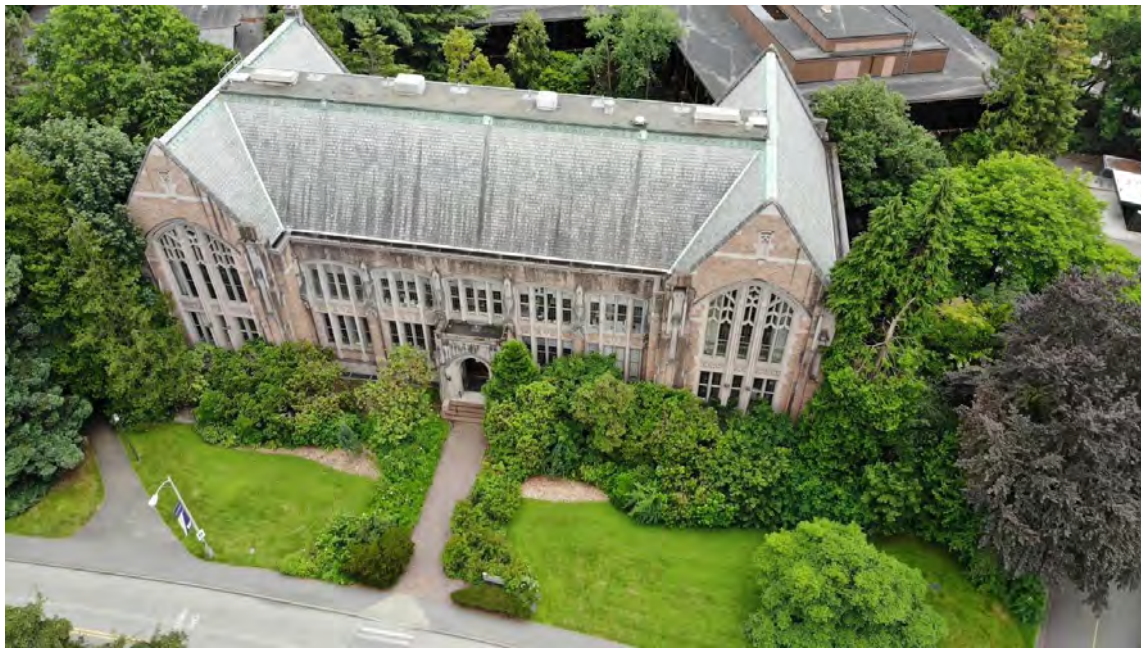
*Exhibit 1. Aerial view of Anderson Hall. The north side of Bloedel Hall is visible in the background.*

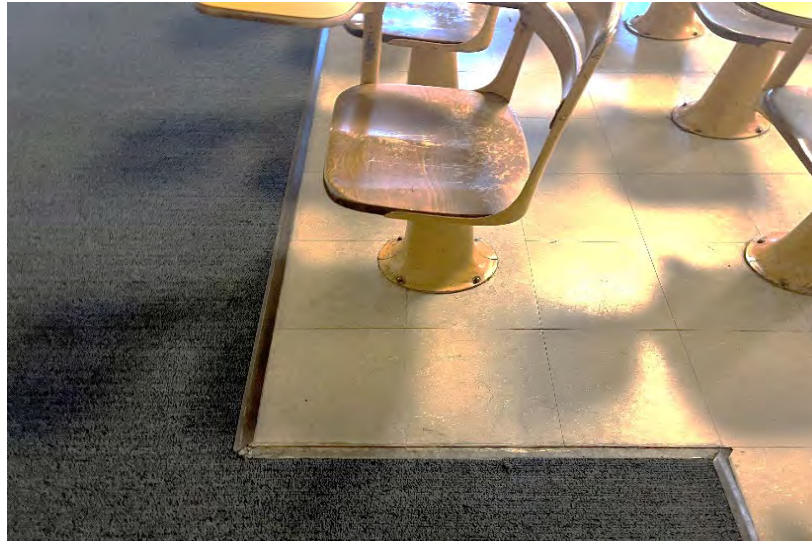
Photo 1: 12"x12" beige floor tile with ACM black mastic in room 223. Beige 12" tile and black ACM mastic throughout the ground, first and second floor.

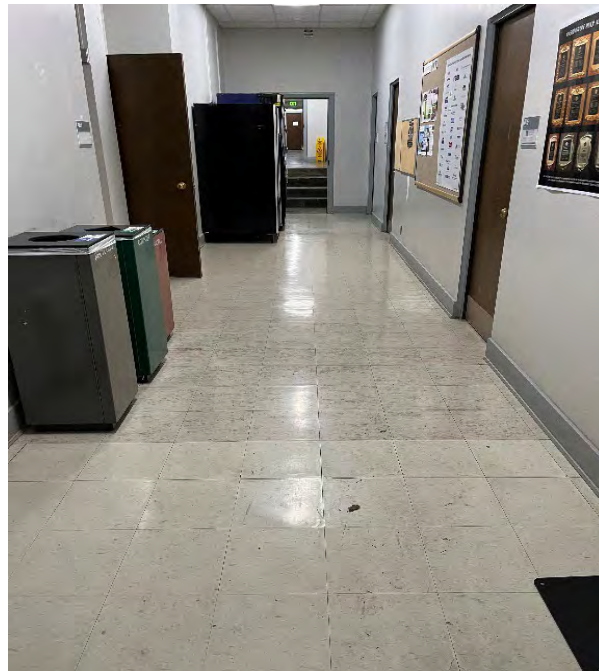
Photo 2: 12"x12" white/off-white and beige floor tile with ACM black mastic in ground floor hallway. Beige and white/off-white 12" tile and black ACM mastic throughout the ground, first and second floor. Assumed less than 1% of asbestos (wallboard/drywall and joint compound composite)

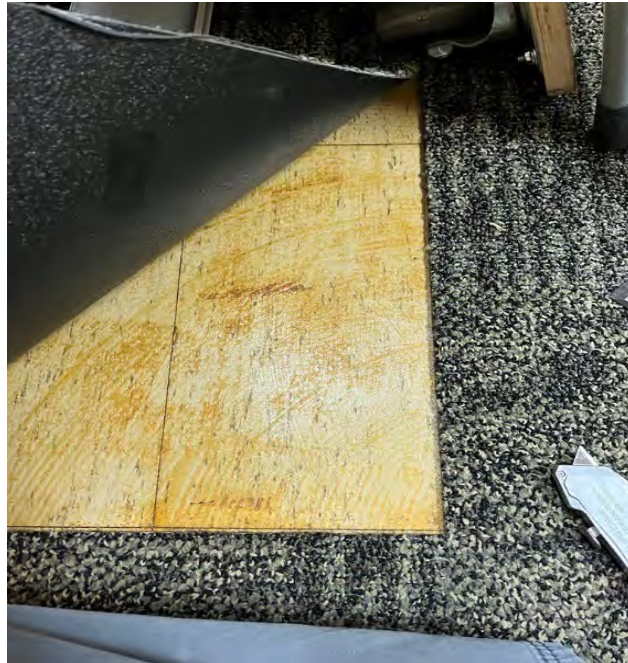
Photo 3: 12" tile with black ACM mastic underneath carpet. Beige and white/off-white 12" tile and black ACM mastic throughout the ground, first and second floor.

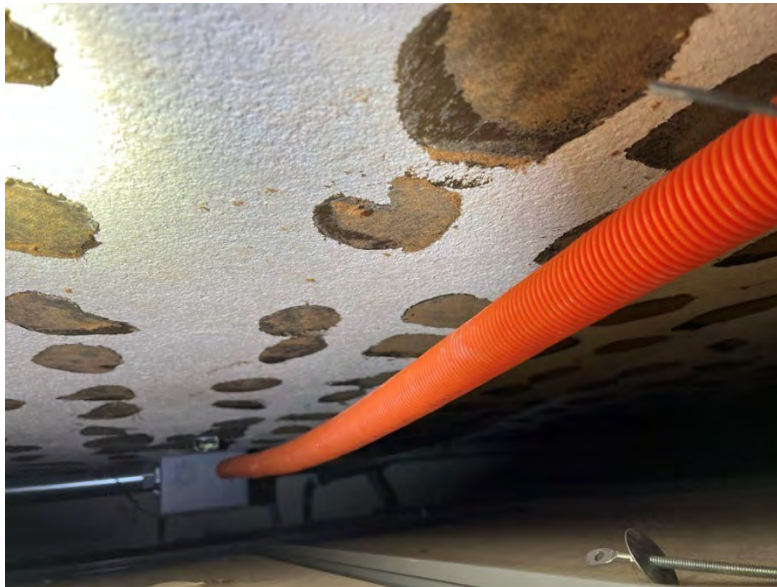
Photo 4: ACM glue dots above dropped ceiling in room 023 associated with 12"x12" glued on ACT.

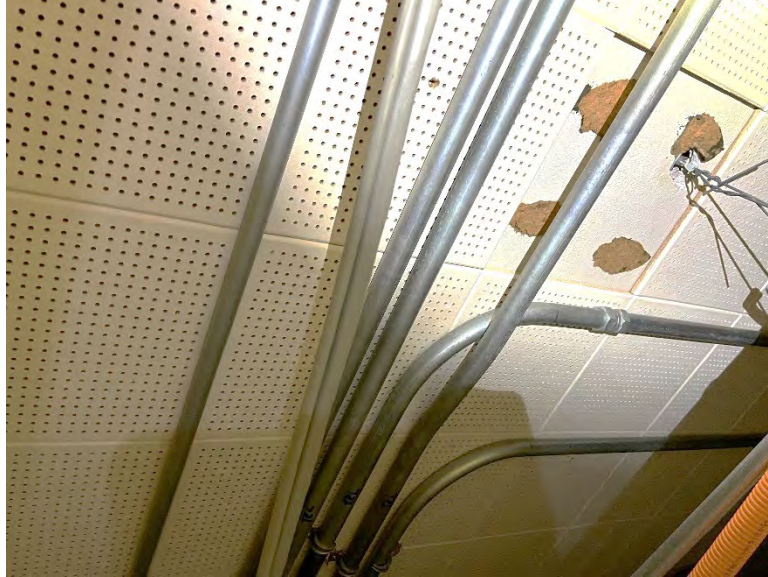
Photo 5: Non ACM 12"x12" glued on ACT above dropped ceiling in room 123. ACM glue dots.

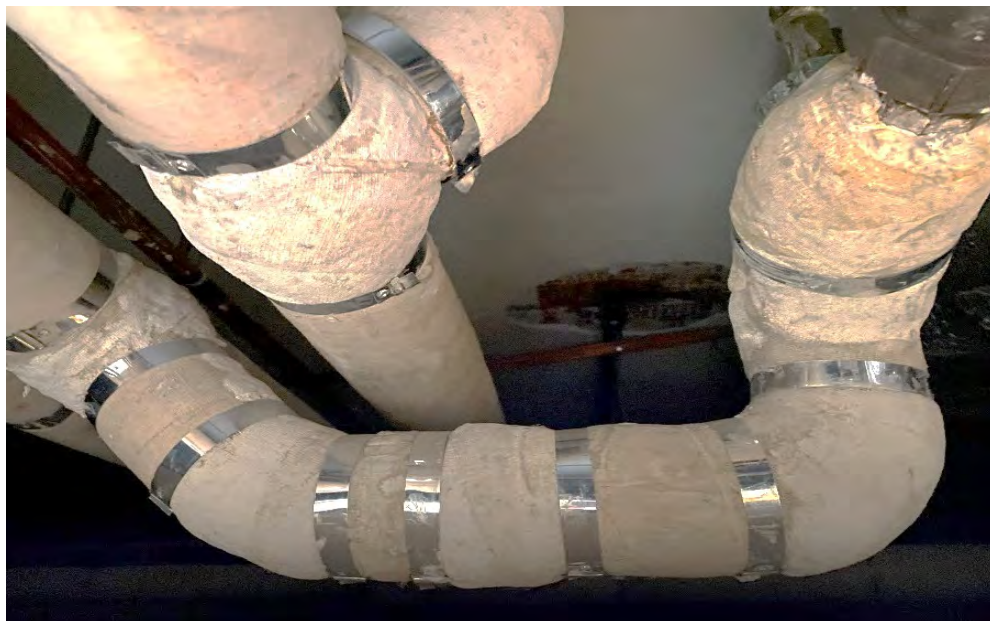
Photo 6: ACM hard fittings and elbows above dropped ceiling throughout building.

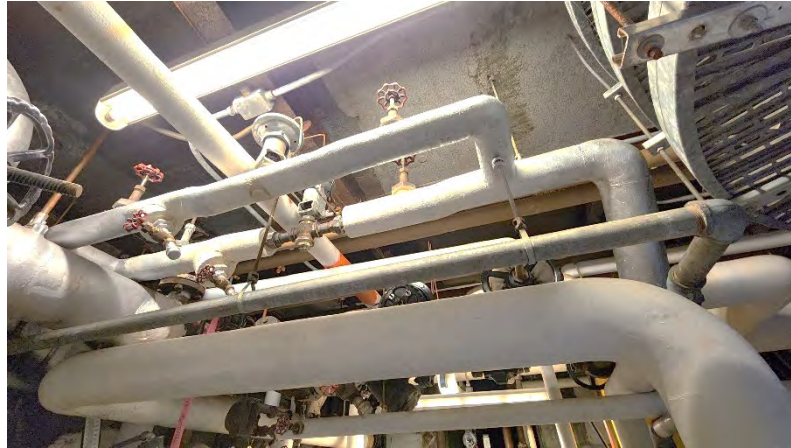
Photo 7: ACM hard fittings and straight runs present in basement mechanical room accessed from south exterior side of building.

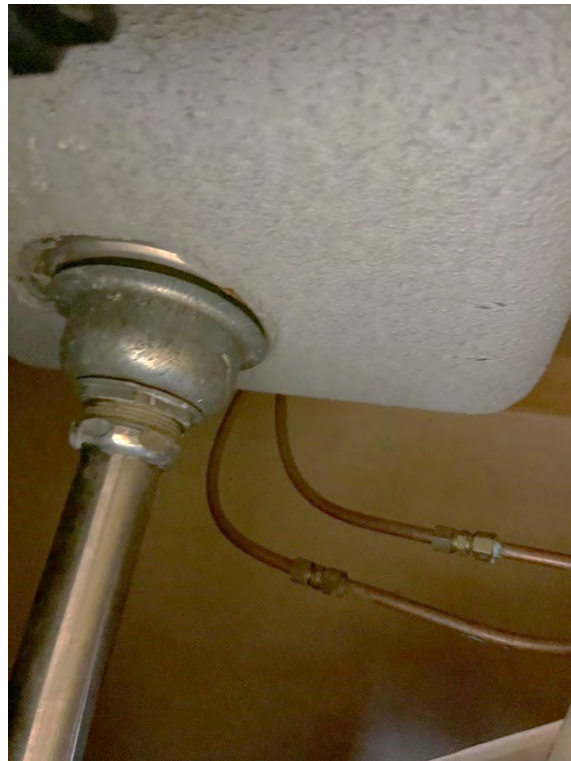
Photo 8: Off-white ACM sink undercoat room 107H.

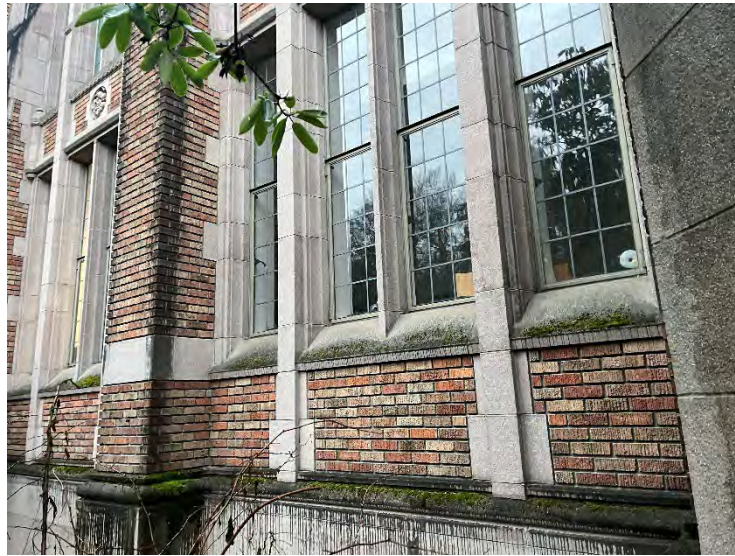
Photo 9: PCB containing grey rough opening caulk at windows. Barium and lead containing brick and mortar.

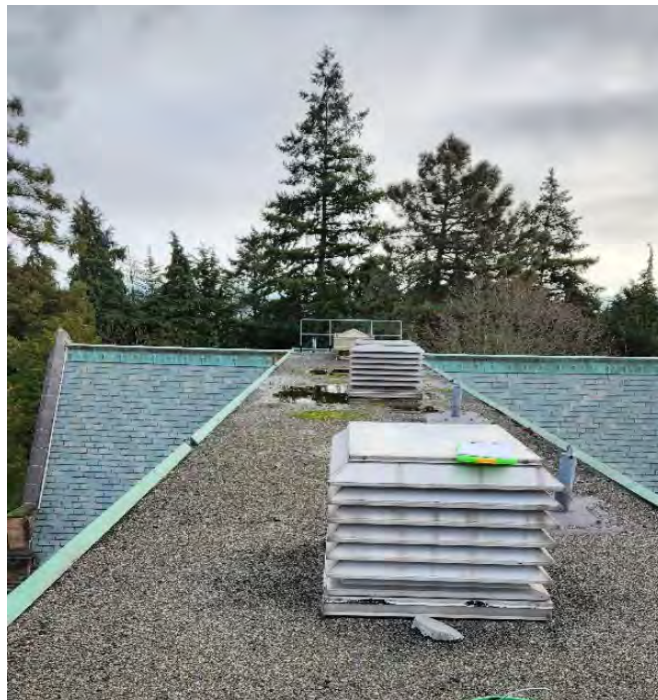
Photo 10: ACM containing silver and black exhaust sealant. ACM built up roofing.

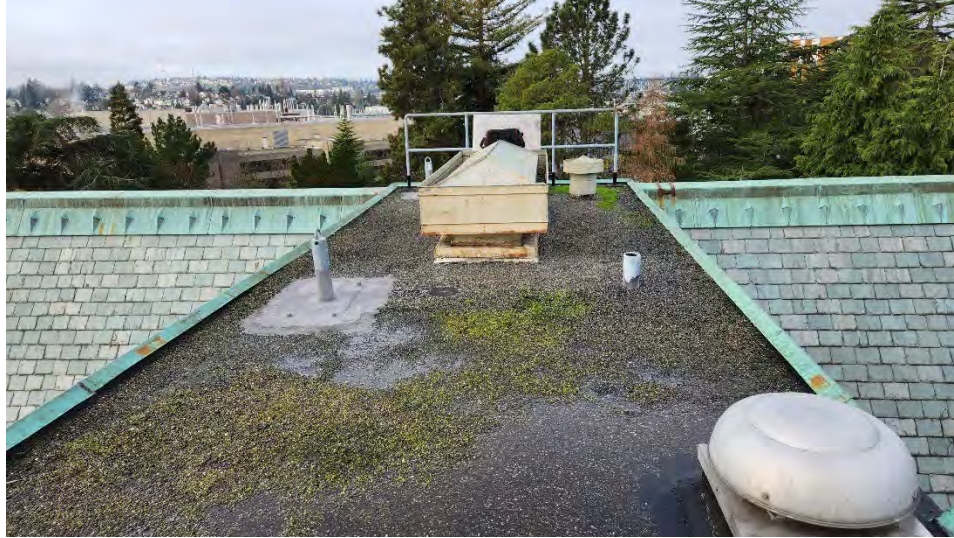
Photo 11: ACM black roof patch, ACM built up roofing.

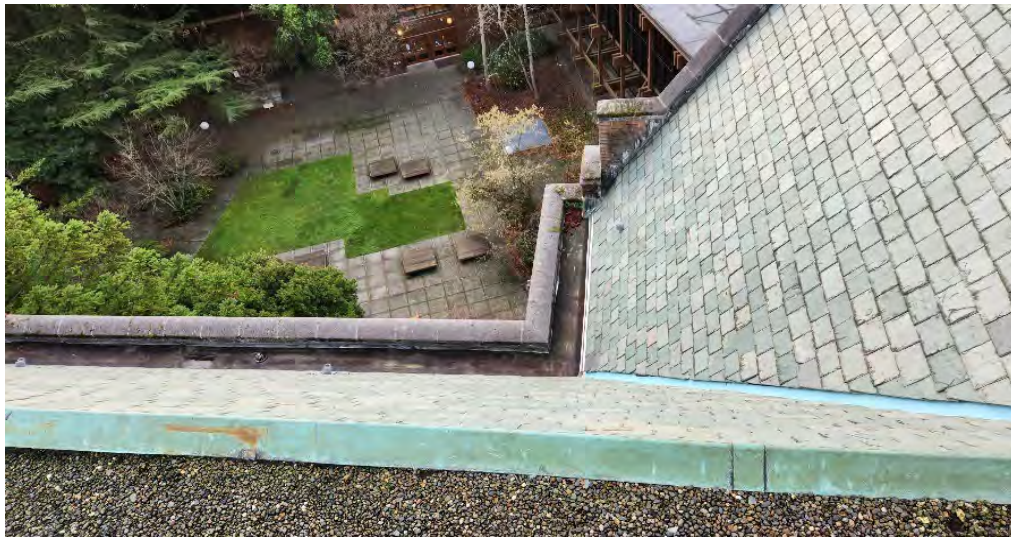
Photo 12: ACM built up roofing around the roof gutter area and parapet wall.

Assumed ACM underlayment underneath Slate roof tiles.
