ENVIRONMENTAL CHECKLIST

*Basketball Training Facility &
Health/High Performance Center
Project*

UNIVERSITY *of* WASHINGTON

July 2022

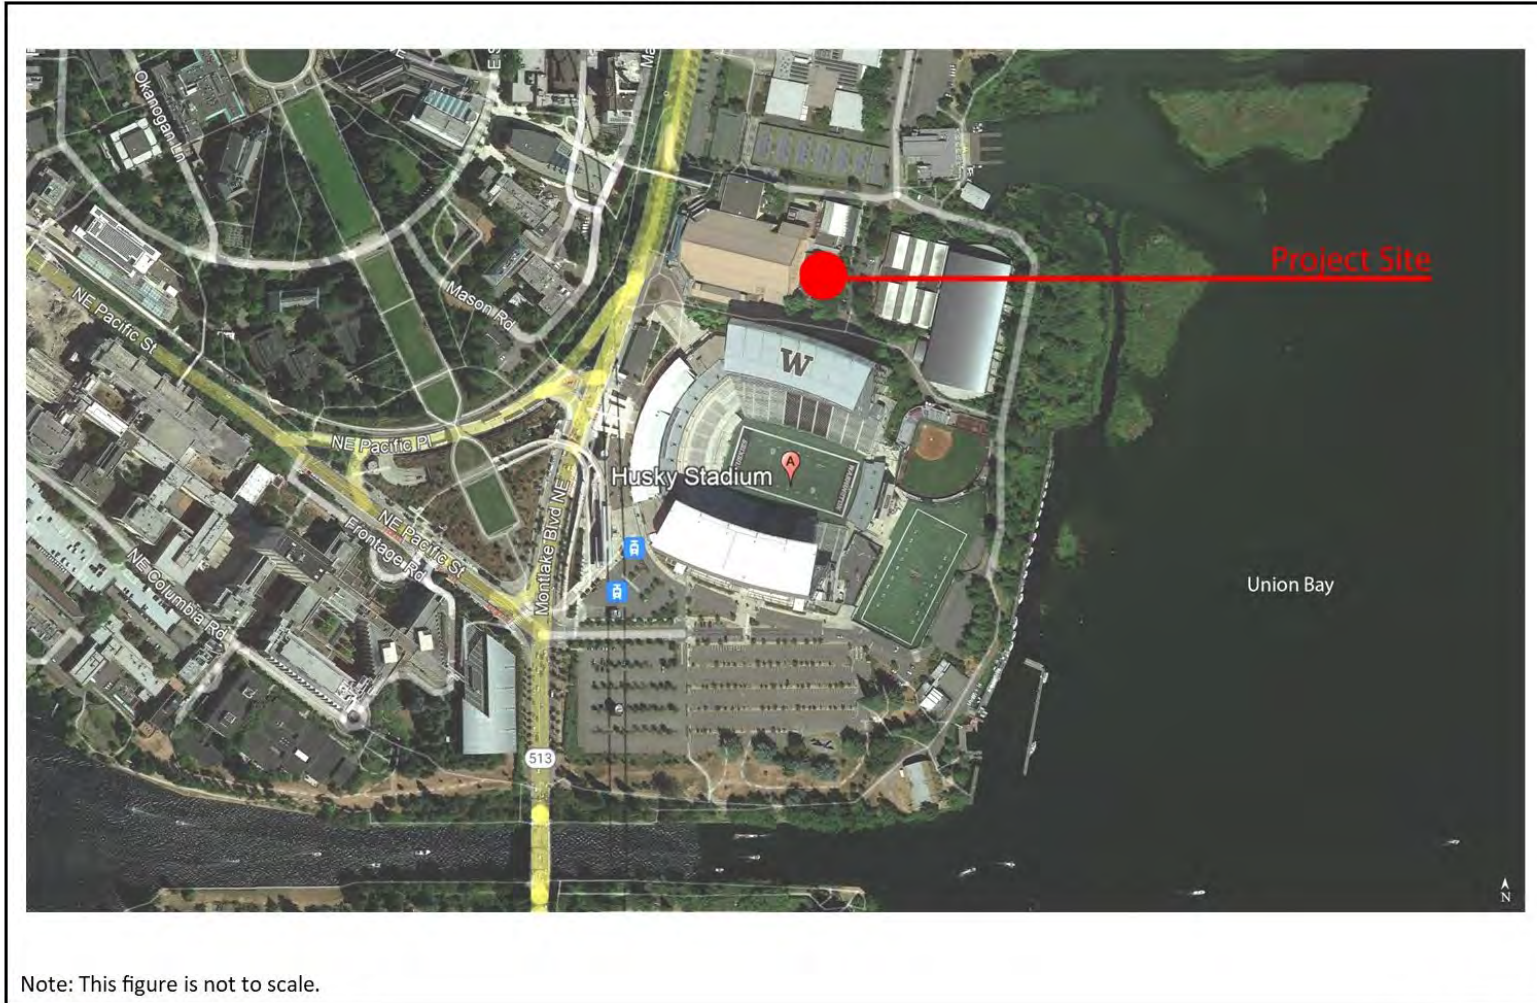
Figure 1
Vicinity Map

Note: This figure is not to scale.

The proposed **Basketball Training Facility & H2P Project** site is located in the south portion of the East Campus area. The site contains the existing Pavilion Pool building and is generally bounded by the Graves Annex to the north; Parking Lot E9, the Nordstrom Tennis Center, and Softball Performance Facility to the east; Snohomish Lane South and Husky Stadium to the south; and Alaska Airlines Arena (Hec Edmundson Pavilion) to the west (see **Figures 1** and **2**).

There is no surface water body on or in the immediate vicinity of the **Basketball Training Facility & H2P Project** site. The nearest surface water body is Union Bay, which is located approximately 600 feet to the east of the project site (see **Figure 1**).

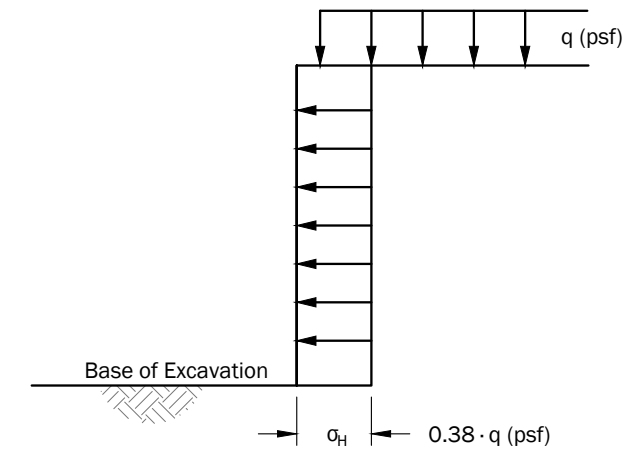
Recommended Surcharge Pressure	
UW ICA Basketball Center Seattle, Washington	
	Figure 5

Lateral Earth Pressure from Point Load, Q_p
(Spread Footing)

$$\sigma_H = \sigma \cos^2 \quad (1.10)$$

$$\text{For } m \leq 0.4 \quad \alpha_H = \frac{k \cdot 0.28 Q_p n^2}{H^2 (0.16 + n^2)^3}$$

Lateral Earth Pressure from Line Load, Q_L
(Continuous Wall Footing)

$$\text{For } m \leq 0.4$$

$$\alpha_H = \frac{k \cdot 0.2n \cdot Q_L}{H(0.16 + n^2)^2}$$

Uniform Surcharges, q
(Floor Loads, Large Foundation Elements or Traffic Loads)

α_H = Lateral Surcharge Pressure from Uniform Surcharge

The earth pressures presented in Figure 4 do not include loading from maintenance equipment or truck surcharge. In addition, other surcharge loads such as cranes, construction equipment or construction staging areas, should be applied to the shoring system as recommended in Figure 5. No seismic pressures have been included in Figure 4 because it is assumed that the shoring will be temporary.

Permanent below-grade walls built against temporary shoring (if required) should be designed for the pressures presented in Figure 4 with the addition of a seismic surcharge pressure equal to $7H$ (where H is the height of the wall in feet). Surcharge loads should be designed for surcharge pressures presented in Figure 5.

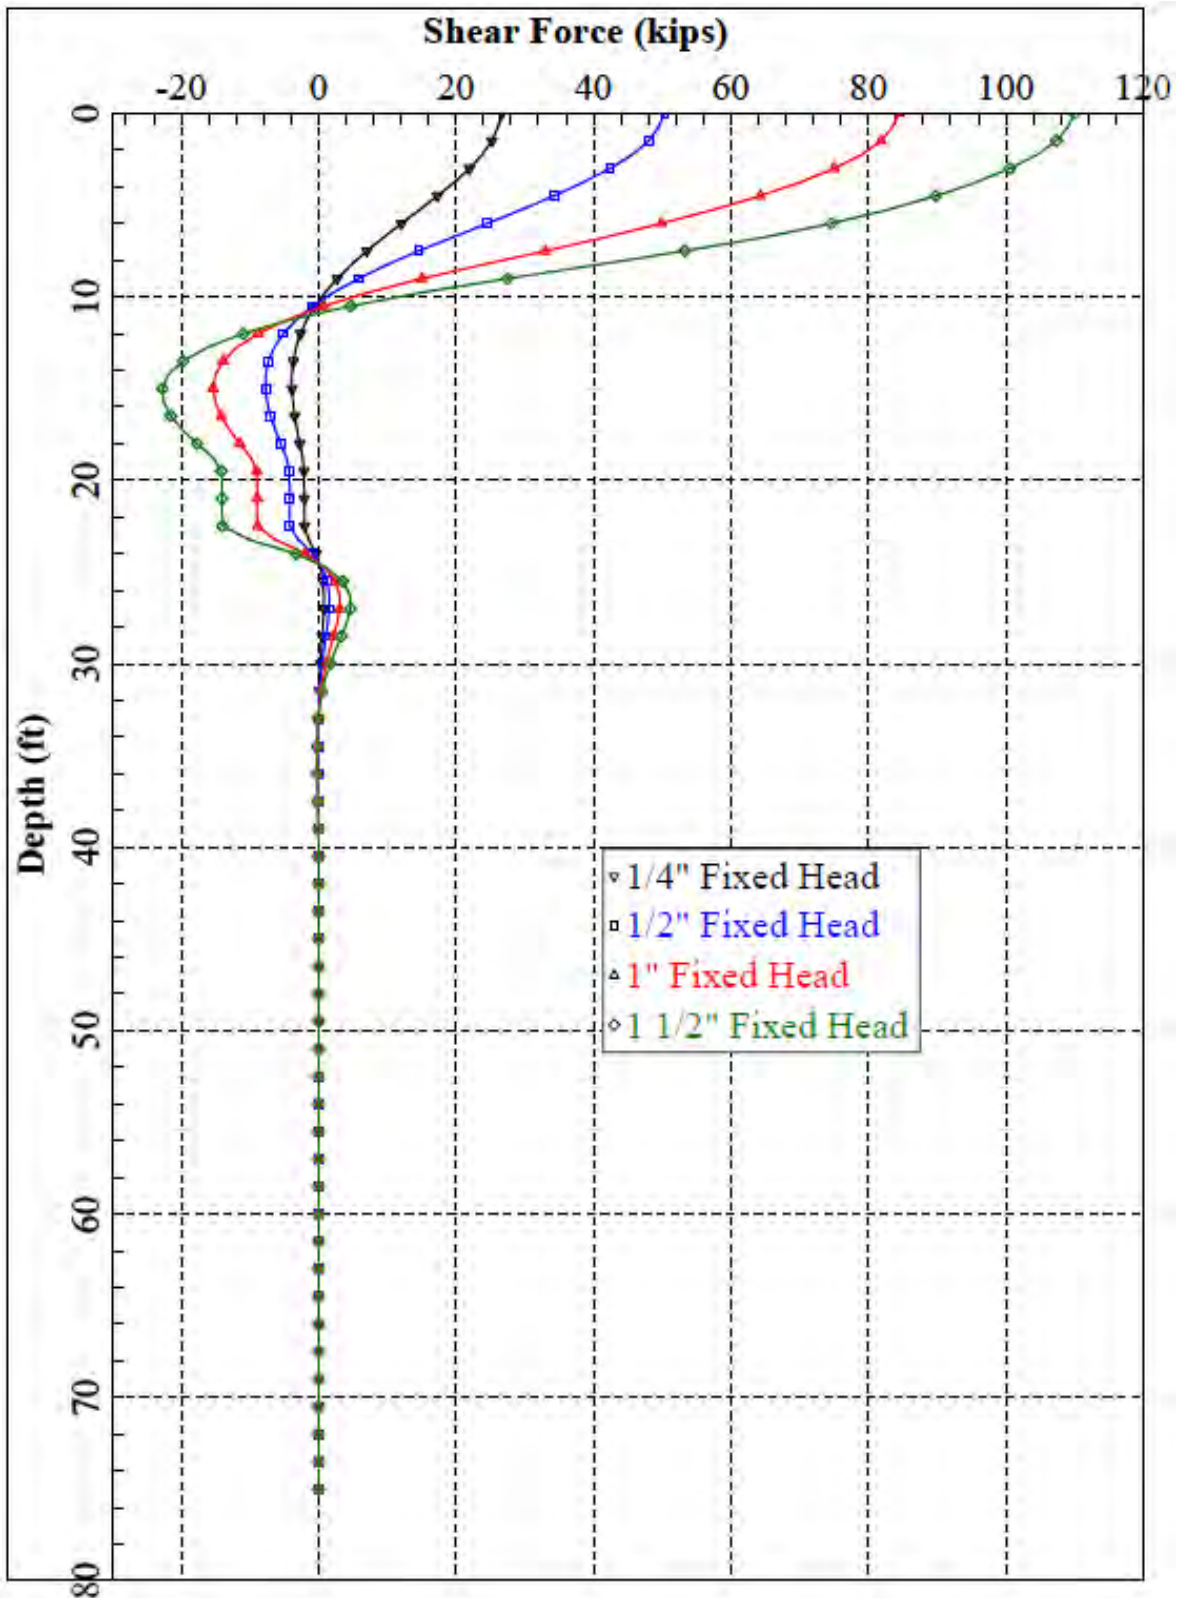
1. Lateral pile capacities were evaluated using LPILE v2019
2. Free- and fixed-head conditions were evaluated for a range of deflections. No axial load was applied to the pile.

18-inch Augercast Pile Shear vs Depth (Fixed Head) LFF at 51 feet, West Side of Building	
UW ICA Basketball Center Seattle, Washington	
 	Figure 16

bending moment vs depth are provided in Figures 6 through 53. The recommended design parameters for the primary soil units are summarized in Table 5. The structural engineer may use the recommended design LPILE soil parameters to evaluate lateral pile capacities for other loading conditions or pile sizes.

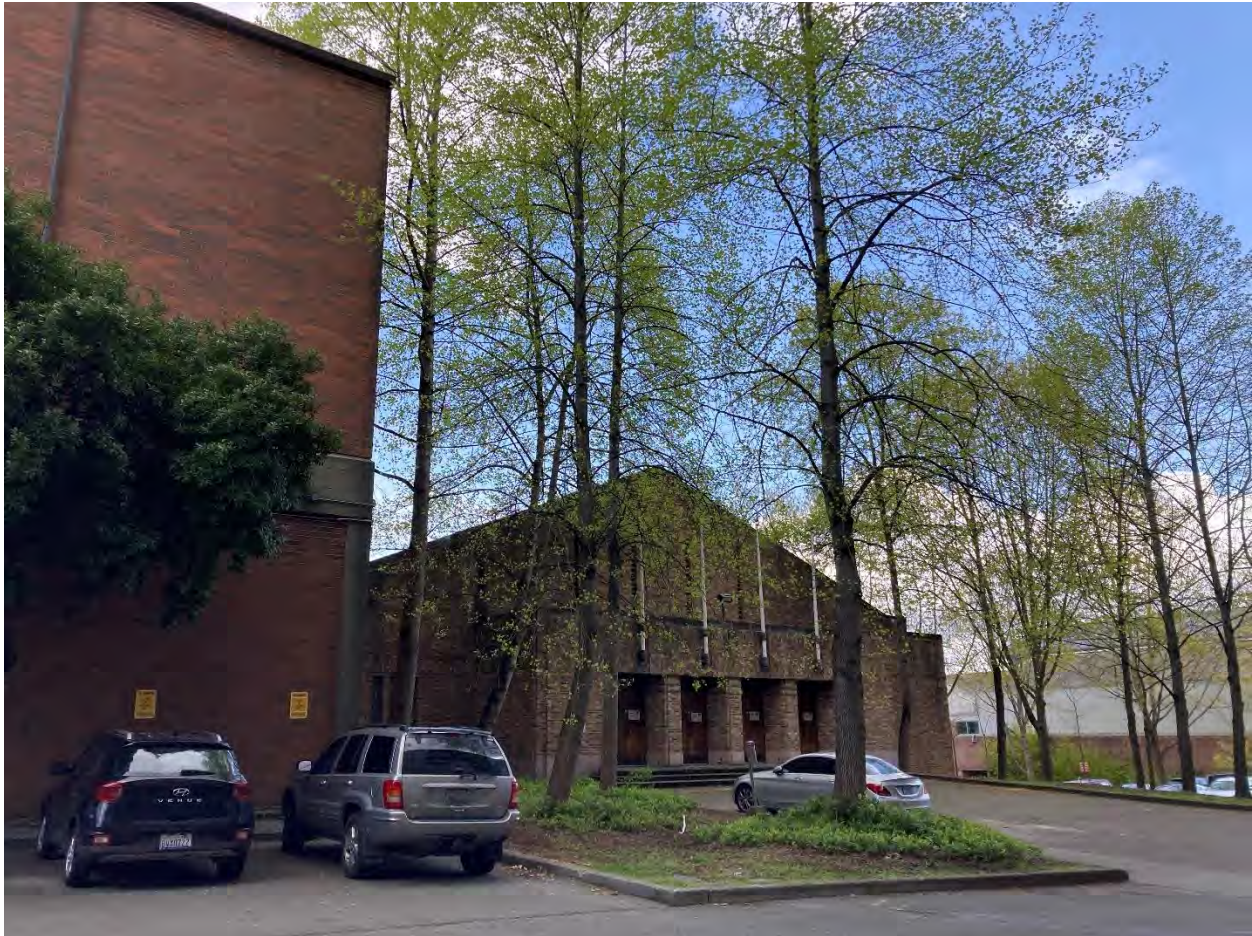
Photo 3. A view looking northeast at two clusters of tulip trees. Trees 590-594 are in the foreground, and trees 585-589 are visible in the background.

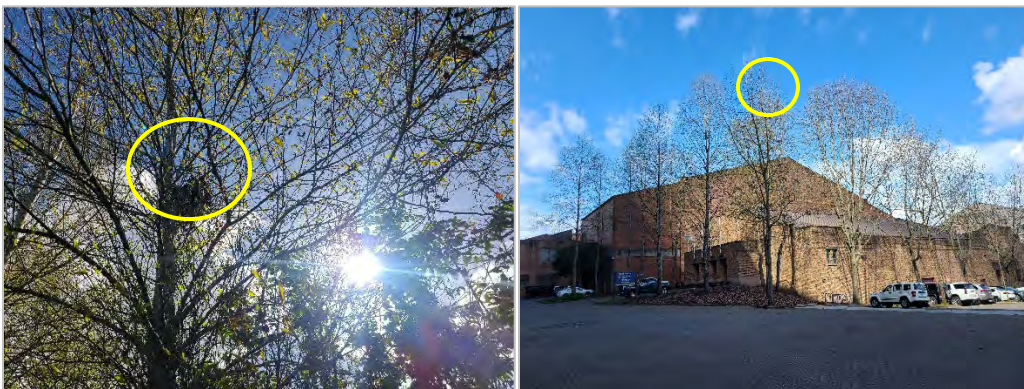
Exhibit 2: Inactive stick nest (yellow circle) observed at the southeast corner of the Project footprint.

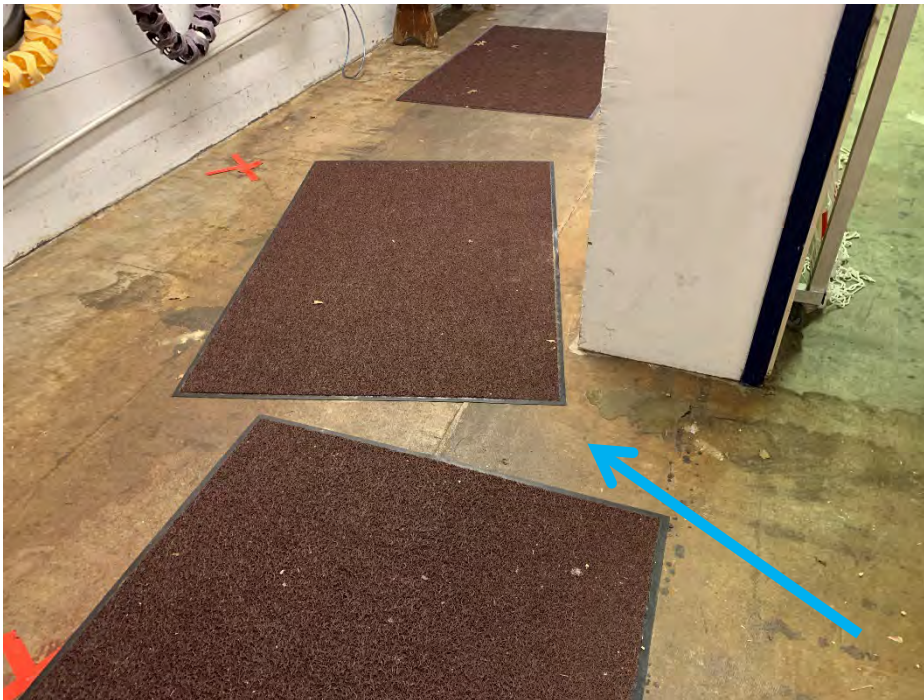
HSA 2. Off-white concrete, gray foam, beige mastic, and gray soft material (M)

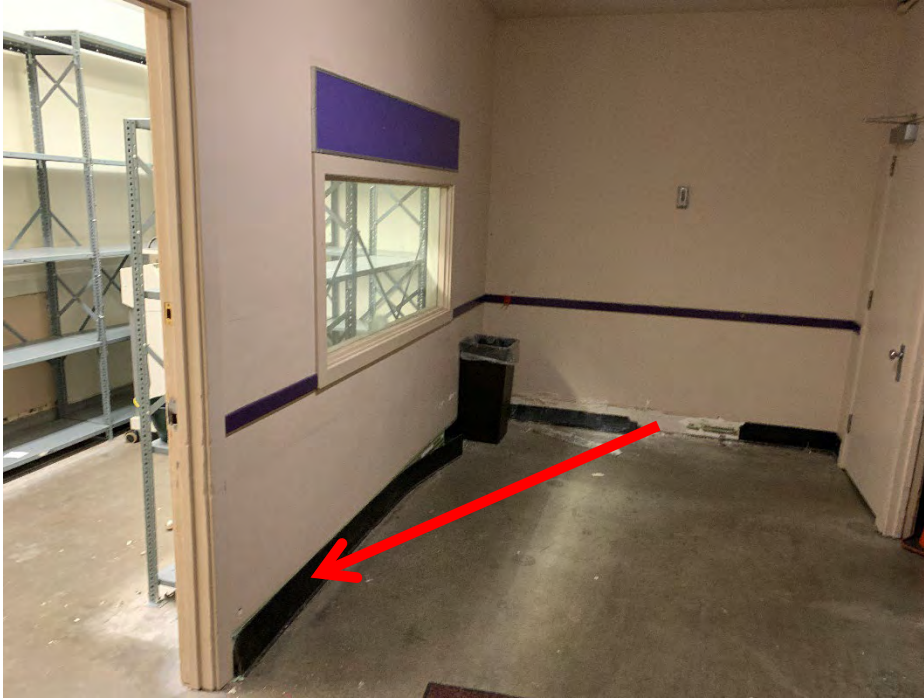
HSA 3. 6" black rubber cove base, brown brittle mastic, yellow mastic, white compacted powdery material with paint, and trace white compacted material (M)

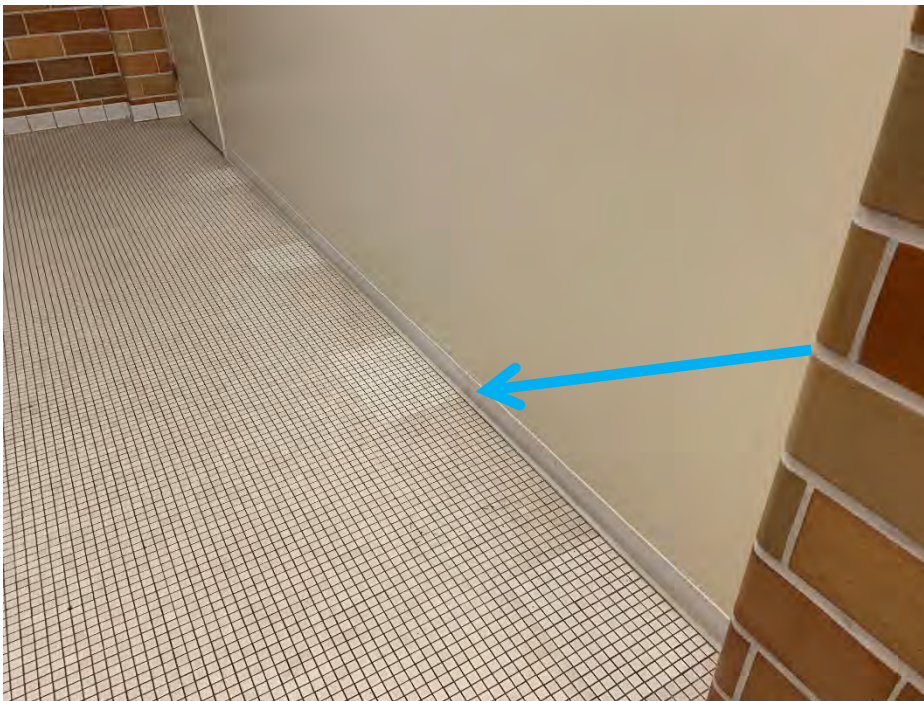
HSA 4. 4" white cove base, yellow mastic and trace joint compound with paint (M)

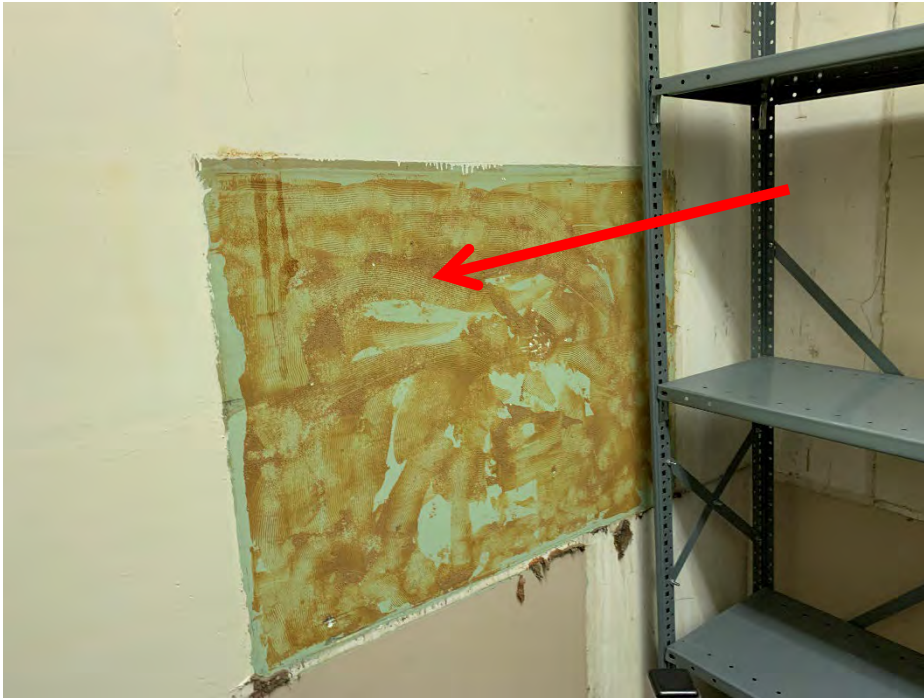
HSA 5. Tan mastic and white crumbly material with paint (M)

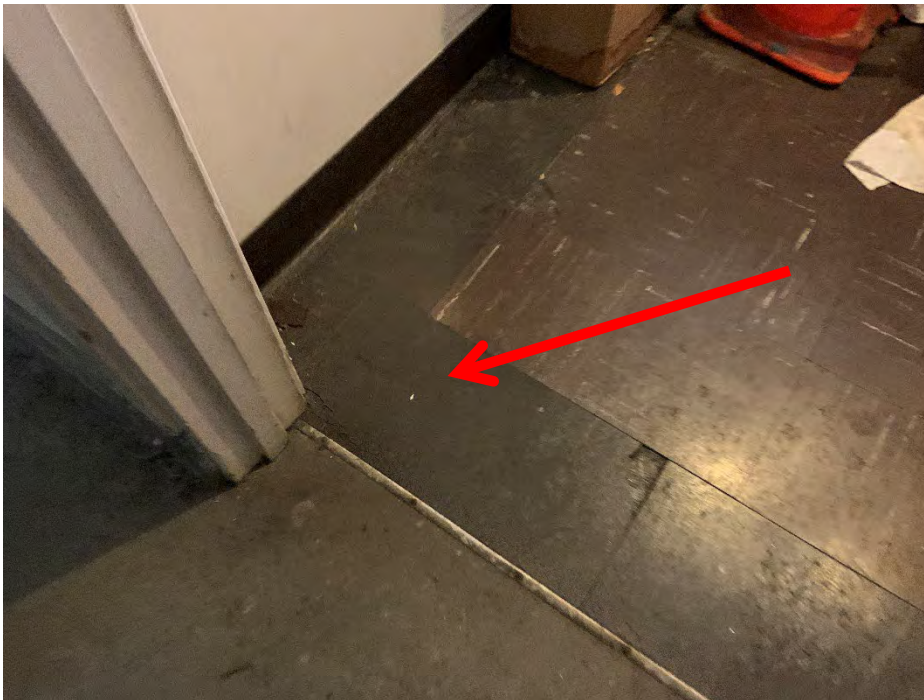
HSA 6. Various sized dark brown vinyl floor tile and black asphaltic mastic (M)

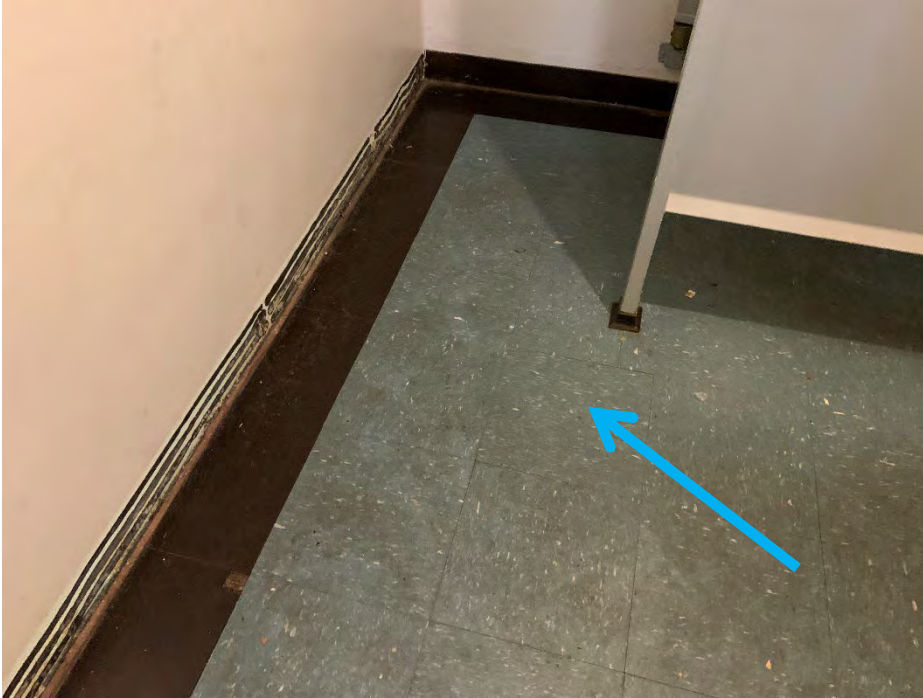
HSA 9. 12"x12" blue vinyl floor tile and black asphaltic mastic (M)

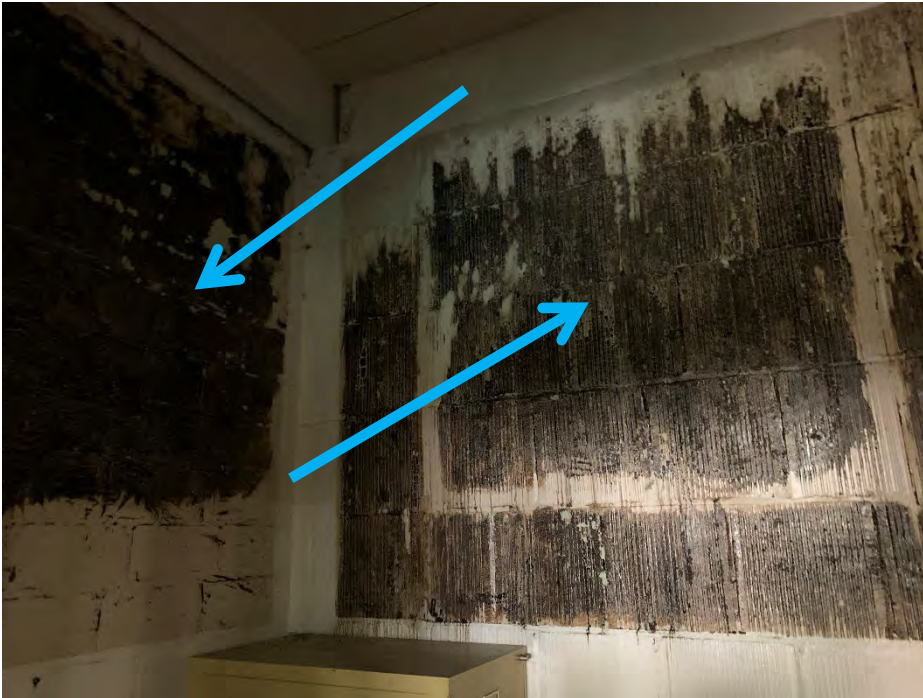
HSA 10. Black residual mastic with paint (M)

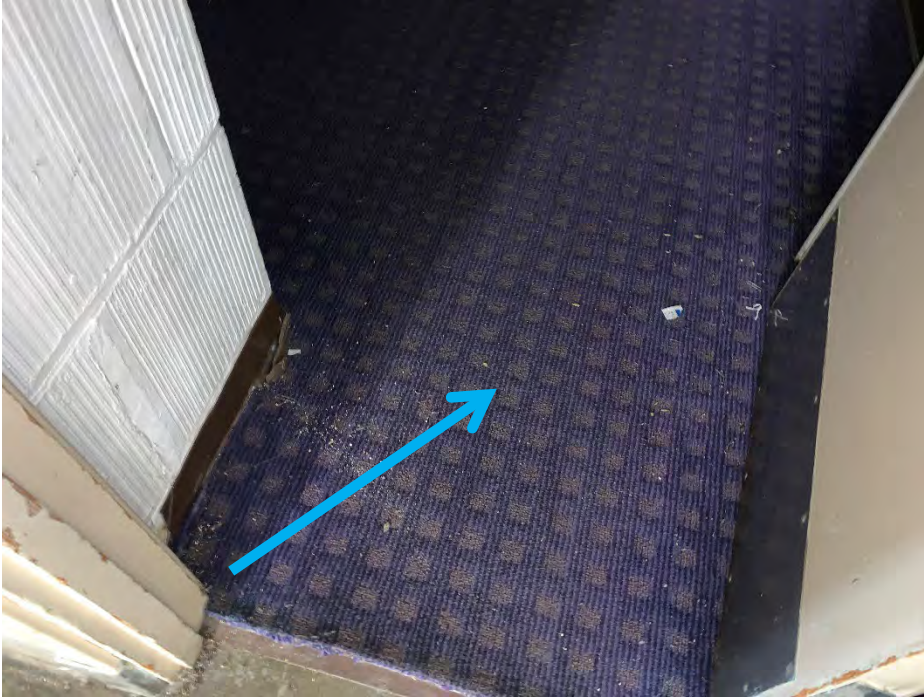
HSA 11. Yellow carpet mastic (M)

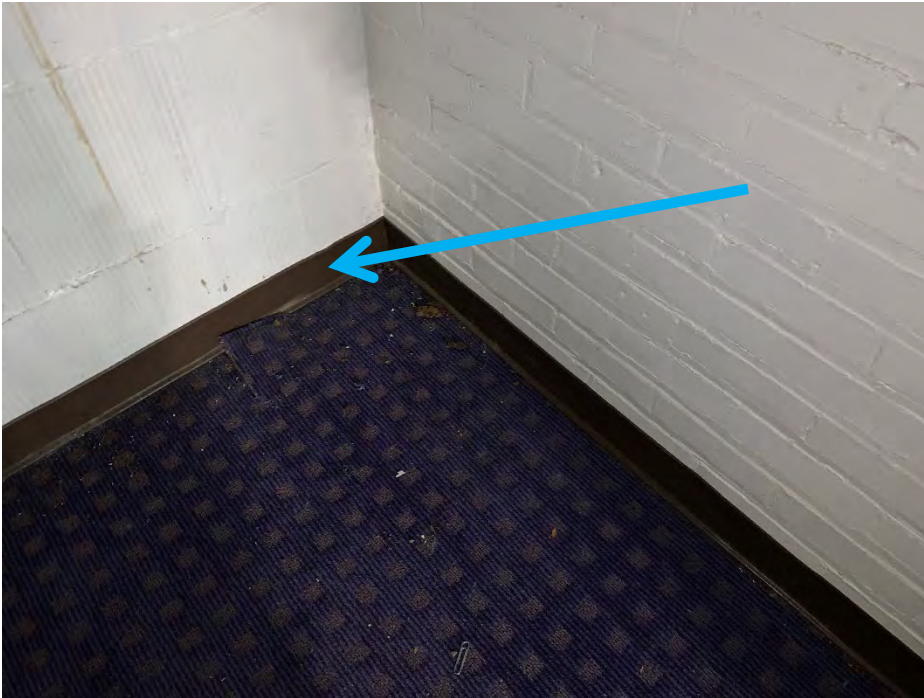
HSA 12. 4" brown rubber cove base and white mastic (M)

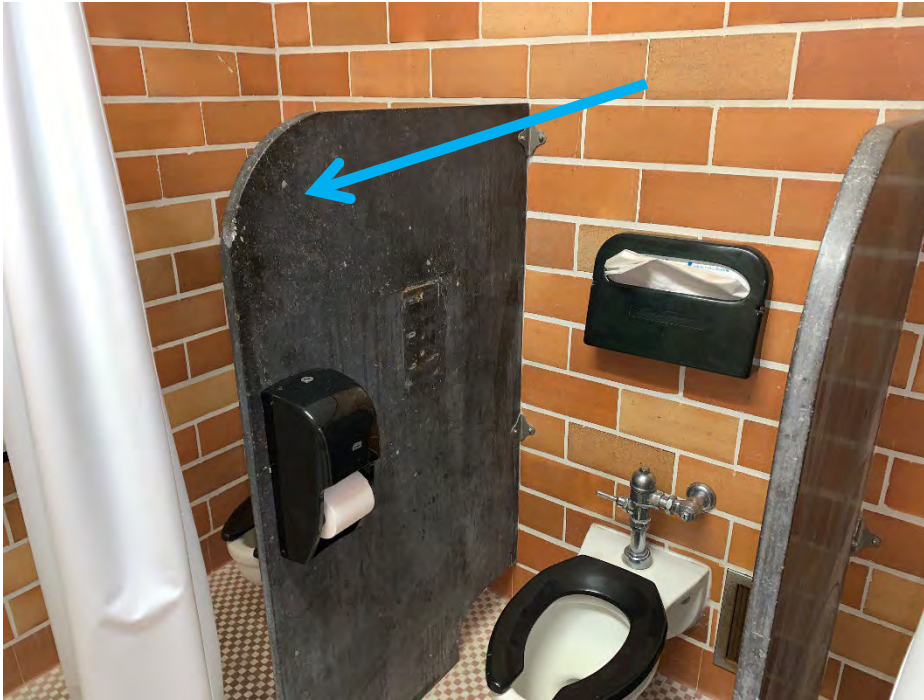
HSA 13. Black brittle material (M)

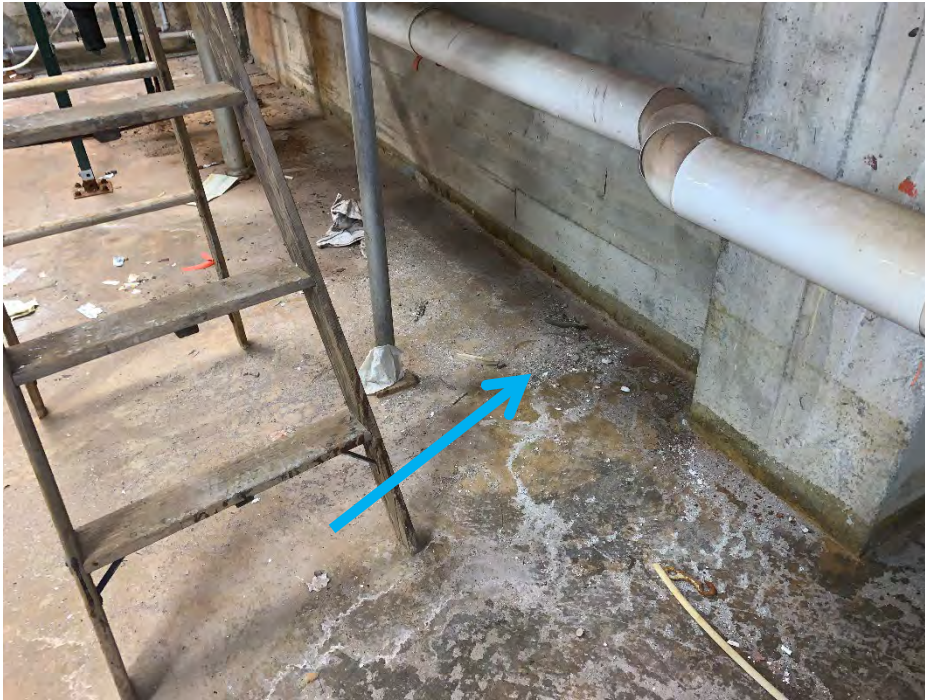
HSA 15. White crumbly material, off-white brittle material, brown/red crumbly material, gray cementitious material with yellow fibrous material, and gray cementitious material (M)

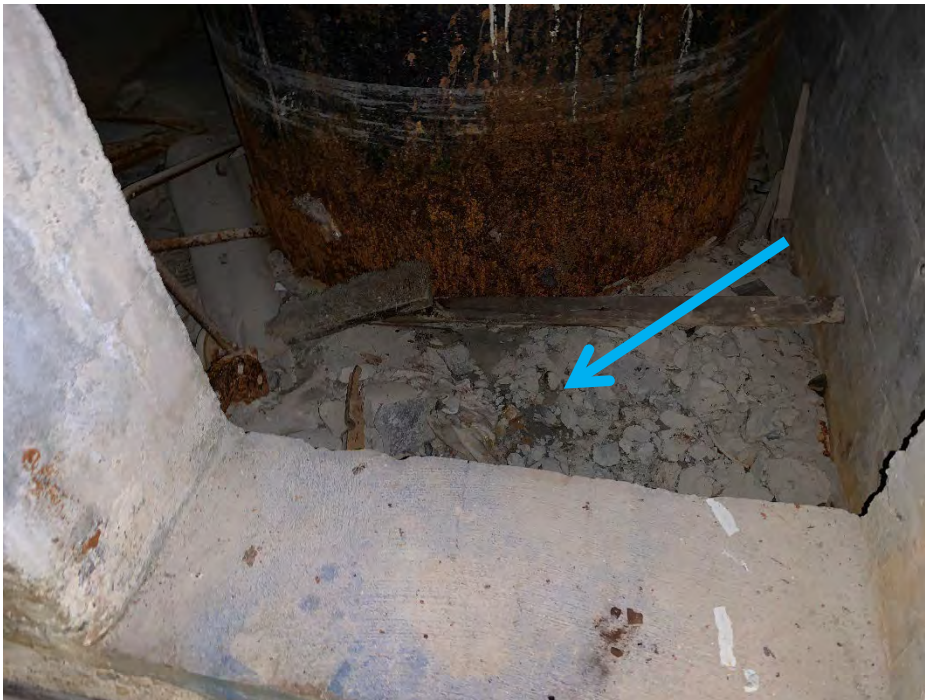
HSA 16. Gray sandy material (M)

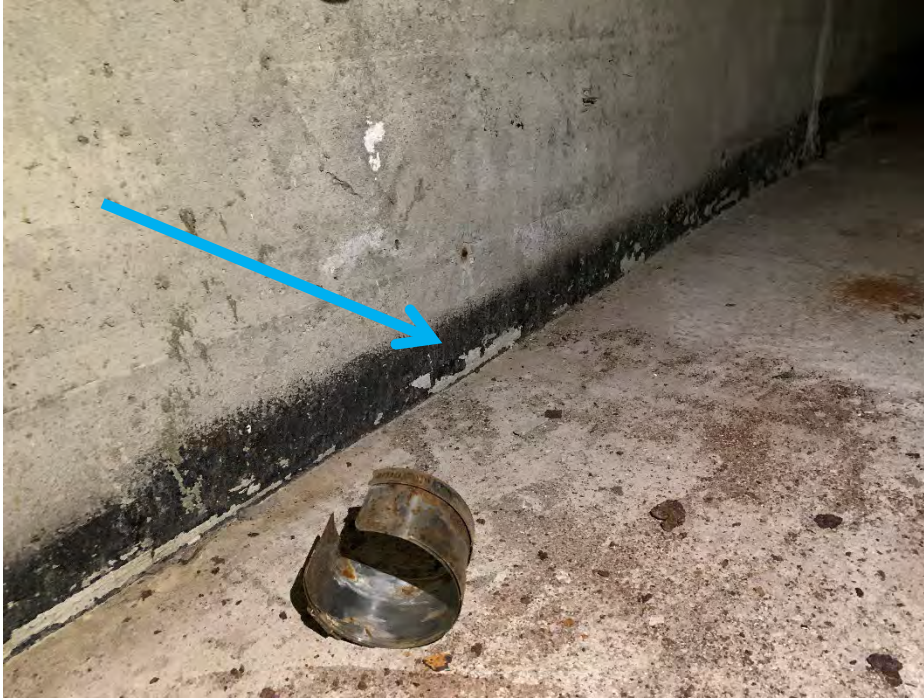
HSA 17. Black asphaltic waterproofing and gray concrete (M)

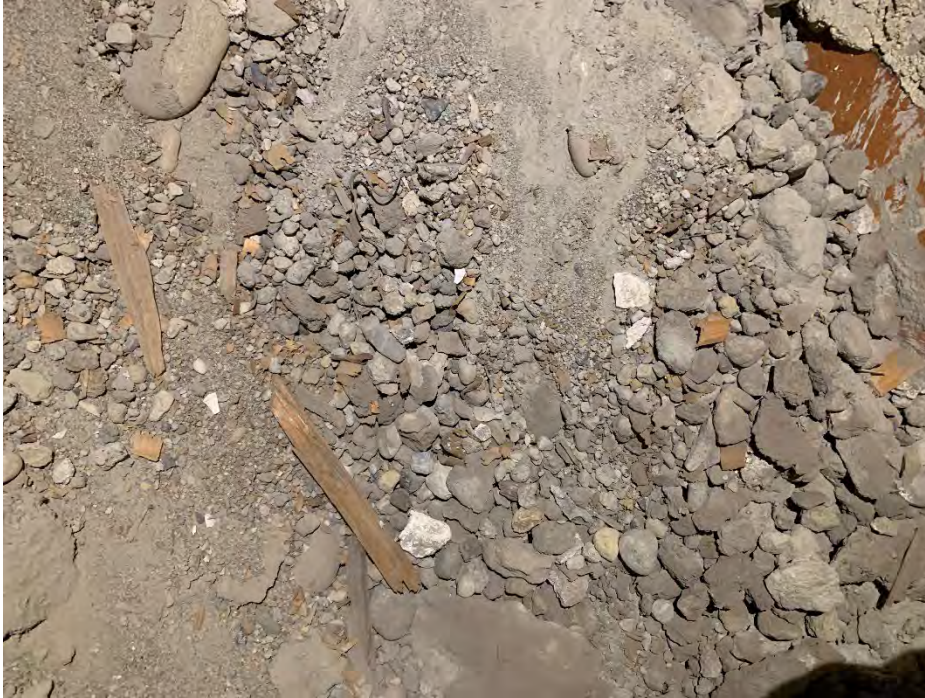
HSA 19. Gray flaky fibrous pipe insulation debris and off-white flaky fibrous residual pipe insulation debris (T)

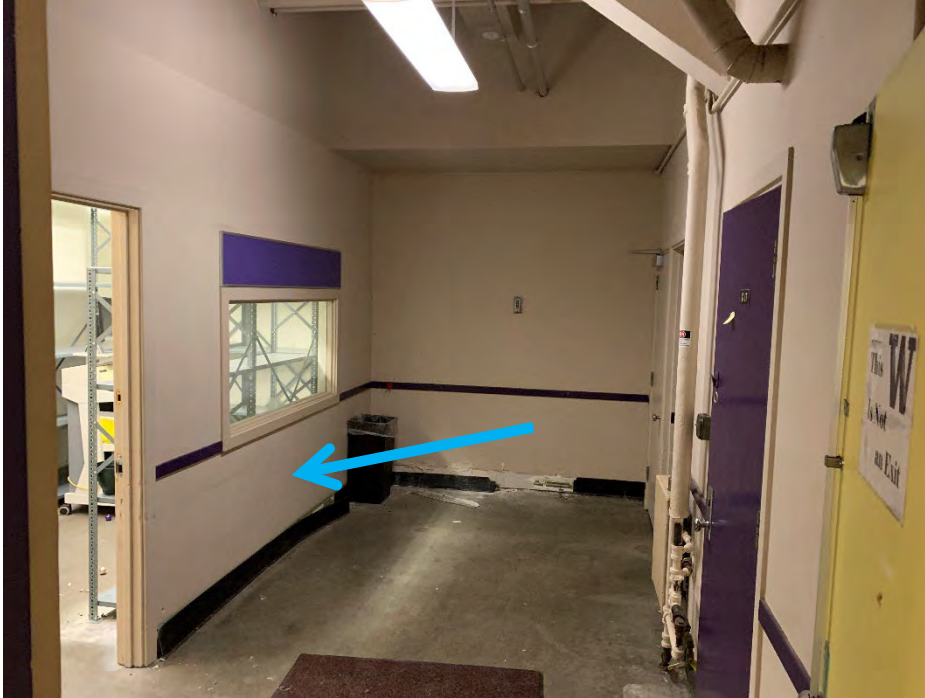
HSA 21. Off-white sandy material with paint (S)

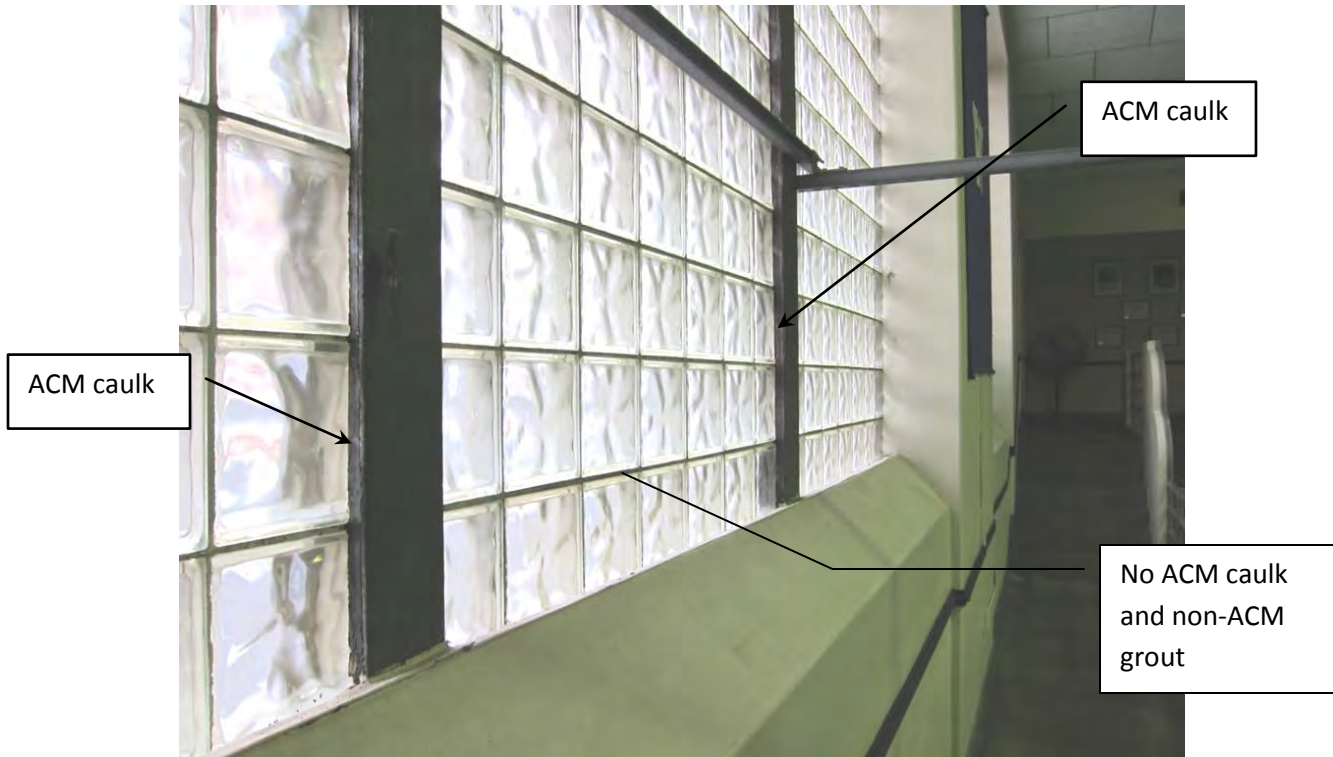
Photo 1: Asbestos-containing material (ACM) caulk (gray/tan) on glass block windows at the north end of the pool area.

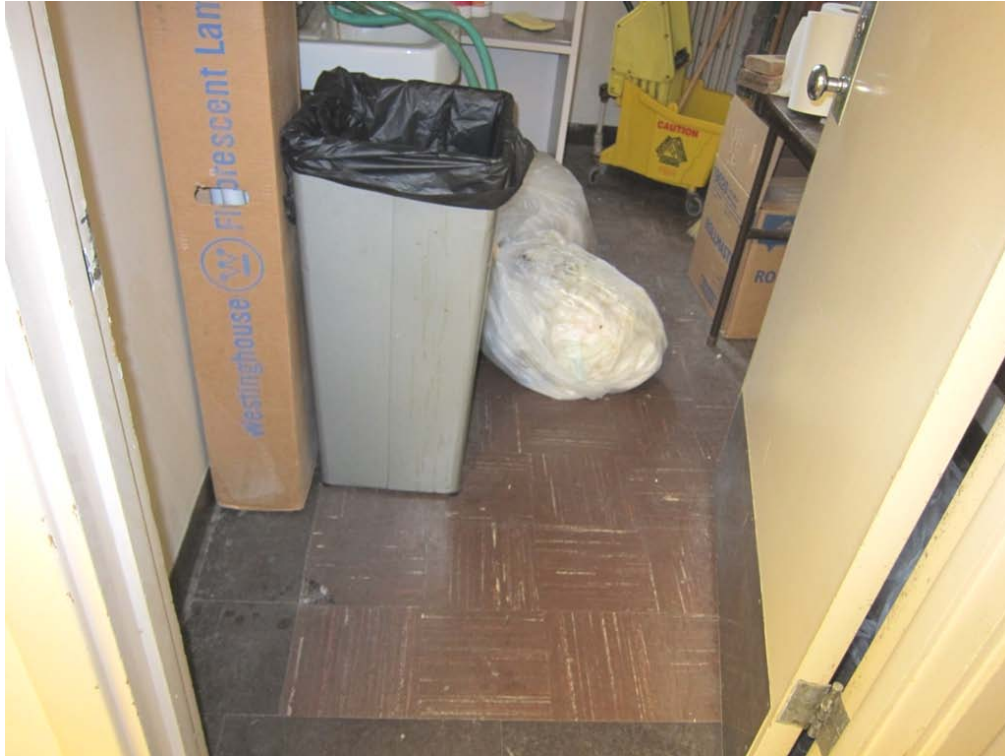
Photo 3: ACM 9" vinyl floor tile and mastic (dark brown) in the pool building.

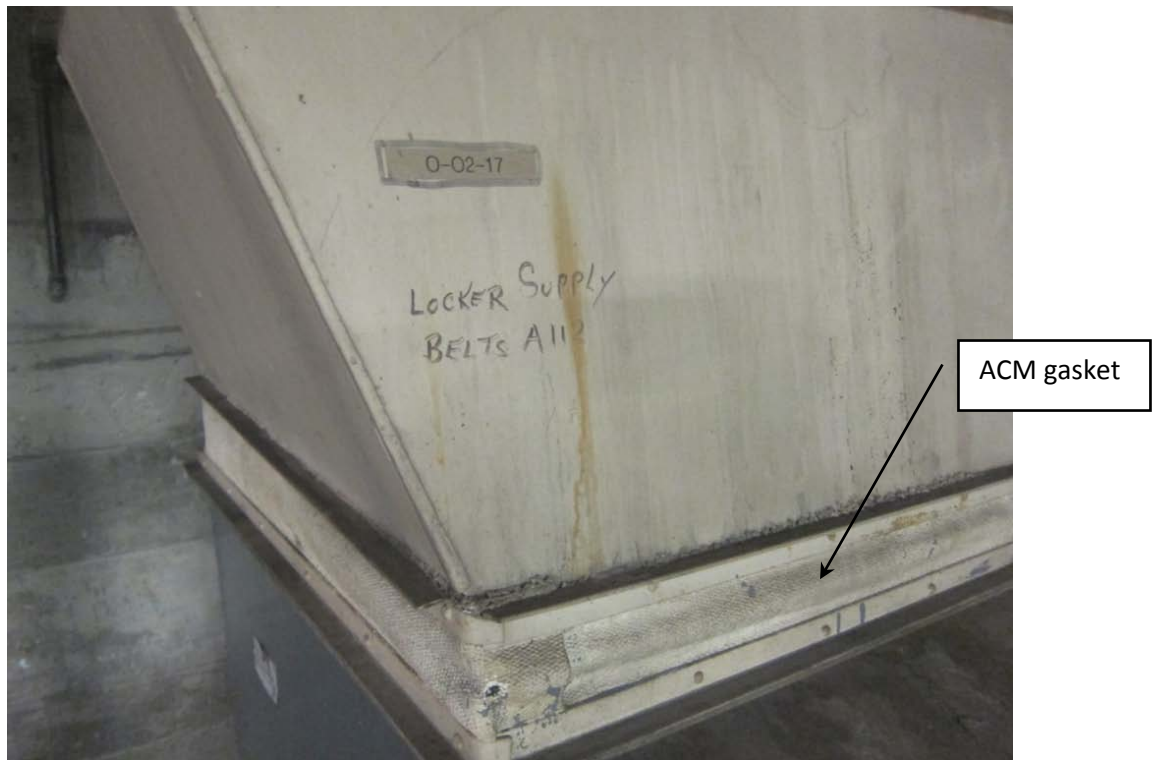
Photo 4: Asbestos-containing vibration isolation gasket associated with HVAC ductwork located in the basement mechanical room.

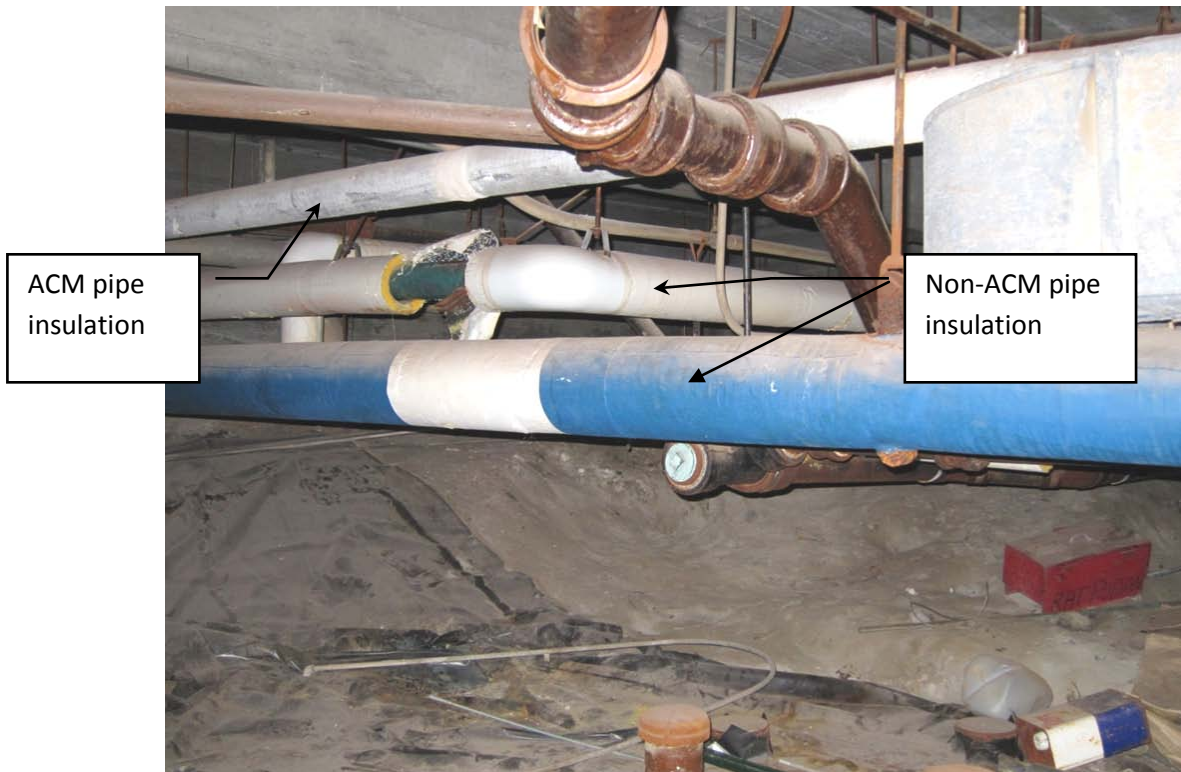
Photo 5: Basement level crawlspace with asbestos-containing pipe insulation with assumed asbestos debris present beneath the plastic sheeting vapor barrier.

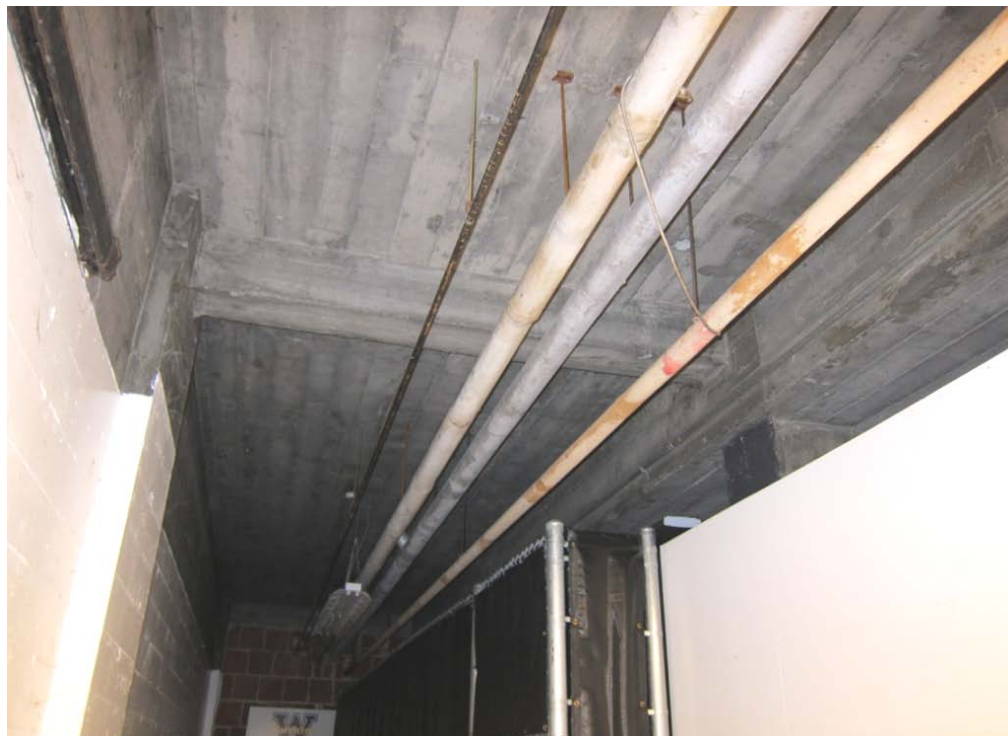
Photo 6: Asbestos-containing pipe insulation located in the ground floor east corridor.

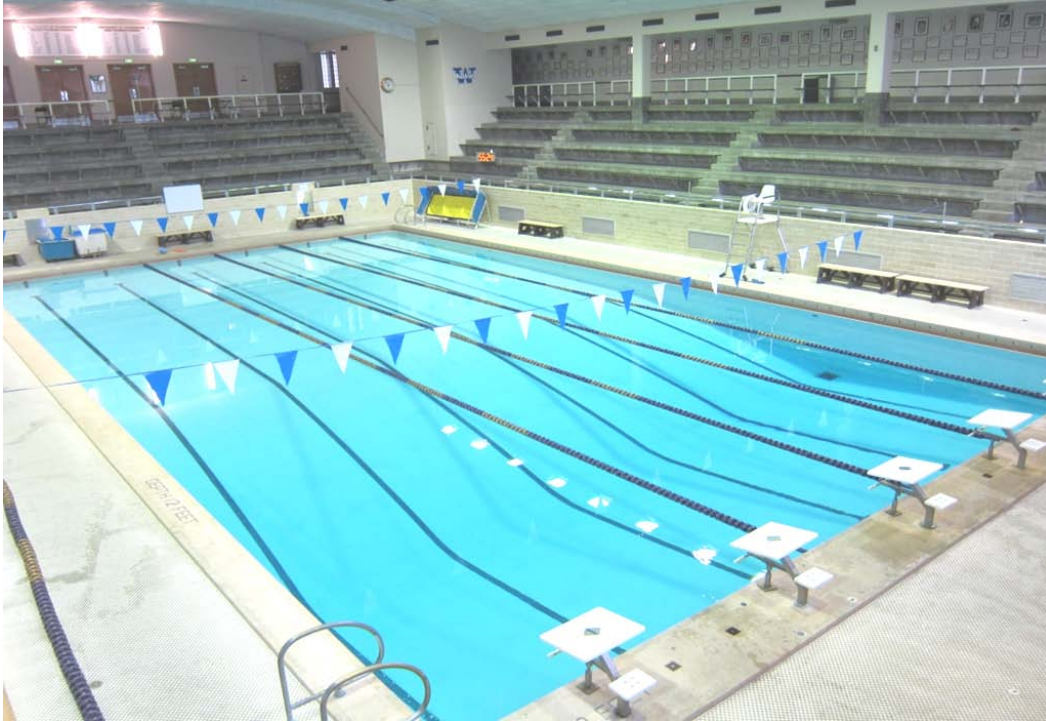
Photo 7: Assumed ACM vapor barrier or coating underneath the pool walls and floor.

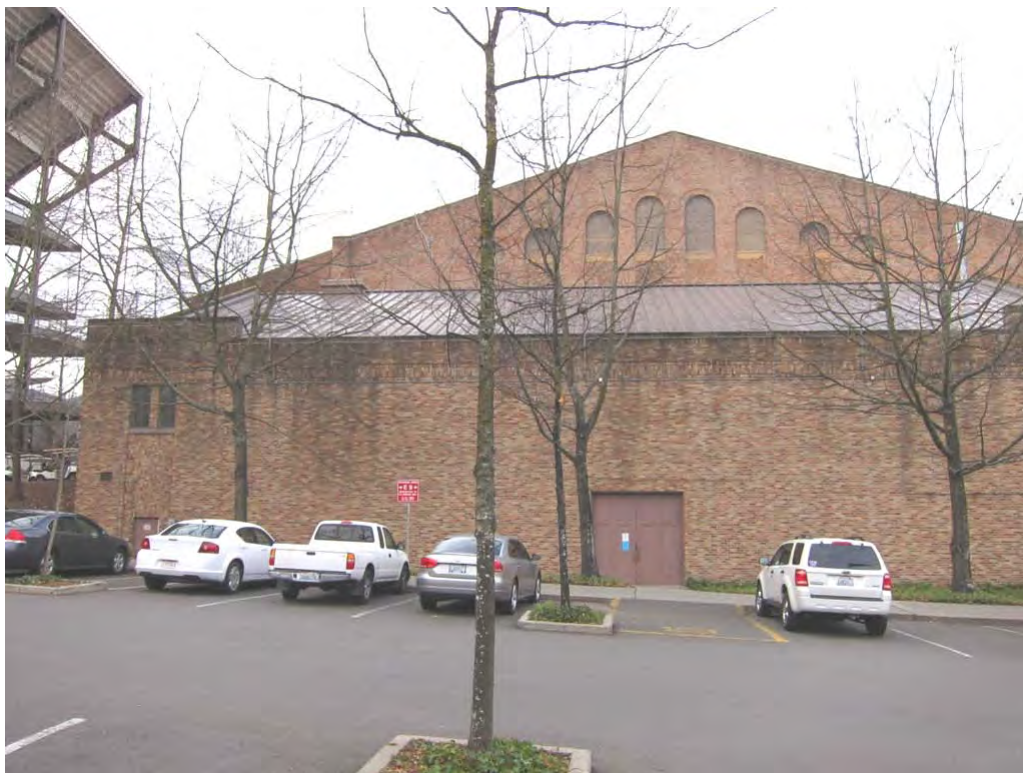
Photo 8: Assumed ACM vapor barrier or coating behind masonry brick façade of the Pavilion Pool building.

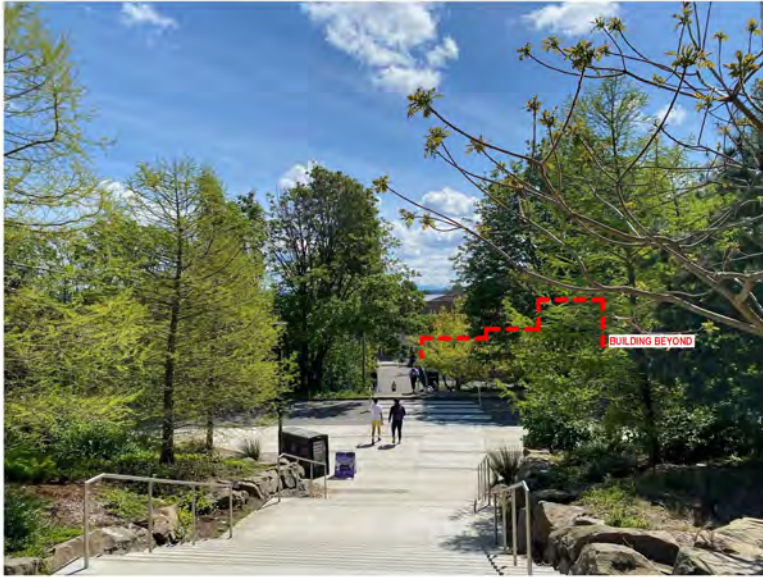
View Corridor 3—Image A

** The red dashed line indicates the location of the proposed project. However, the project would be located behind Alaska Airlines Arena and existing vegetation and would not be visible from this location.*
