ENVIRONMENTAL CHECKLIST

*University of Washington
IMA Addition Project*

October 2021

*EA Engineering, Science, and Technology, Inc., PBC
GeoEngineers
PBS Engineering and Environmental, Inc.*

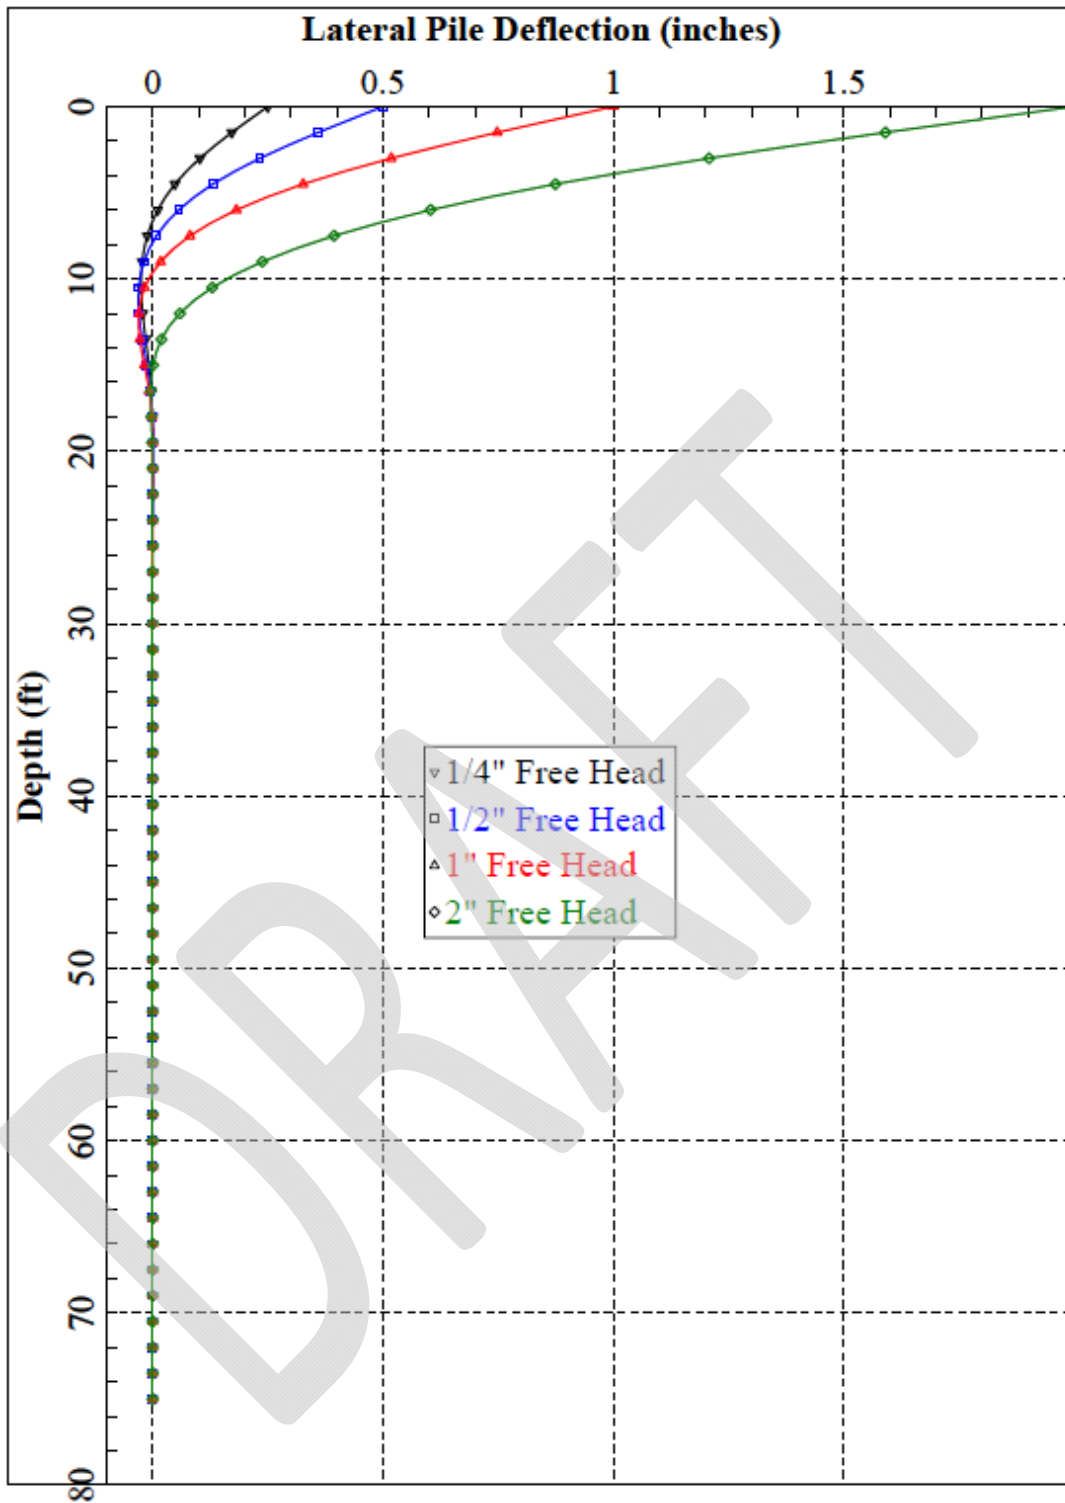
Figure 5

1. Lateral pile capacities were evaluated using LPILE v2016
2. Free-head conditions were evaluated for a range of deflections. No axial load was applied to the pile.

Pile shear and bending moments were evaluated as described above by controlling lateral deflections at the top of the pile. LPILE runs were completed for deflections of ¼, ½, 1, and 2 inches. Plots from LPILE of deflection vs depth, shear force vs depth, and bending moment vs depth are provided in Figures 5 through 22. The recommended design parameters for the primary soil units are summarized in Table 3. The structural engineer may use the recommended design LPILE soil parameters to evaluate lateral pile capacities for other loading conditions or pile sizes.

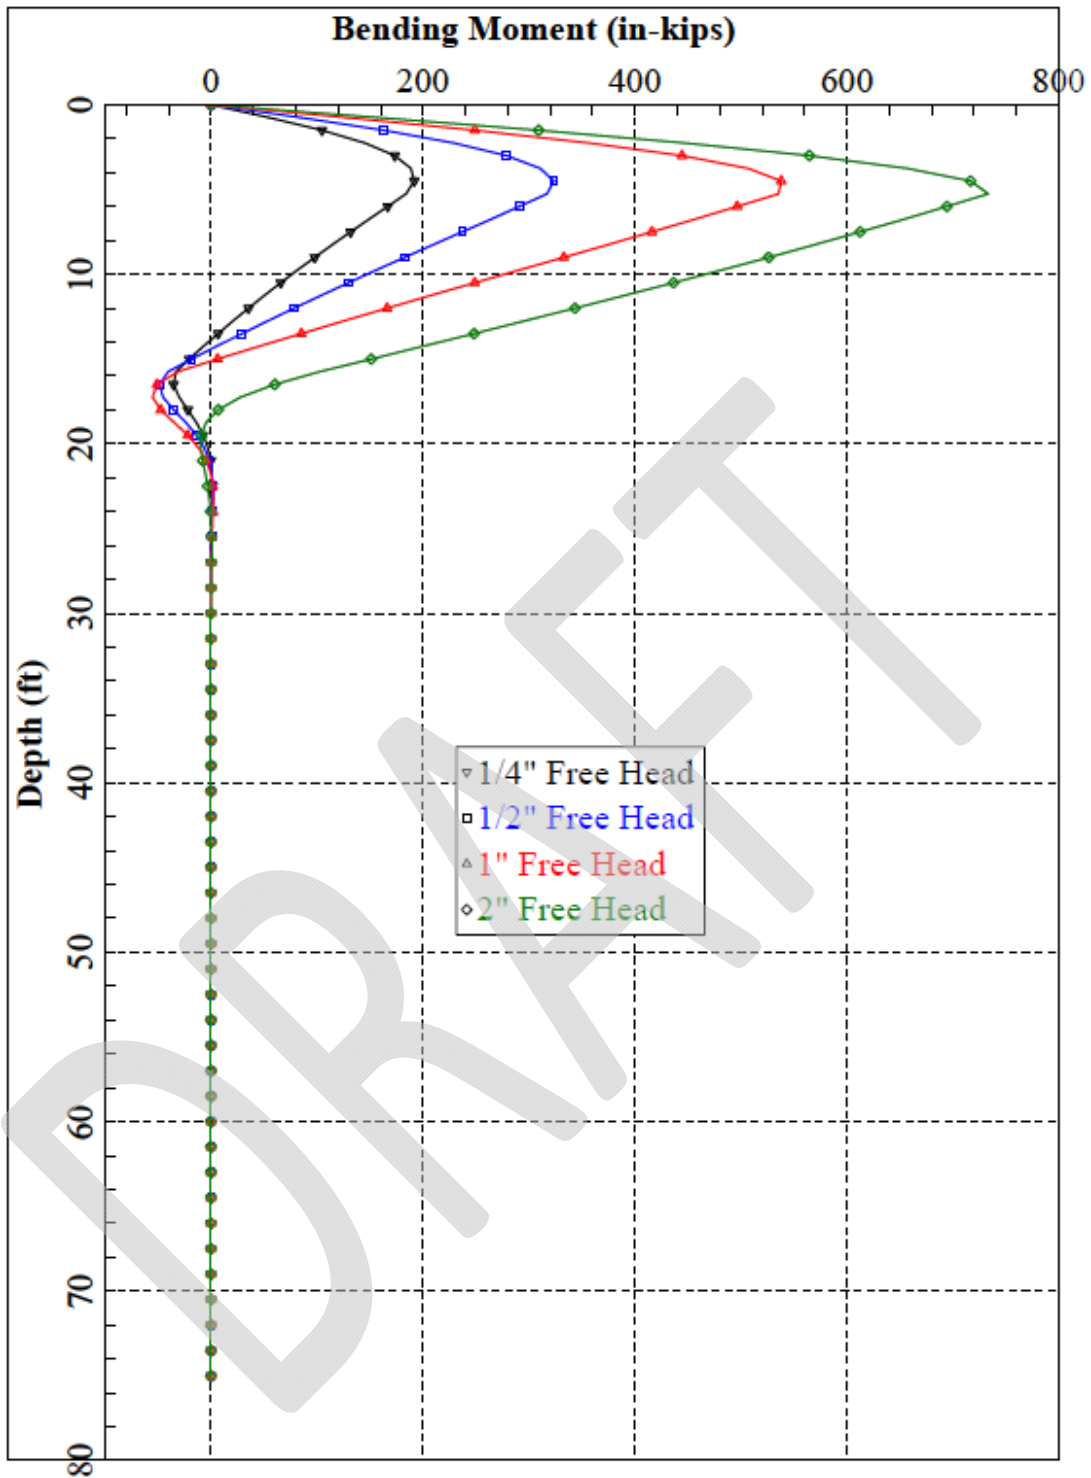
Figure 7

1. Lateral pile capacities were evaluated using LPILE v2016
2. Free-head conditions were evaluated for a range of deflections. No axial load was applied to the pile.

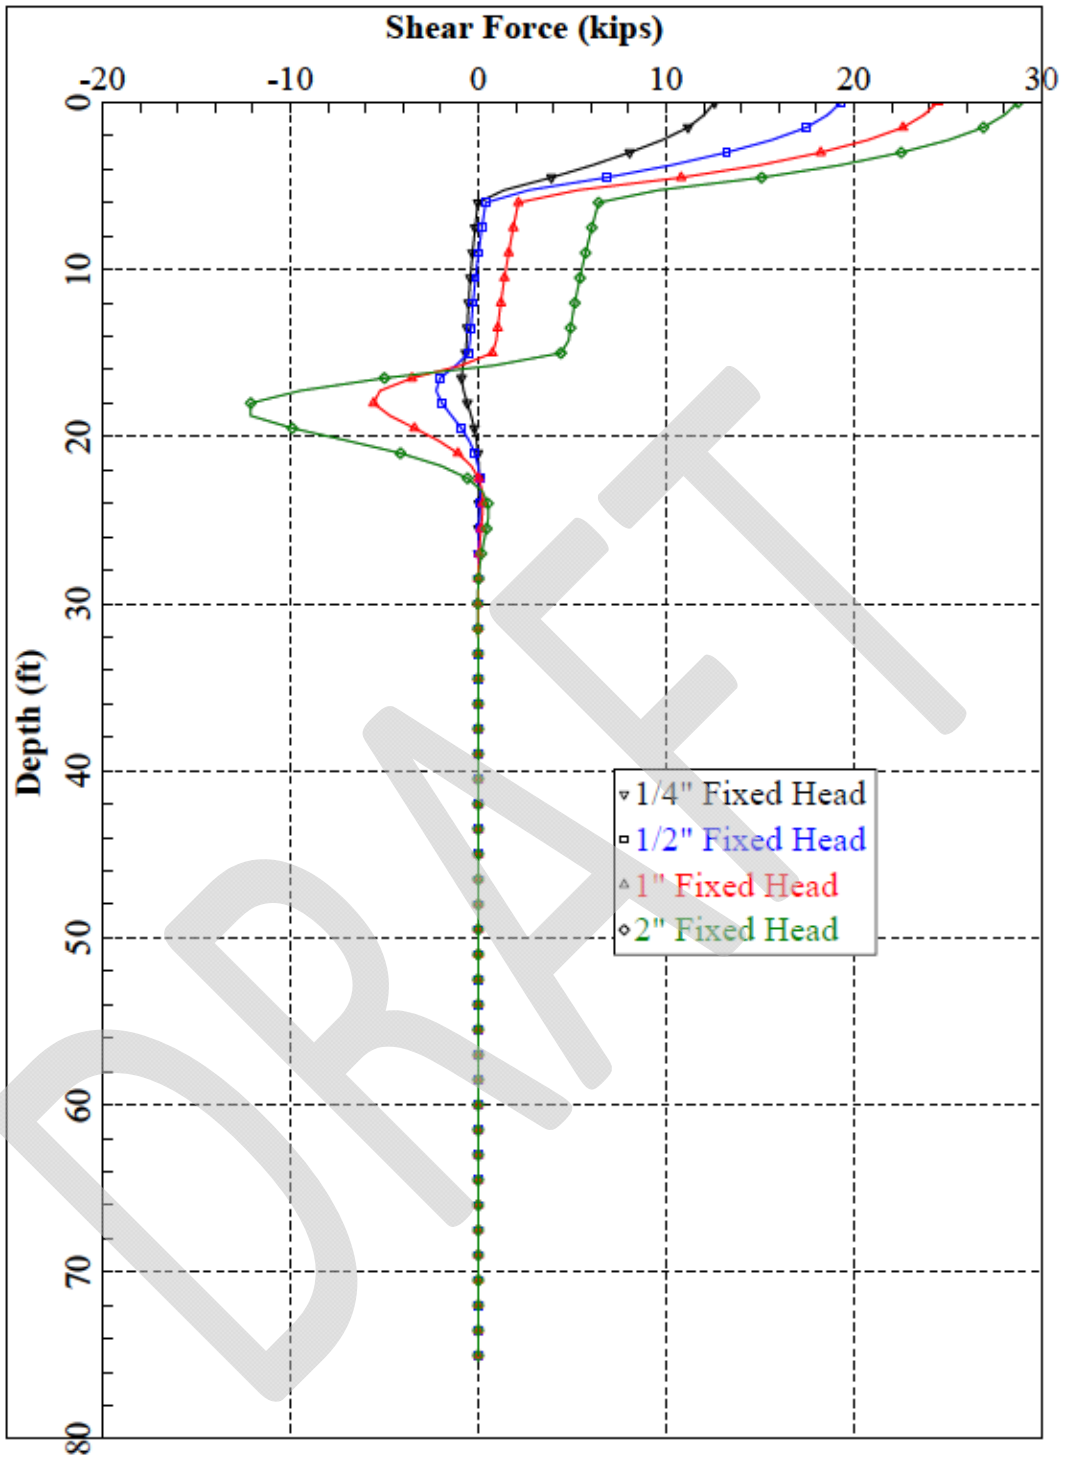
Figure 9

1. Lateral pile capacities were evaluated using LPILE v2016
2. Free-head conditions were evaluated for a range of deflections. No axial load was applied to the pile.

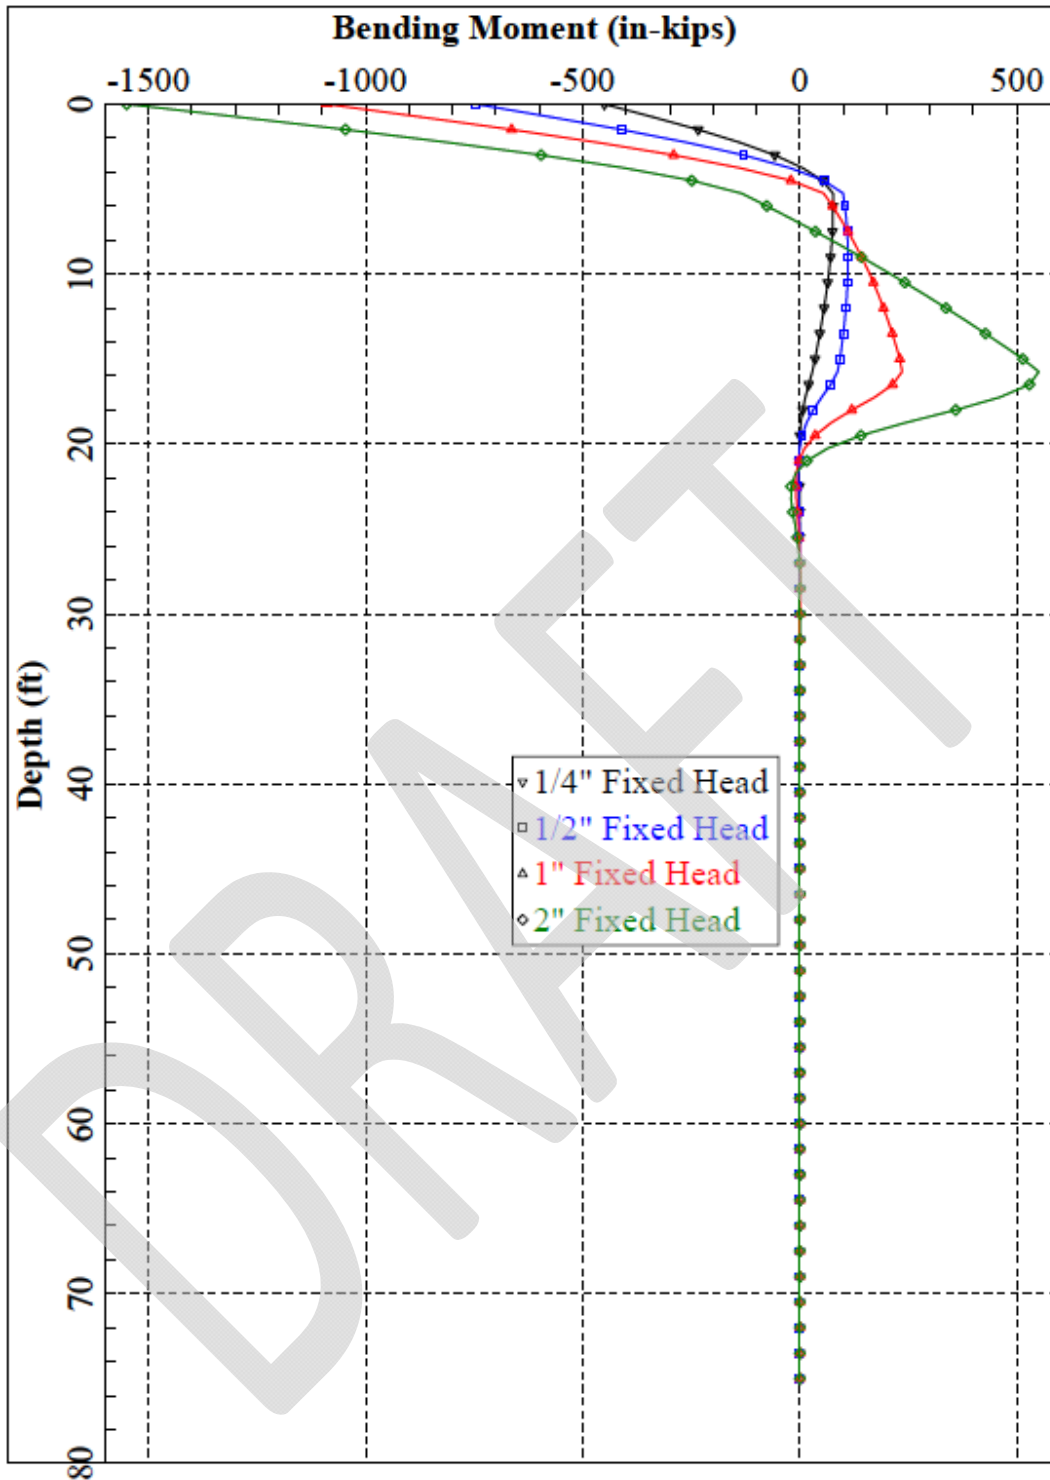
Figure 10

1. Lateral pile capacities were evaluated using LPILE v2016
2. Free-head conditions were evaluated for a range of deflections. No axial load was applied to the pile.

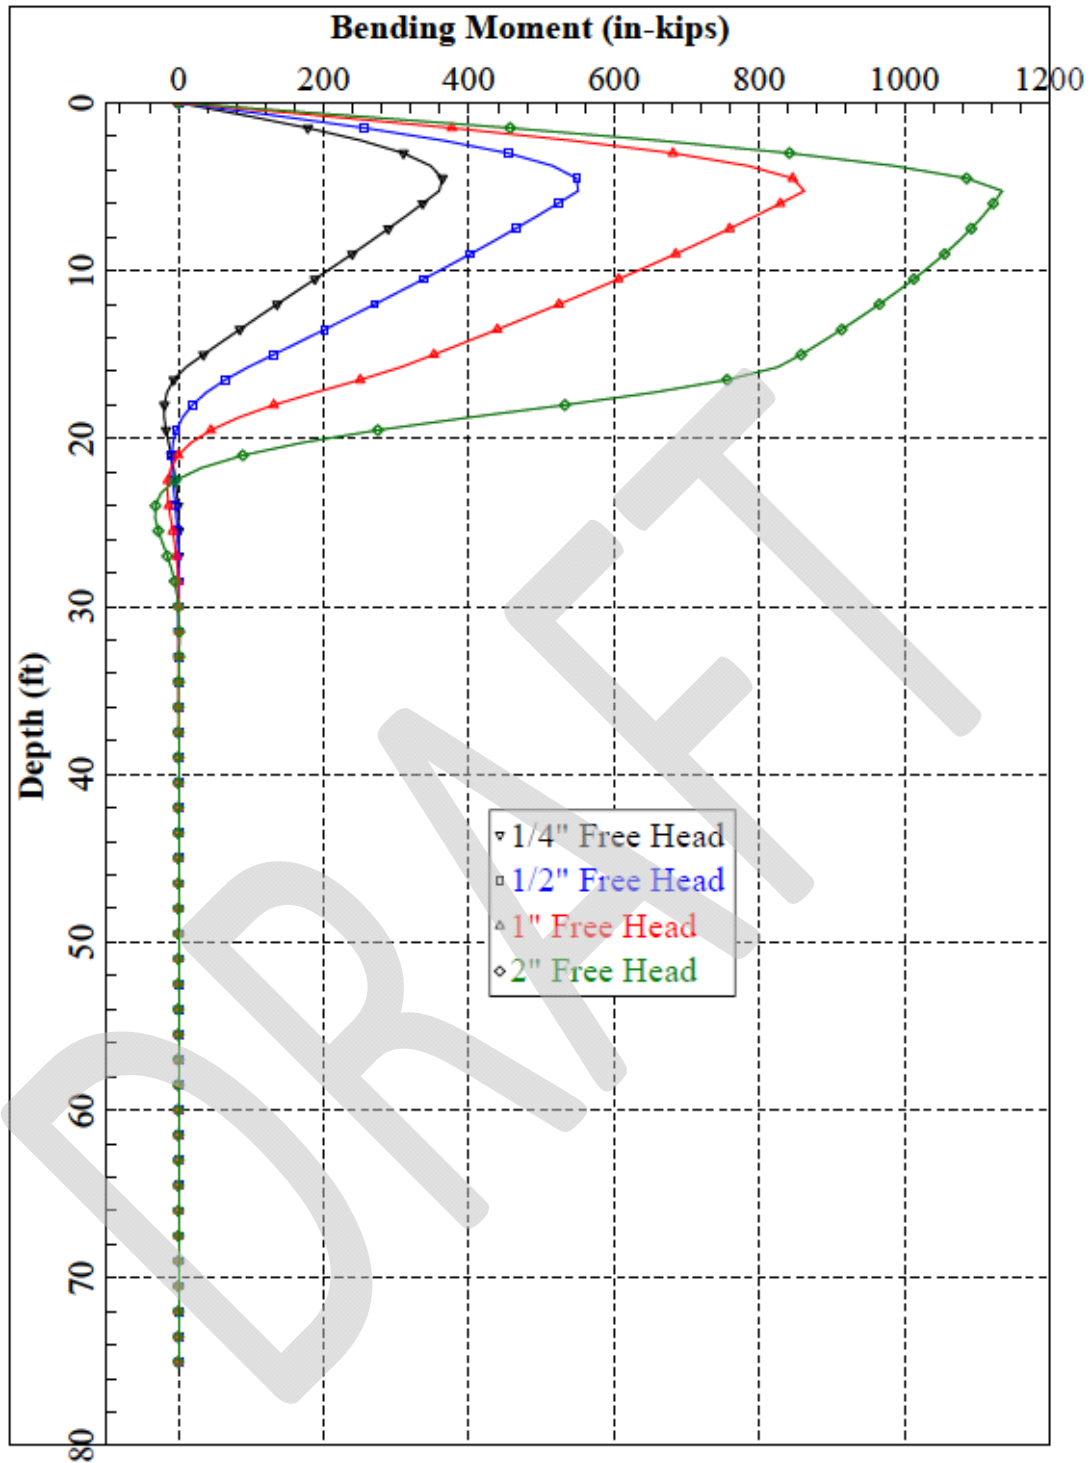
Figure 13

1. Lateral pile capacities were evaluated using LPILE v2016
2. Free-head conditions were evaluated for a range of deflections. No axial load was applied to the pile.

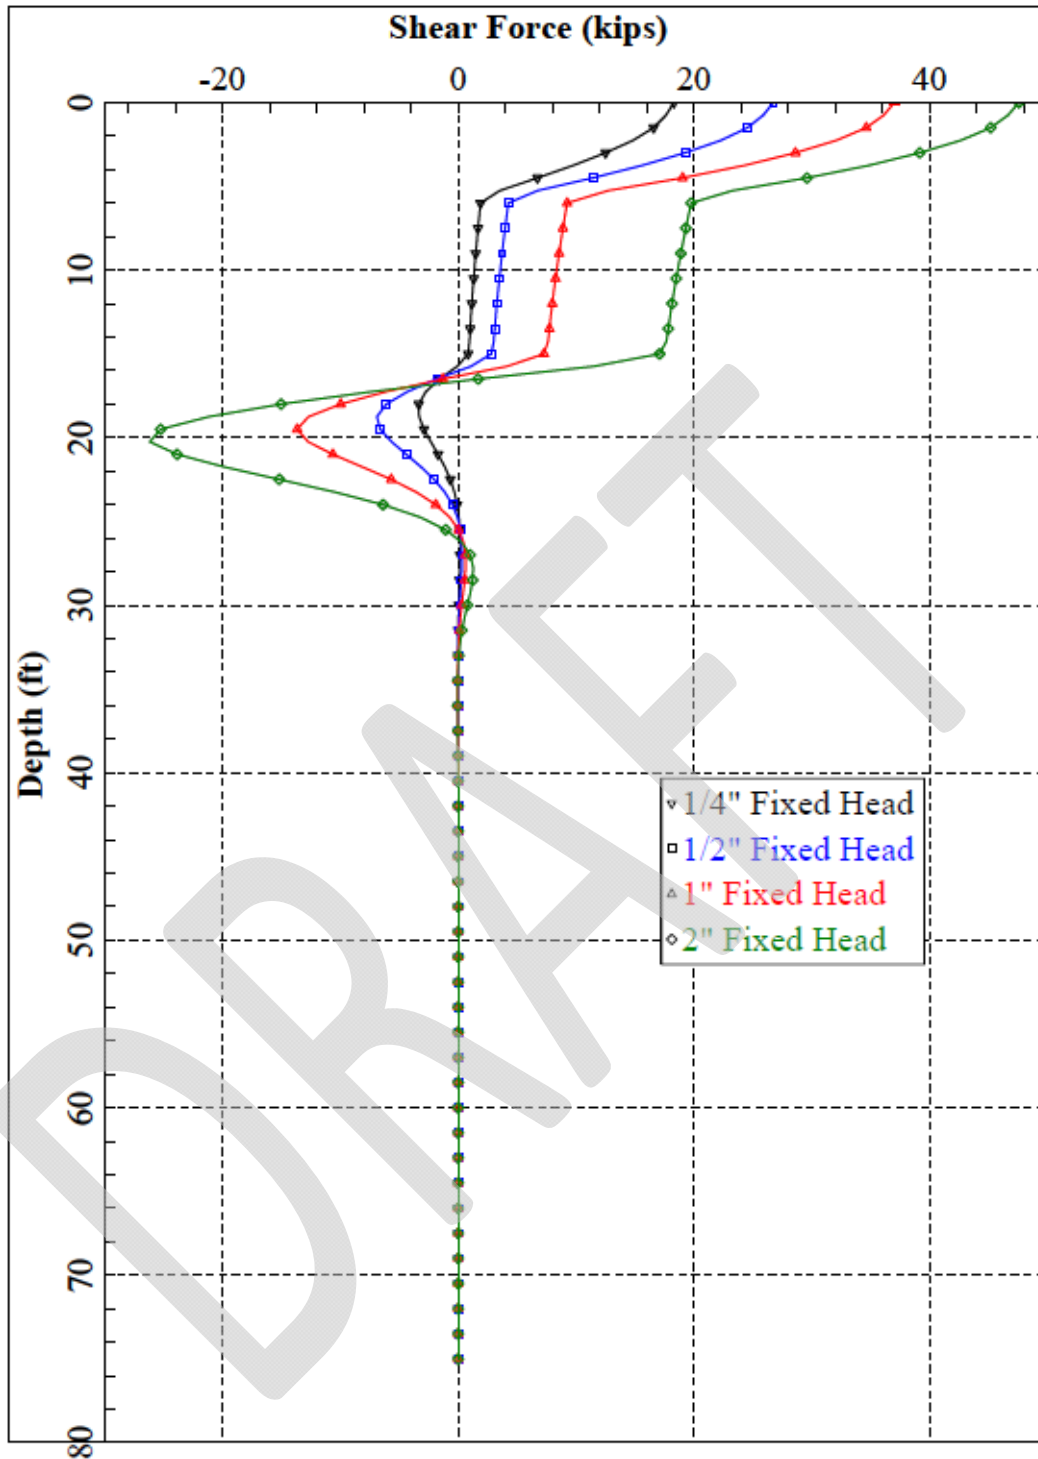
Figure 15

1. Lateral pile capacities were evaluated using LPILE v2016
2. Free-head conditions were evaluated for a range of deflections. No axial load was applied to the pile.

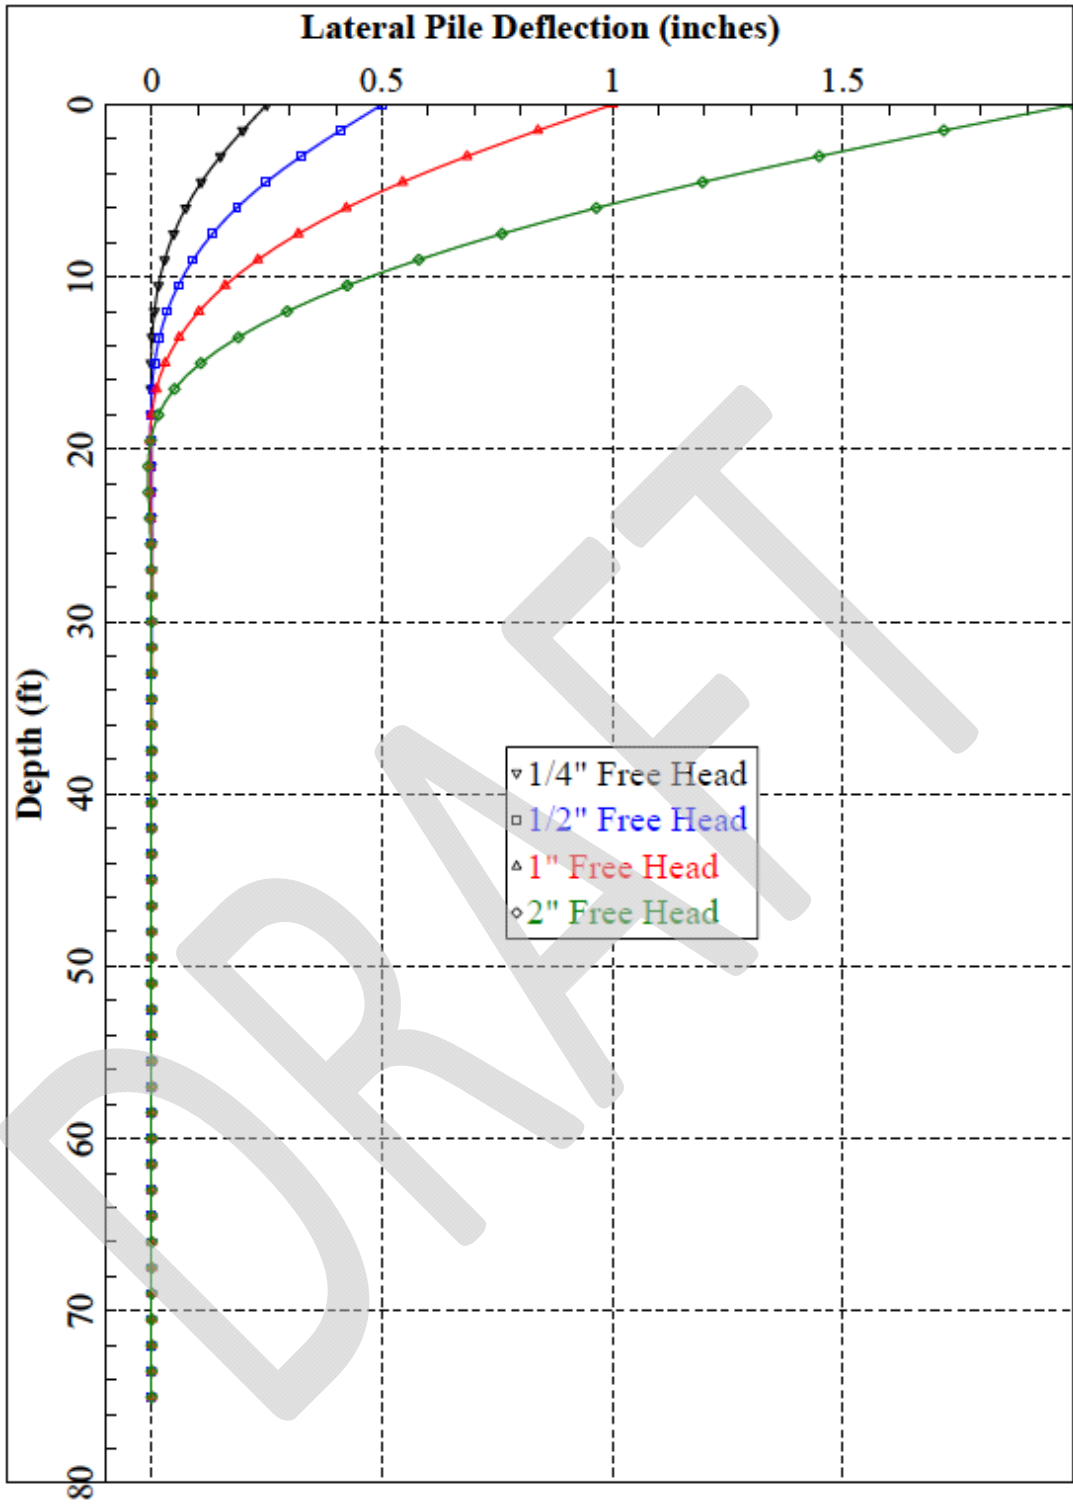
1. Lateral pile capacities were evaluated using LPILE v2016
2. Free-head conditions were evaluated for a range of deflections. No axial load was applied to the pile.

18-inch Augercast Pile Deflection vs Depth (Free Head)	
UW IMA Pool and Locker Room Upgrades Seattle, Washington	
GEOENGINEERS  	Figure 17

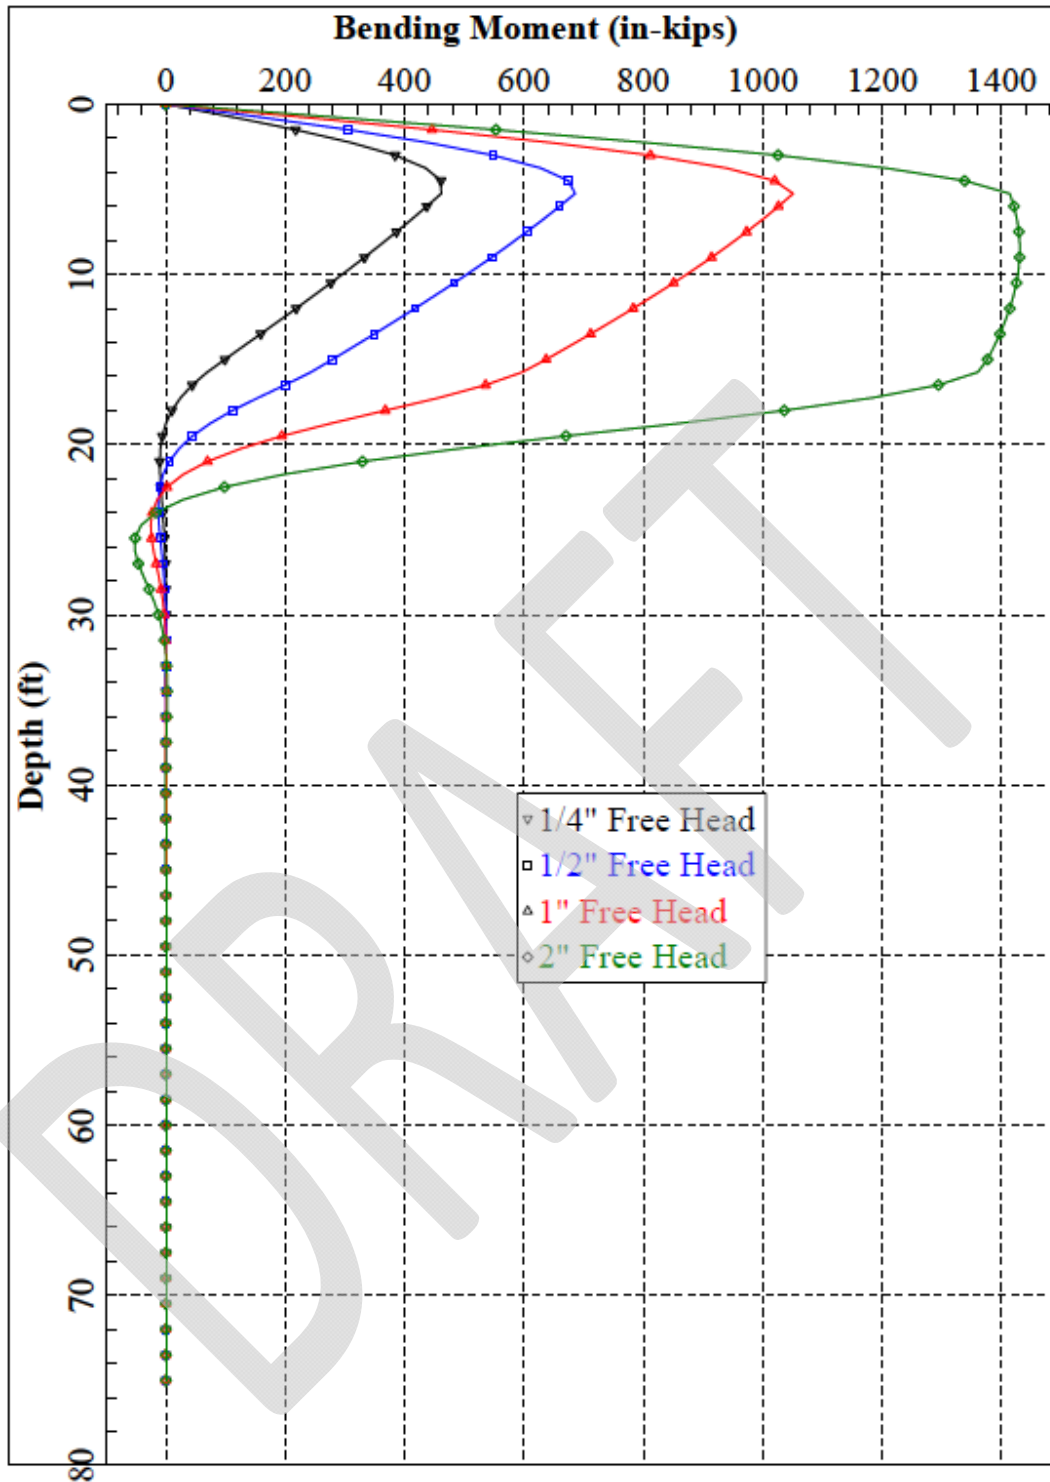
Figure 19

1. Lateral pile capacities were evaluated using LPILE v2016
2. Free-head conditions were evaluated for a range of deflections. No axial load was applied to the pile.

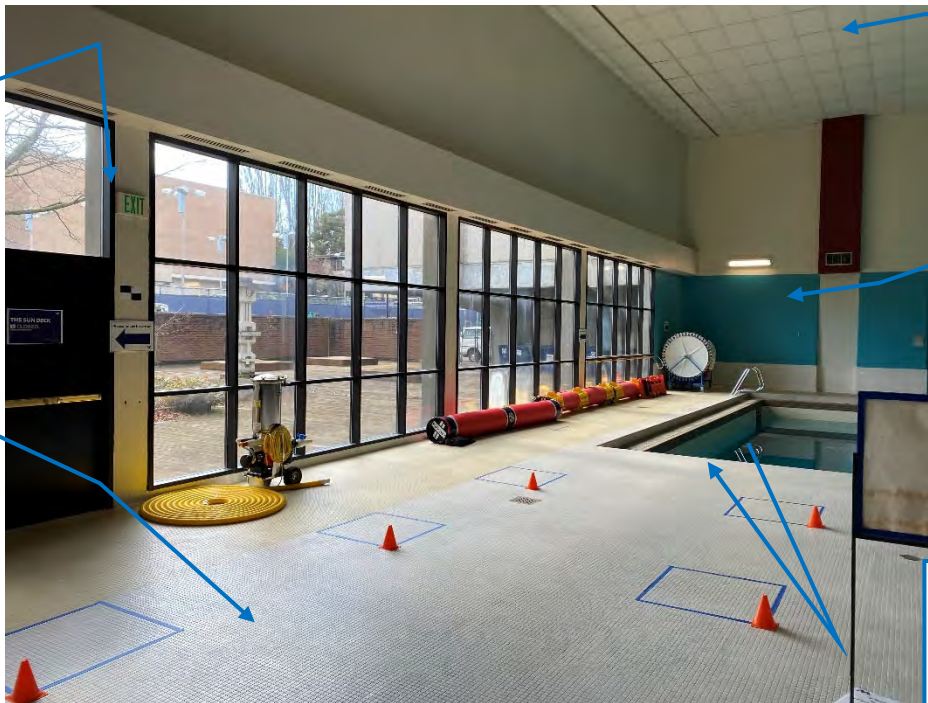
Photo 4: Pool Area.

ACM Hard pipe fittings associated with fiberglass insulation

Non-ACM white insulation cloth blanket

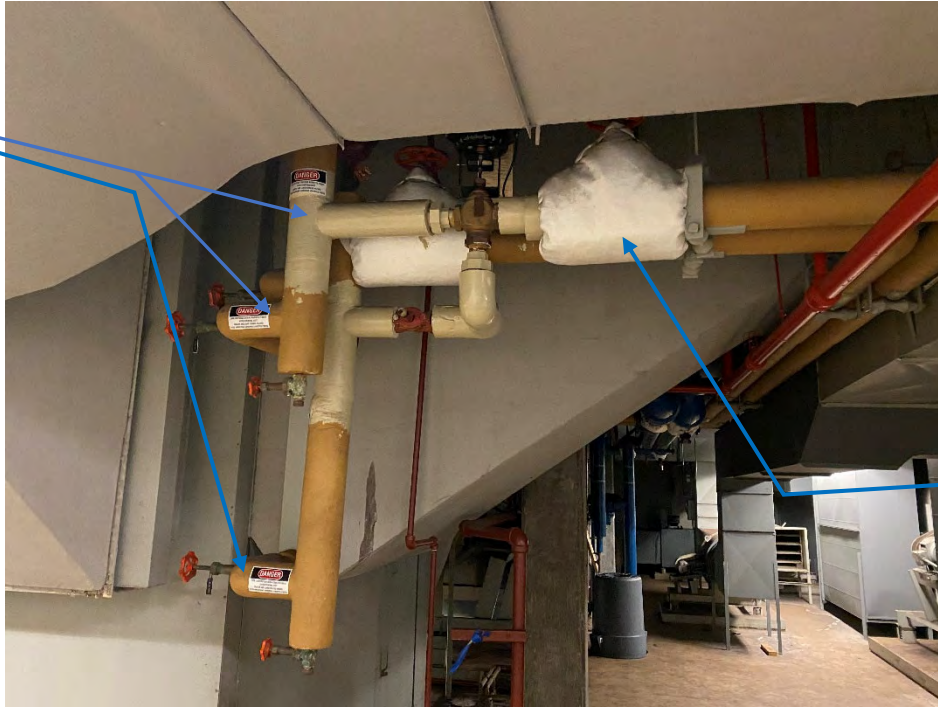
Photo 5: East Penthouse mechanical room.

ACM pipe insulation associated with steam & condensate lines

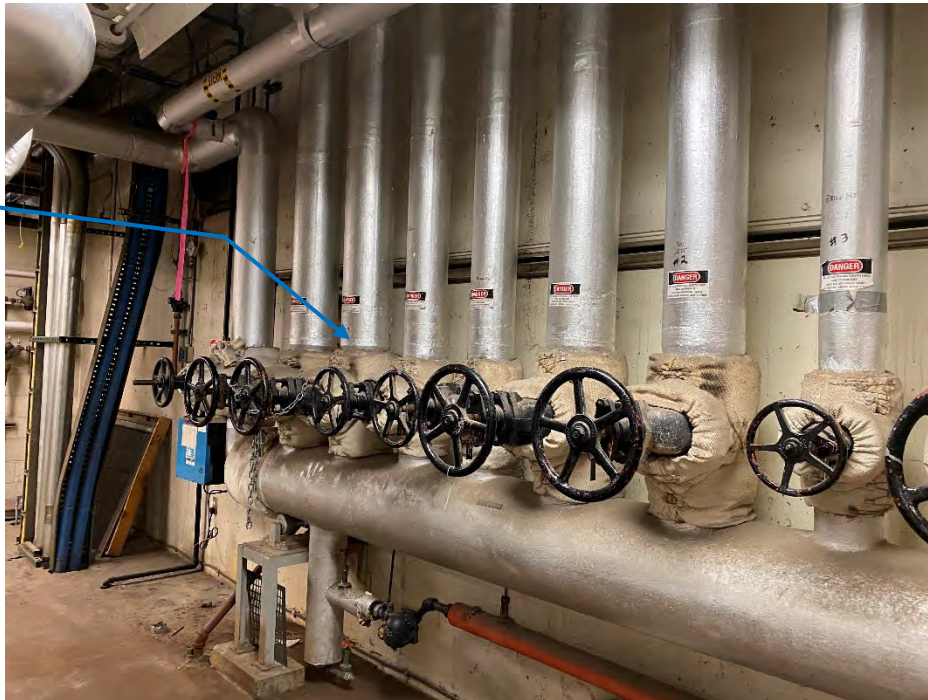
Photo 6: Ground Floor (1st floor) Mechanical Room (north). ACM Pipe & Fitting insulation and ACM pipe valve gaskets and select blanket insulation.
