Name: Alaska-Yukon-Pacific Exposition Foundry,
UW Engineering Annex

Foundry (Engineering Annex)

UNIVERSITY OF WASHINGTON

April 2019

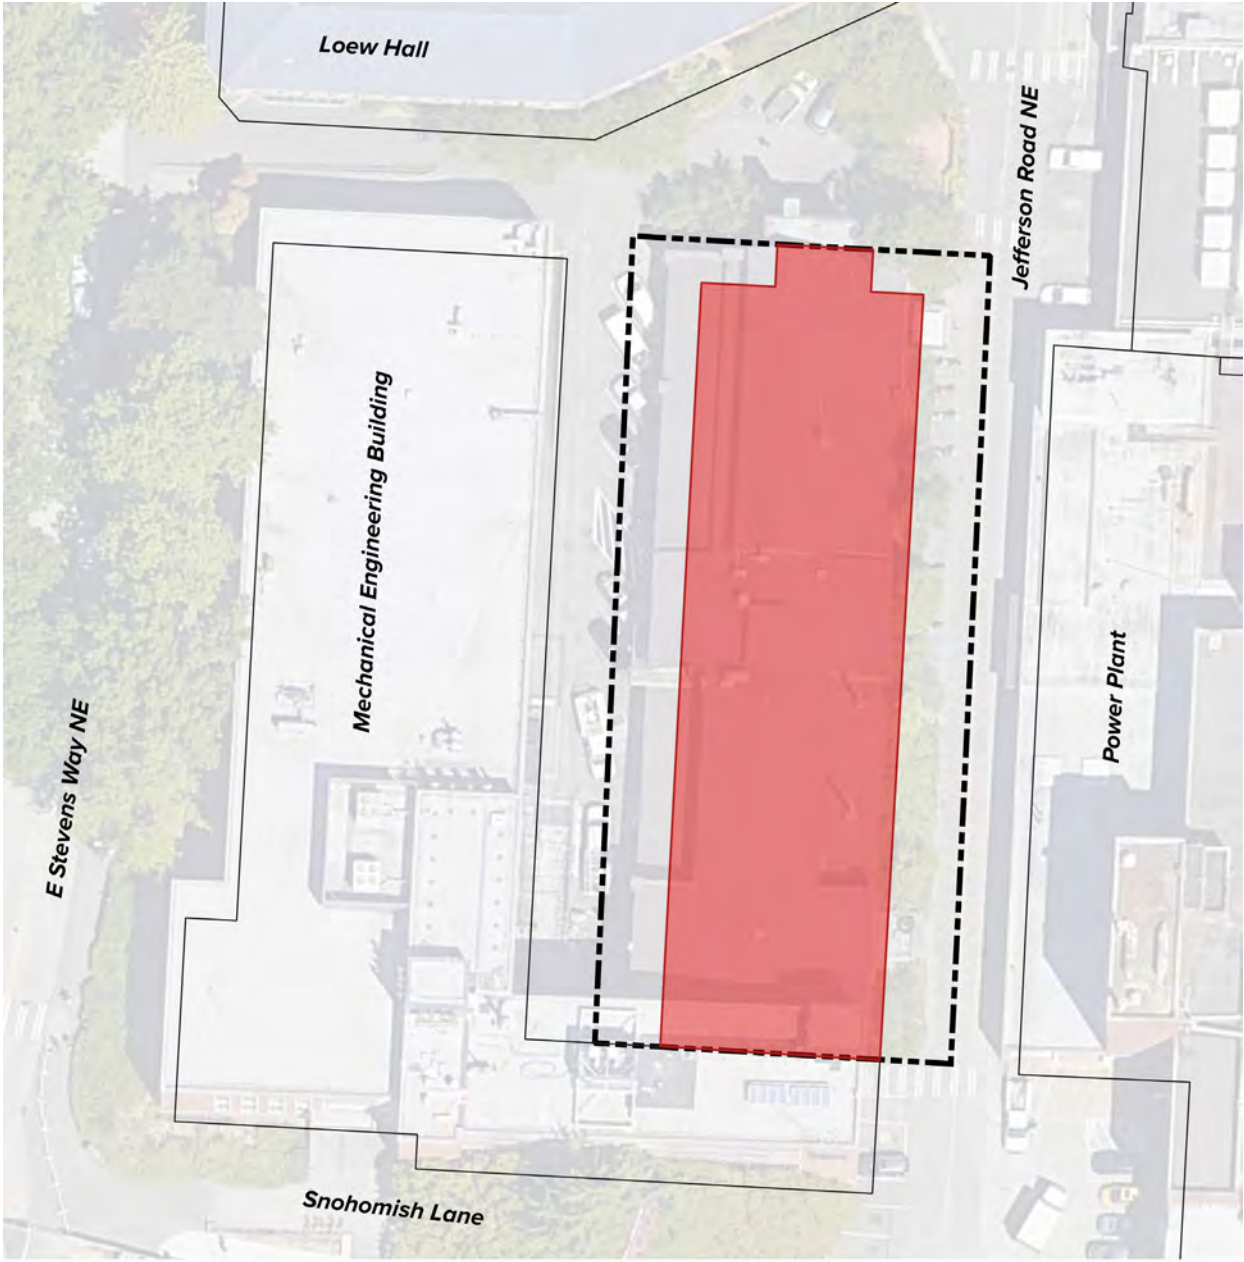
Figure 2. Nominated property map showing the nomination boundary with the building shaded in red.

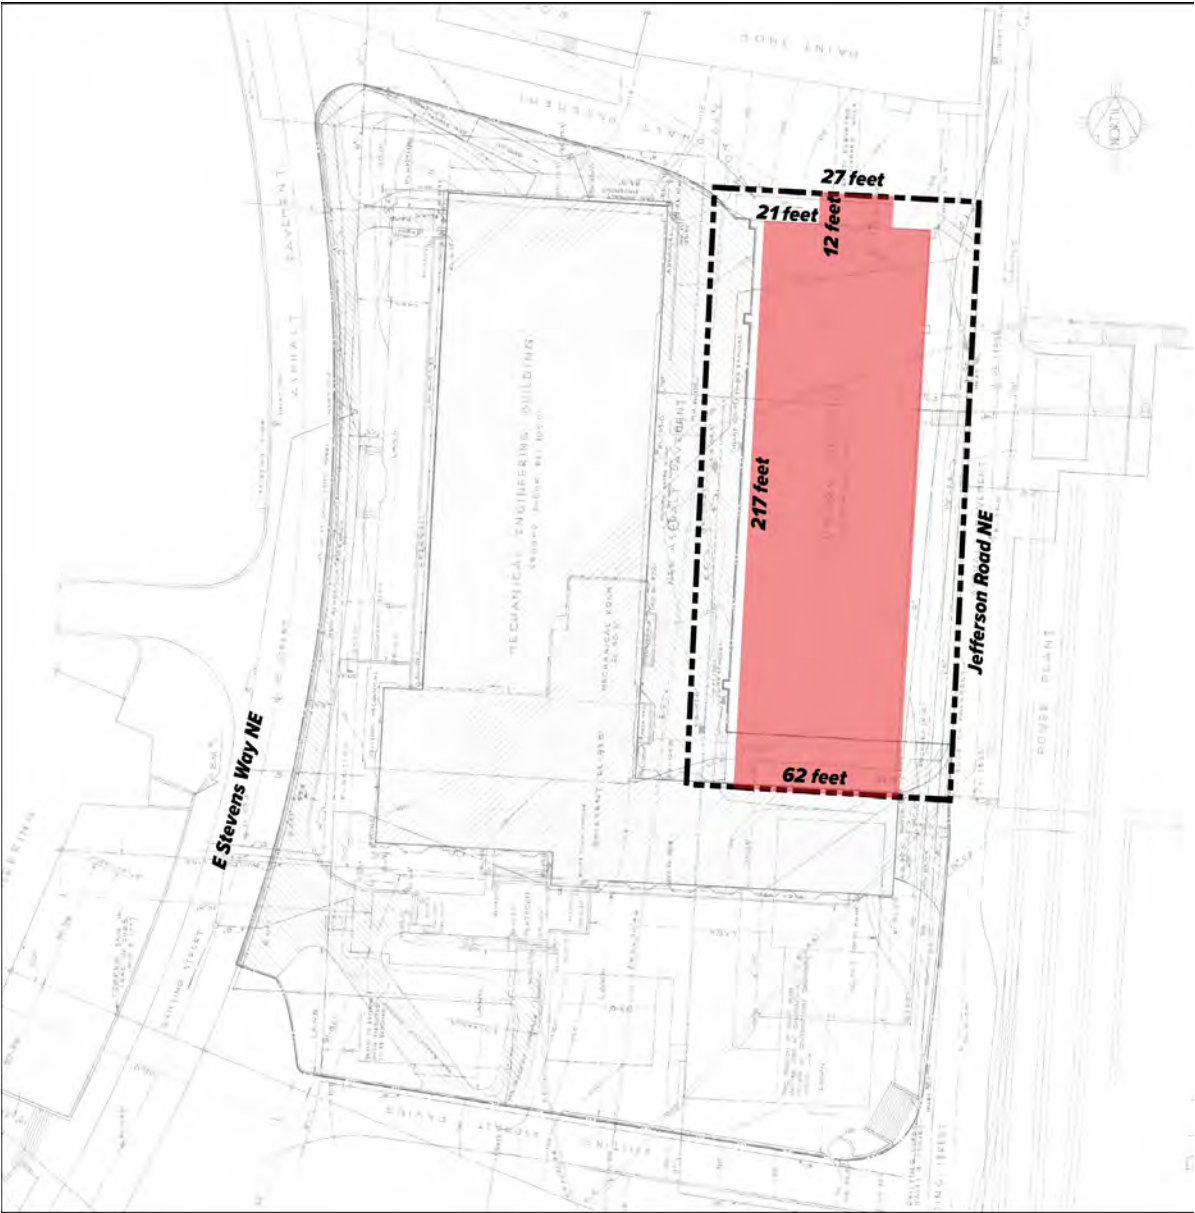
Figure 3. Site Plan. This map shows the nominated building (in red) and nomination boundary.

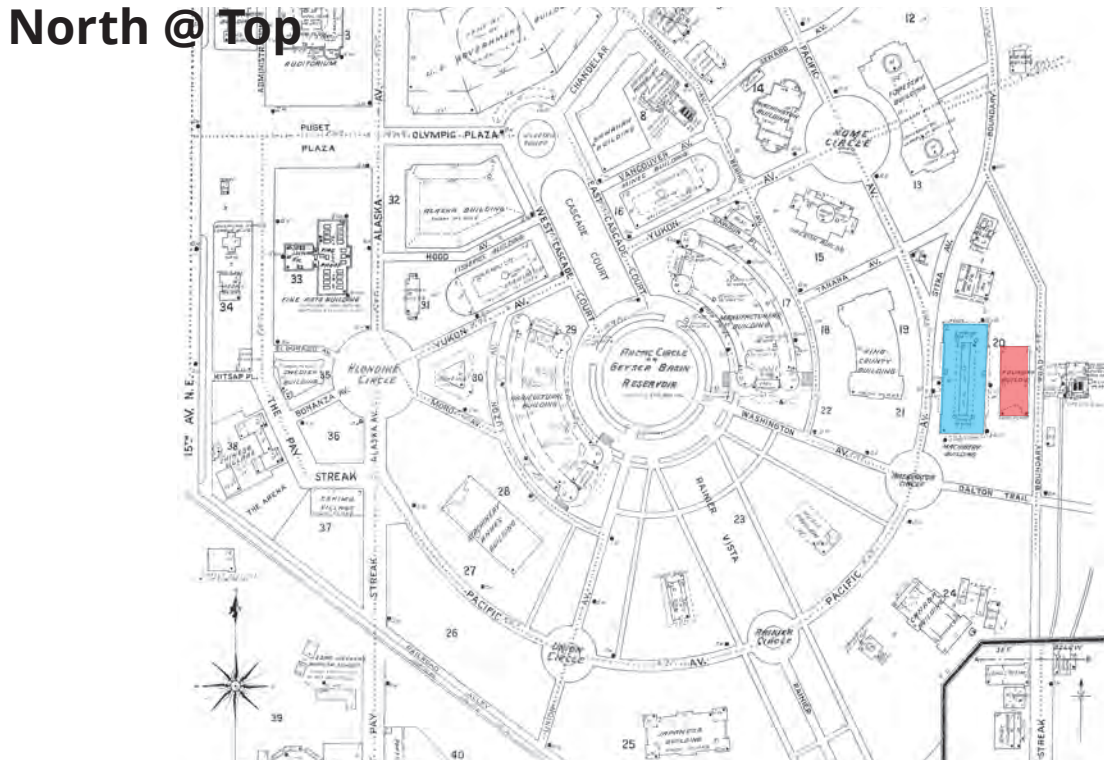
Figure 12. 1909 Sanborn Fire Insurance map for the AYPE, the Foundry (Engineering Annex) in red and the Machinery Building in blue. Source: Seattle Public Library.

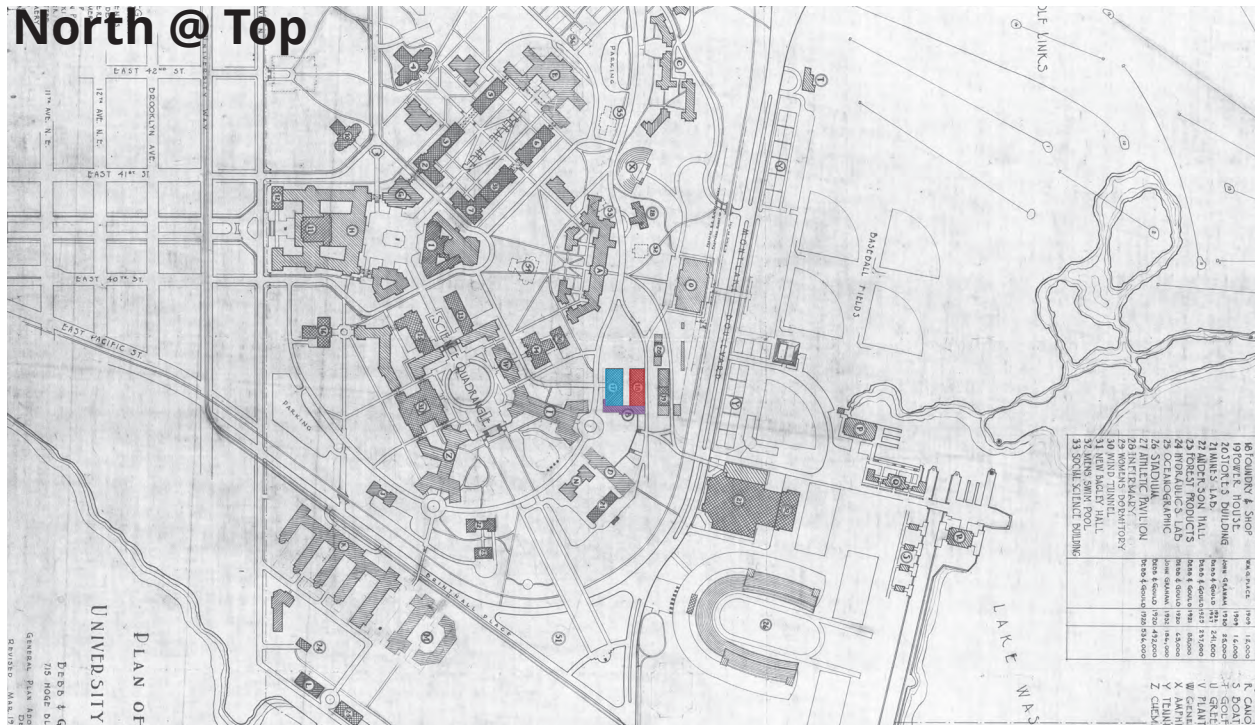
Figure 13. 1915 master plan for the campus, the Engineering Annex in red and the former Machinery Building in blue. The purple section shows a connecting wing proposed as part of this plan. Source: University of Washington.

- Regents Plan of 1915. Local architect and founder of the university’s newly formed architecture department, Carl F. Gould designed this new plan. This plan became the guiding document for the university for the next two decades. The Regents Plan followed a simplified version of the Beaux Arts-design of the Olmsted’s plan. Collegiate Gothic was established as the predominant architectural style for new construction, which persisted into the 1950s. The plan established groupings of buildings on campus with the liberal arts programs on the Upper Campus, administrative and library facilities on a quadrangle at the center of campus and science and engineering programs along Rainier Vista and southern campus.¹⁶
(Figure 13)

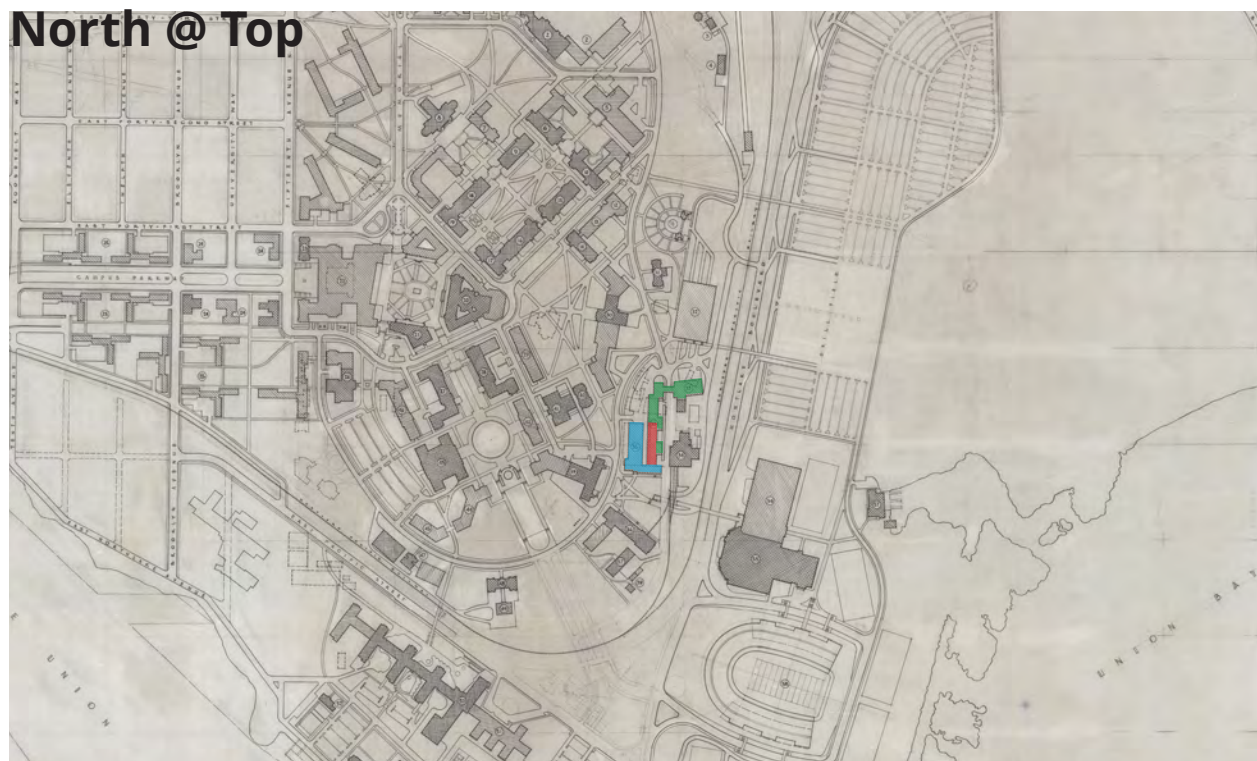
Figure 18. 1949 master plan for the campus, the Engineering Annex in red and the planned future site of the Mechanical Engineering Building in blue, and proposed additions to the Engineering Annex in green. Source: University of Washington.

- 1948-49 Plan by Bindon & Jones. This plan reflected the university’s growing enrollment, recommending the acquisition of additional acreage southwest of the original campus (the Northlake area) and the creation of additional student housing (dormitories and married student housing). **(Figure 18)**

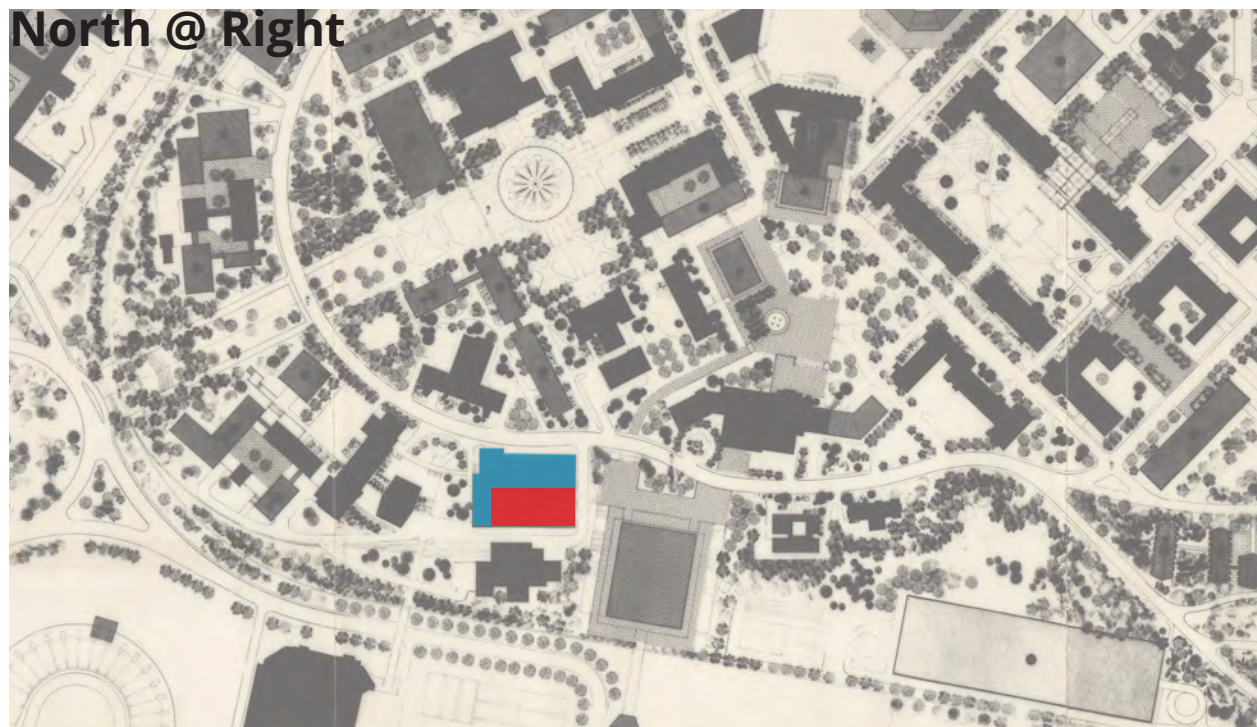
Figure 20. 1962 landscape master plan for the campus, the Engineering Annex in red and the Mechanical Engineering Building (MEB) in blue. In this plan the service court space between the buildings would be built out as an addition. Source: University of Washington.

- 1962 General Development Plan and 1965 General Planning and Development Plan. These plans, designed by Paul Thiry (1962) and Walker & McGough (1965), recommended the introduction of larger developments on the campus including the plaza garage, Red Square and surrounding buildings, additions to Suzzallo Library, and a range of new buildings (science, medical, professional, recreation, and residential).¹⁷ These plans also substantially reconfigured the northwest portion of the campus. **(Figures 20 and 21)**

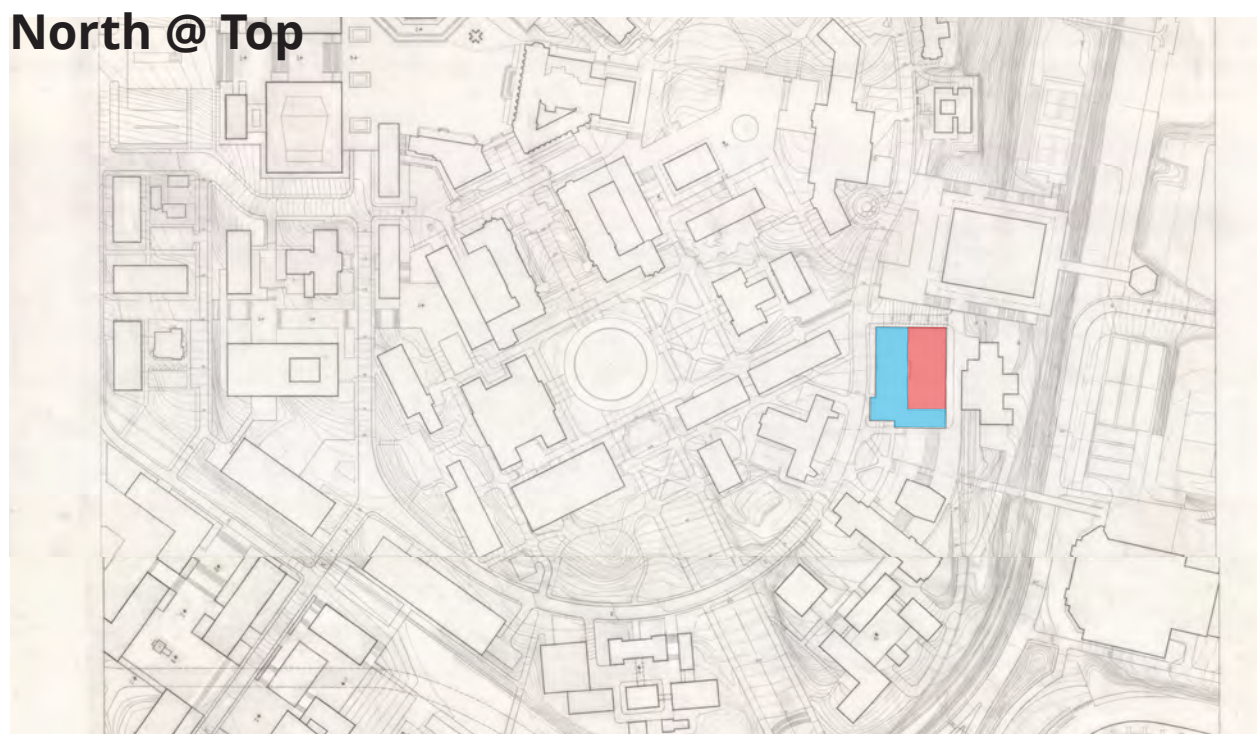
Figure 21. 1962 master plan for the campus, the Engineering Annex in red and the Mechanical Engineering Building (MEB) in blue. In this plan the service court space between the buildings would be built out as an addition. Source: University of Washington.

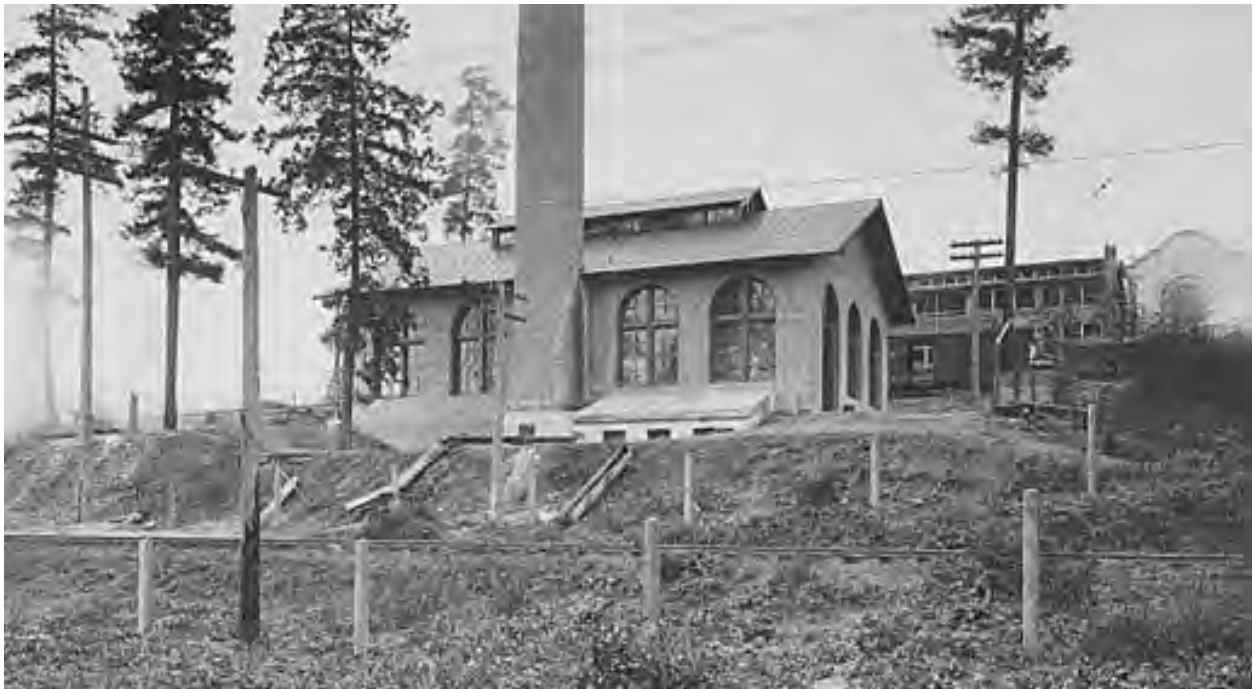
Figure 23. Ca. 1908 view during construction of the Foundry taken from east of Power House #1 (in the foreground) and looking west with the northeast end of the Foundry Building visible in the background and a portion of Machinery Hall visible behind the Foundry. Photographed by Frank H. Nowell. University of Washington Libraries, Special Collections, Negative Number Nowell x769.

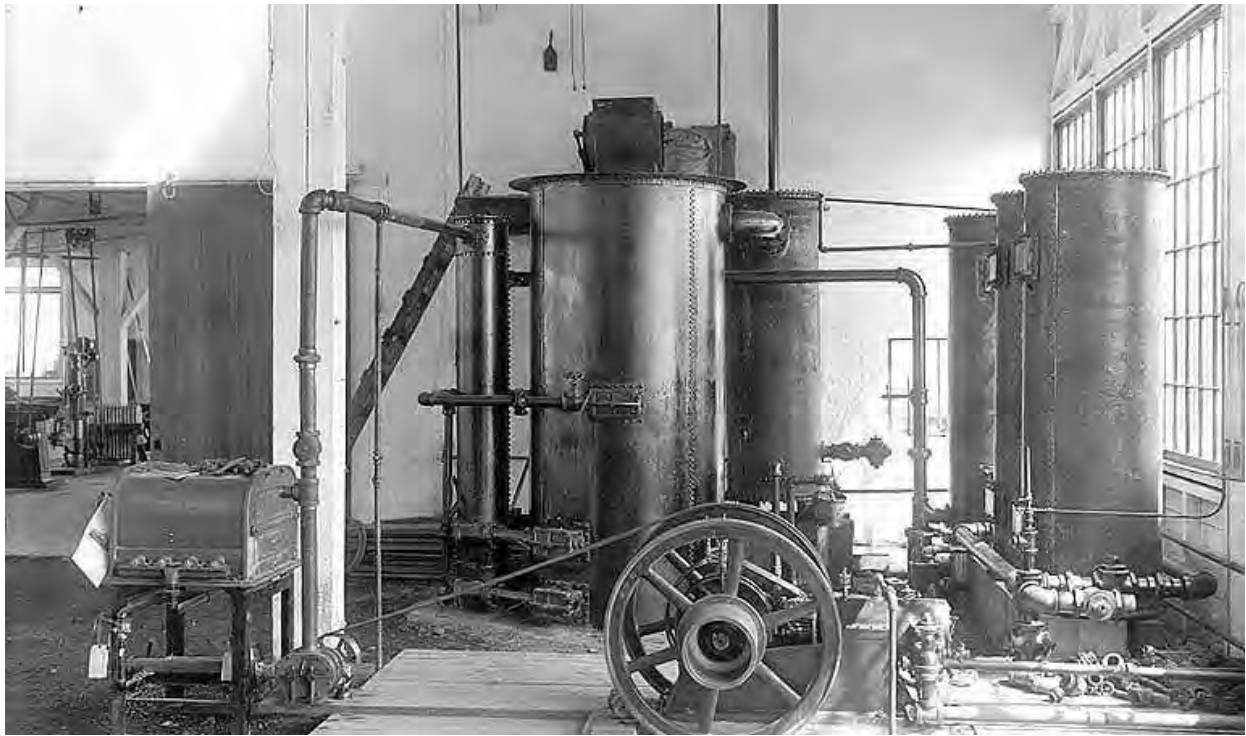
Figure 24. Foundry Building motors and boilers exhibit, Alaska Yukon Pacific Exposition, Seattle, 1909. Photographed by Frank H. Nowell. University of Washington Libraries, Special Collections, Negative Number UW28514z.

The subject building was constructed in 1909 for use as a foundry with exhibit space for the AYPE. A foundry is a workshop or factory where metal is heated to a molten state and cast. The building opened to the public on July 22, 1909. According to the September 1909 edition of *The Foundry*, the AYPE foundry was “the first attempt to hold an exhibition of foundry supplies and equipment at any point west of the Mississippi River.”¹⁸ **(Figures 22 through 29)**

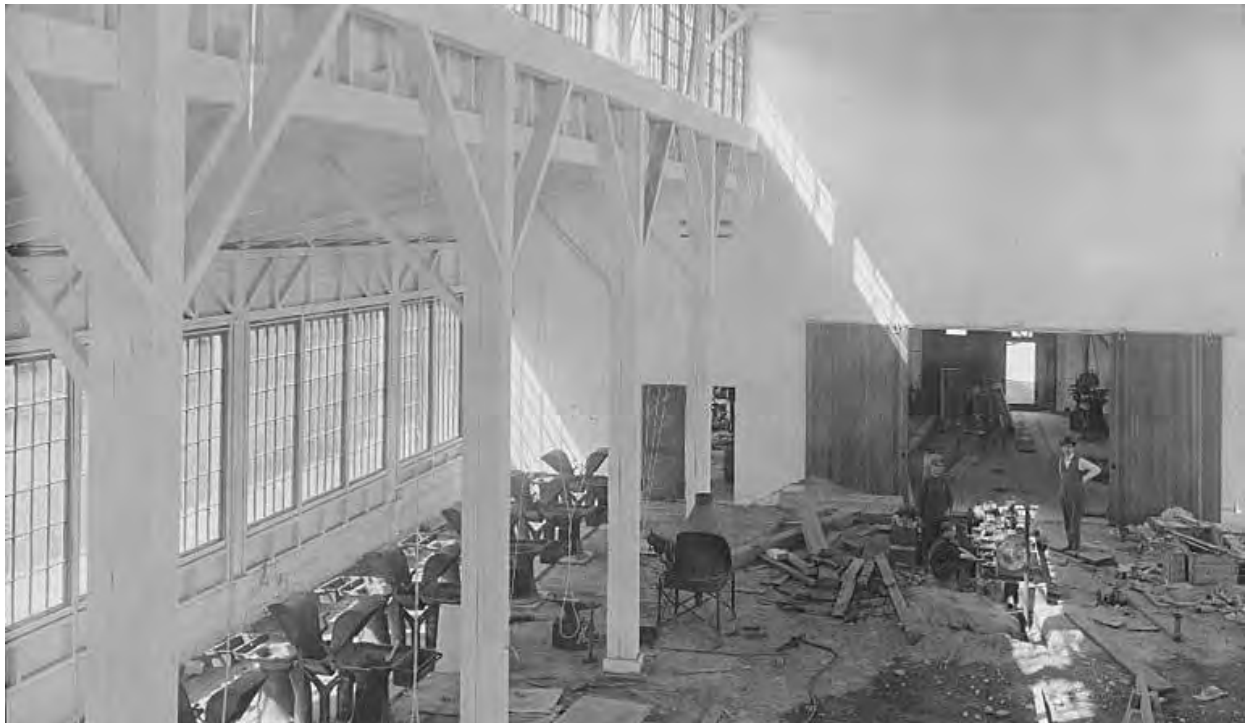
Figure 25. Foundry interior under construction, Alaska-Yukon-Pacific-Exposition, Seattle, Washington, 1909. Photographed by Frank H. Nowell. University of Washington Libraries, Special Collections, Negative Number UW28519z.

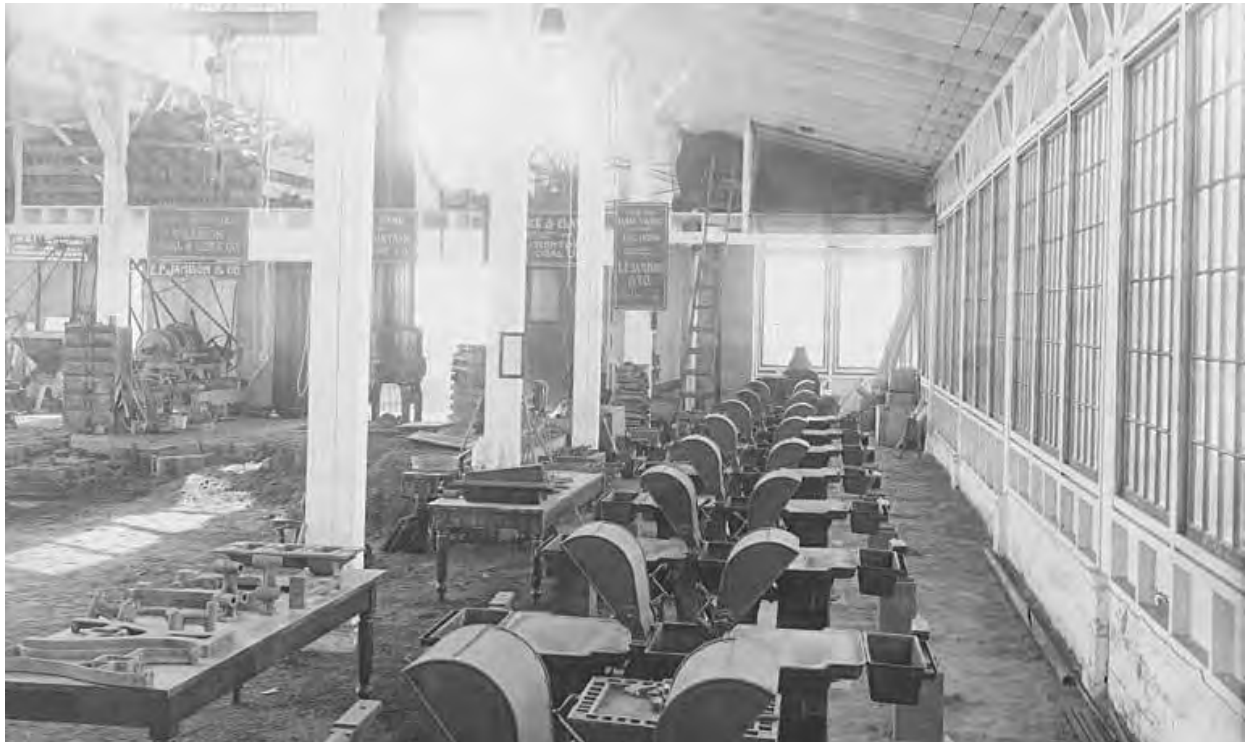
Figure 26. Foundry machinery exhibit, Alaska-Yukon-Pacific-Exposition, Seattle, Washington, 1909. Photographed by Frank H. Nowell. University of Washington Libraries, Special Collections, Negative Number UW28509z.

During the AYPE, the building exhibited foundry supplies and equipment in the side bays with the central bay utilized as the molding floor for demonstrations. Exhibits displayed in the Foundry included:

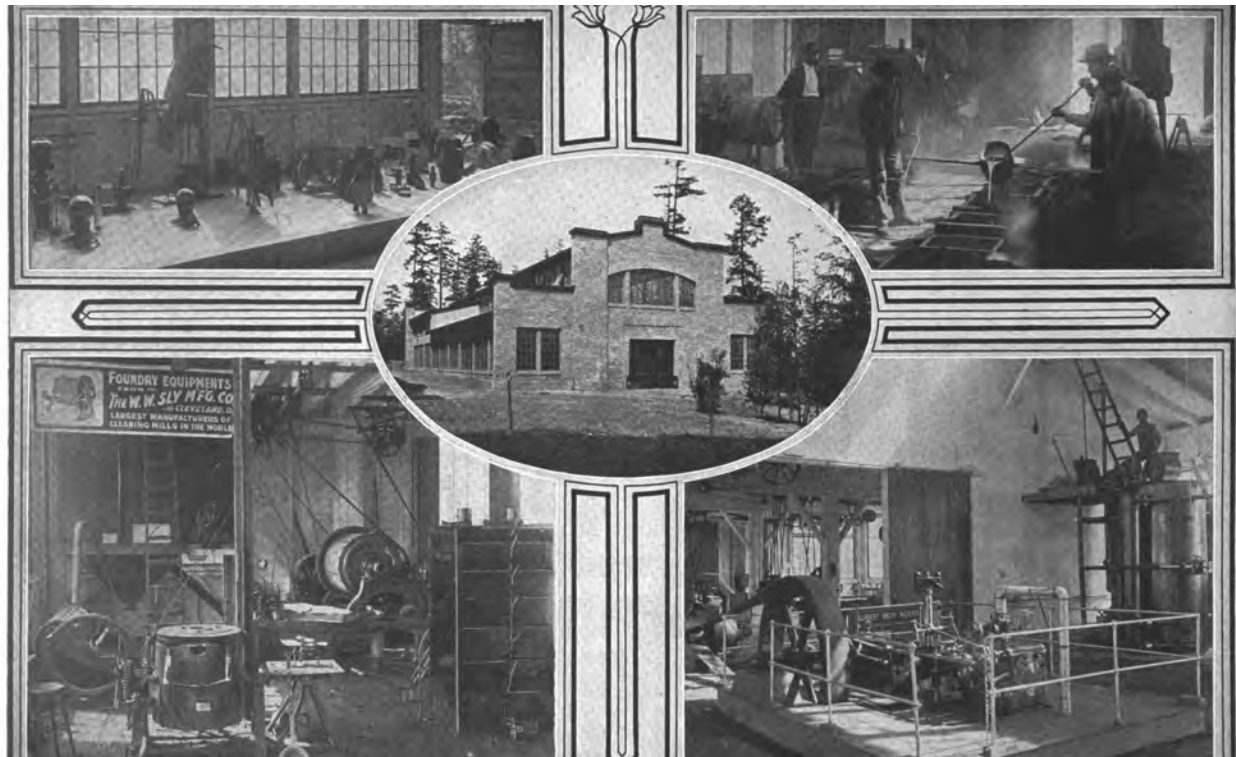
Figure 28. 1909 views of the Foundry interior. Source: "The Foundry" Volume 35, Number 1, British Foundrymen's Convention: Report of the proceedings at the sixth annual meeting of the British Foundrymen's Association held at Birmingham.

Stylistically, the building was built as a typical commercial foundry, but with a few key differences, since it was constructed for the Alaska-Yukon-Pacific Exposition (AYPE), Seattle's first world's fair. A 1909 article in *The Foundry*, a report of the proceedings of the sixth annual meeting of the British Foundrymen's Association, noted a few key differences: the placement of the cupola at the south end rather than centered (to improve visibility for spectators at the Alaska Yukon Pacific Exposition), the unusually large windows, and end wall doors large enough to accommodate a box car.¹ During the AYPE, the main two-story center volume was the molding floor with exhibits located in the side bays.

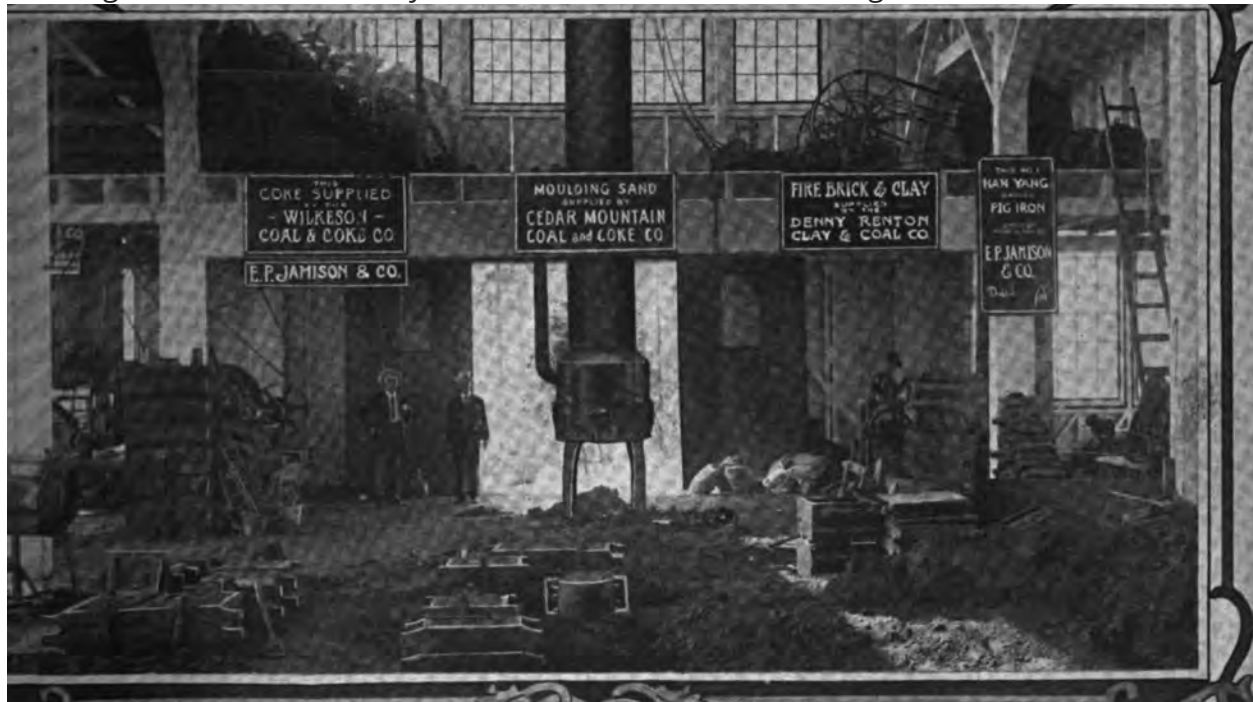
Figure 29. 1909 views of the Foundry interior. Source: "The Foundry" Volume 35, Number 1, British Foundrymen's Convention: Report of the proceedings at the sixth annual meeting of the British Foundrymen's Association held at Birmingham.

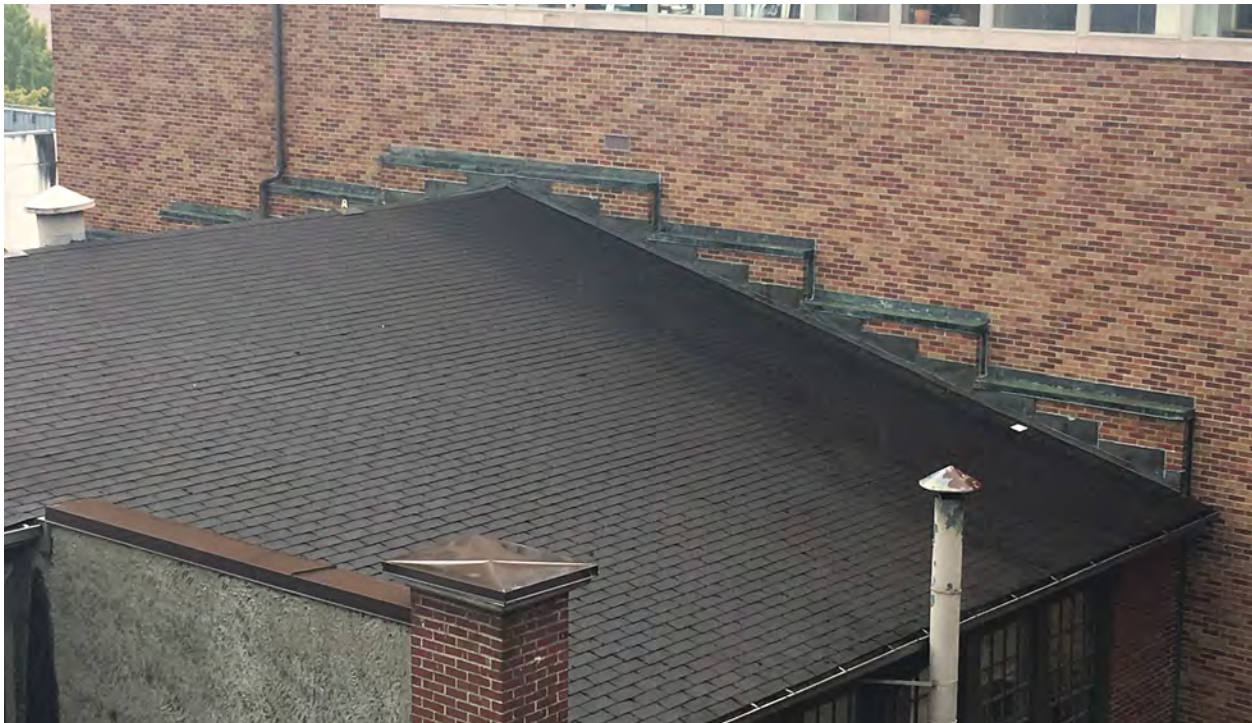
Figure 39. South end wall connection with MEB detail.

Connecting the Mechanical Engineering Building's southeast wing to the south end of the Engineering Annex required removal of the south end wall, and approximately 5 to 8 feet of the side walls, of the Engineering Annex. A new reinforced concrete block wall and associated foundation was built as the new south end wall for the Engineering Annex with a six-inch air space between this end wall and the concrete structure of the Mechanical Engineering Building. The location for the new south wall of the Engineering Annex was shifted slightly north of its original location in order to accommodate the Mechanical Engineering Building. Existing wood framing and roof structure for the Engineering Annex were anchored to this new end wall. Stepped wall projections along the north wall of the Mechanical Engineering Building transition to the counter flashing over the cavity between the two buildings and the parapet of the new end wall. Brick cladding on the side walls of the Engineering Annex was rebuilt and the southernmost windows at each floor were removed and replaced with solid, brick clad walls.

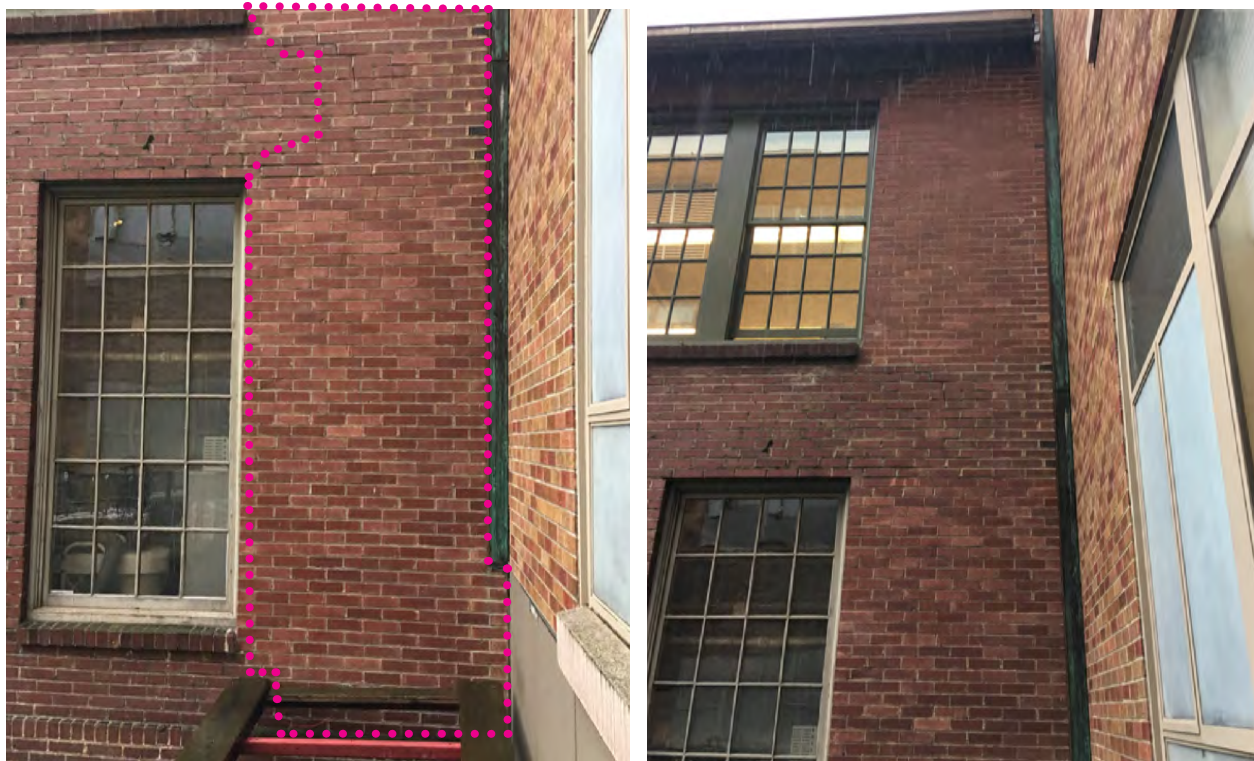
Figure 46. West facade, south end, details of 1958 brick rebuild and window removal as part of the MEB end wall connection.

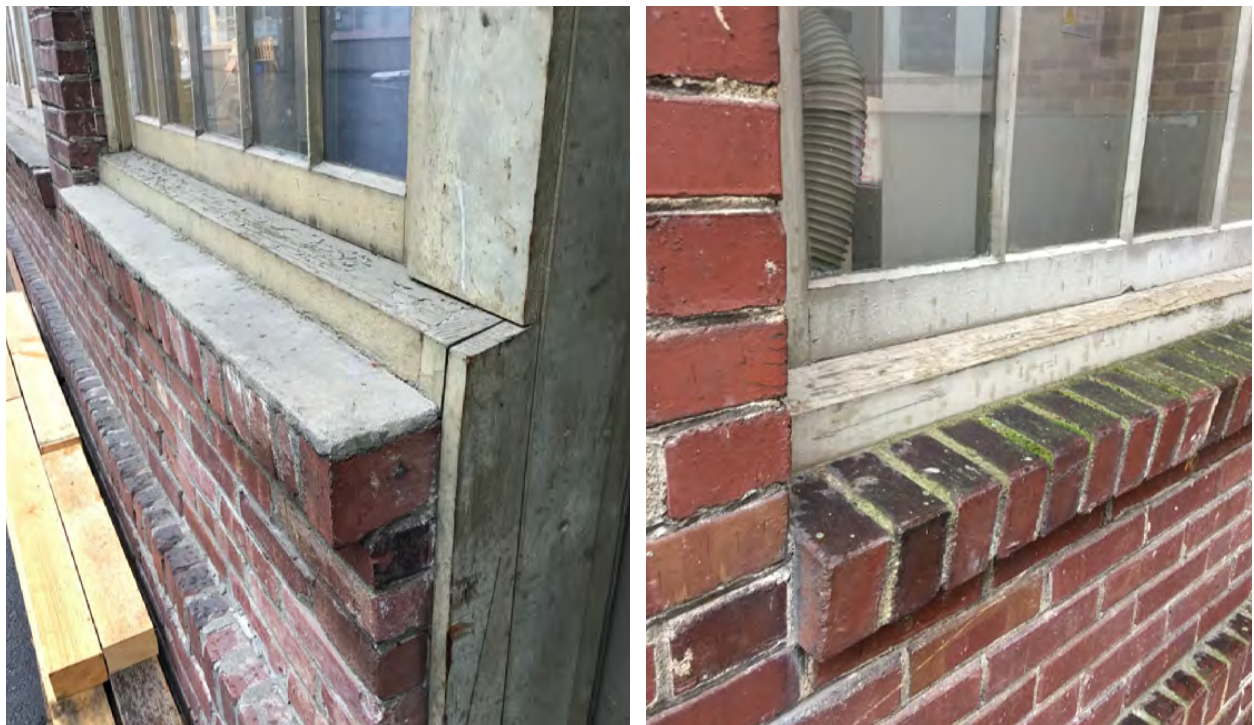
Figure 47. 1909 window sill and sub sill detail with cement wash (above left) and 1920 window sill and sub sill detail (above right).

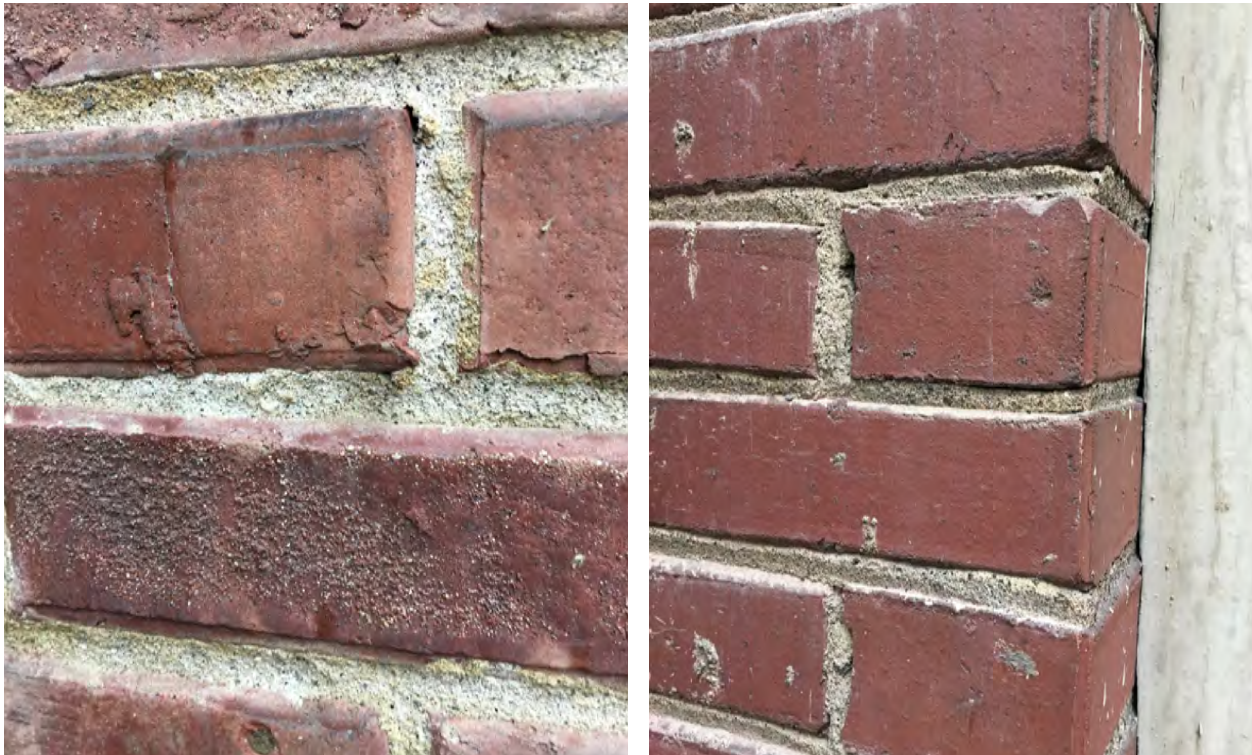
Figure 48. 1909 brick with light sand texture on surface (above left) and 1920 brick with smoother face and more uniform color (above right).

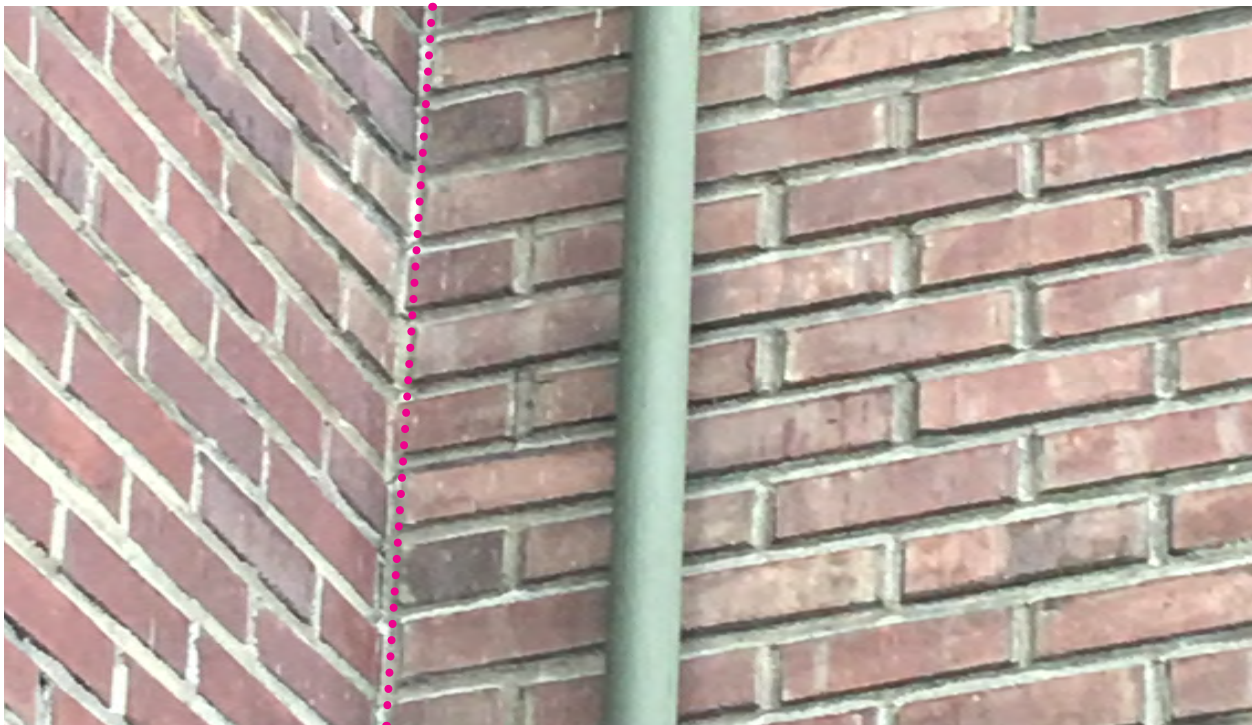
Figure 49. 1920 brick (left of dotted line) and north addition brick (right of dotted line). Note the difference in color between the two brick.

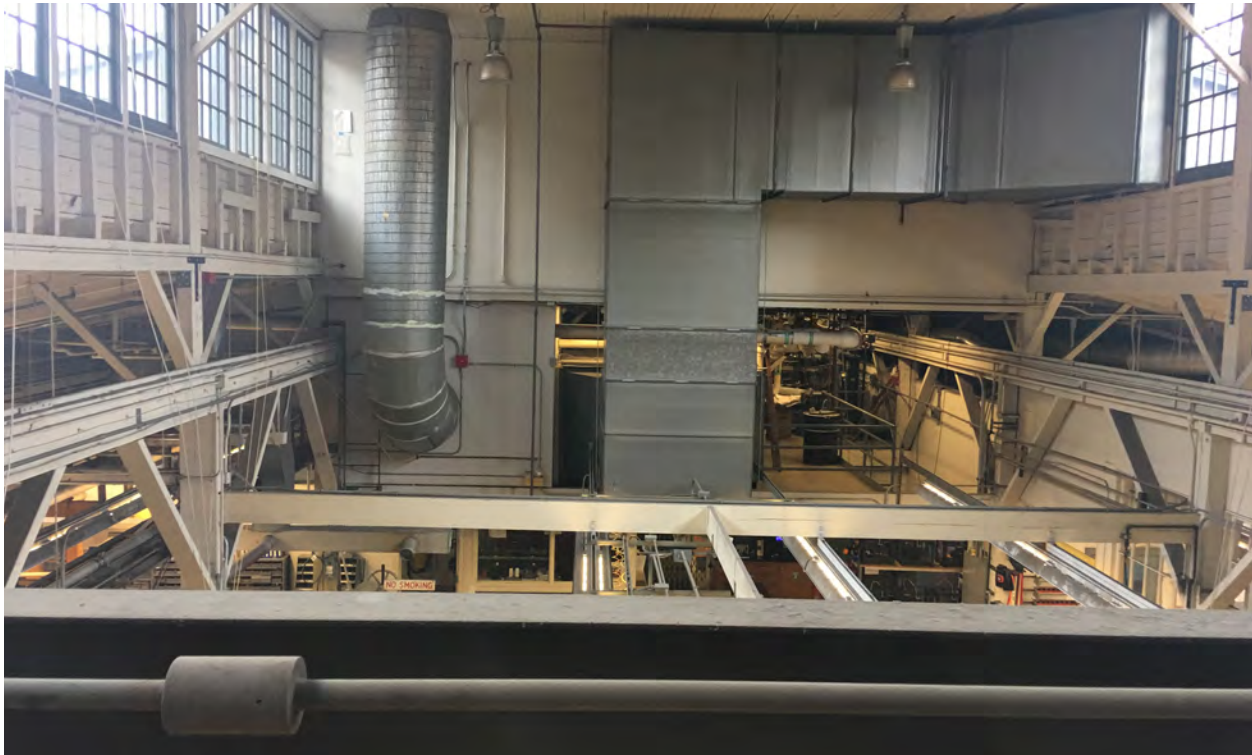
Figure 50. Main volume looking north from the mezzanine. The solid wall in the background is the original location of the wall separating the second floor from this area.

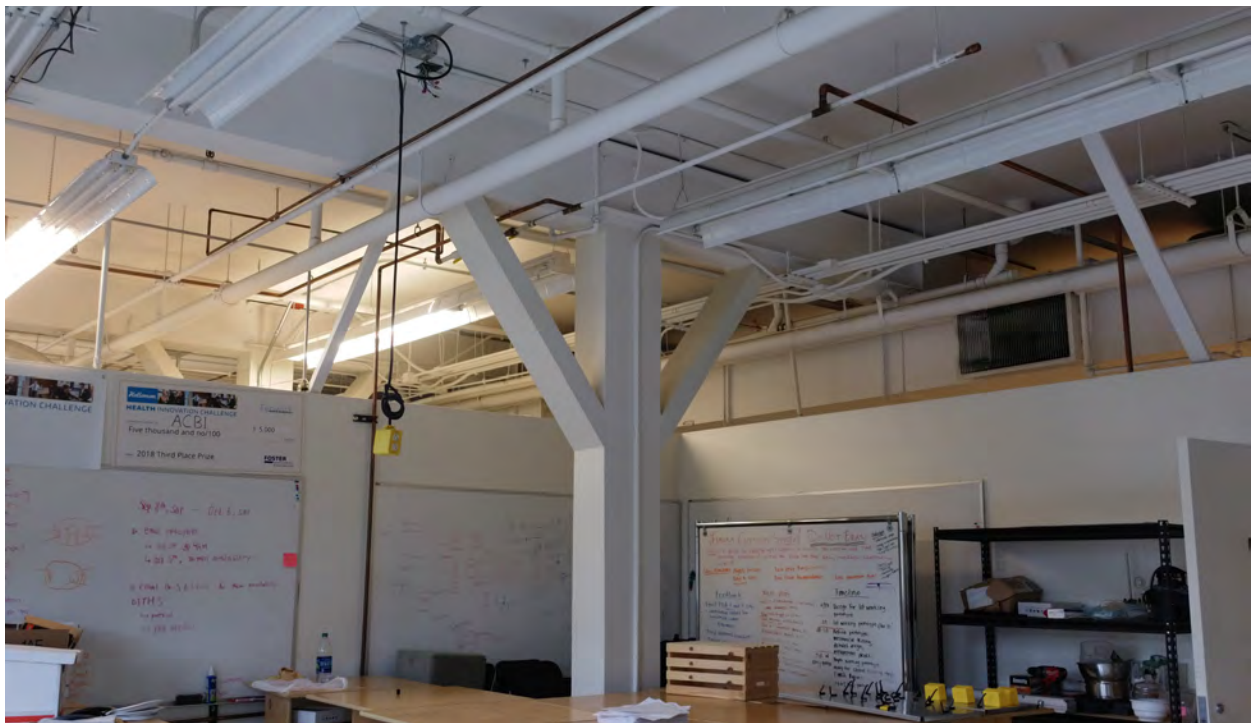
Figure 59. First floor, north end. Note the added gypsum board cladding at the timber elements.

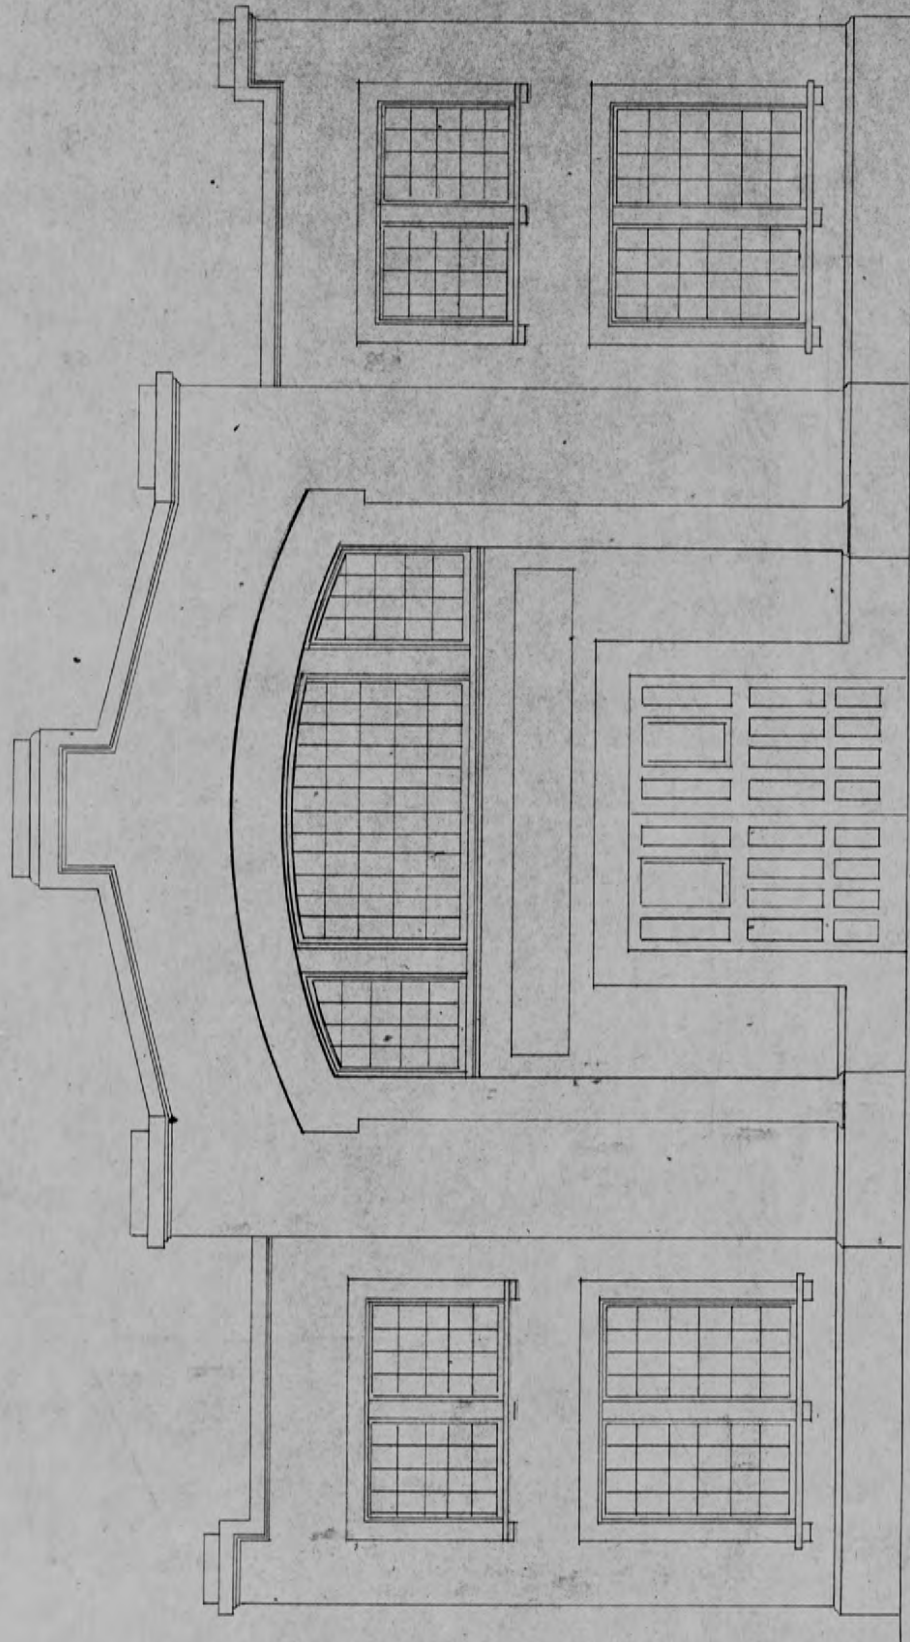
027-A-2

NORTH ELEVATION
Scale
1/4" = 10"

FOUNDRY BUILDING
for
U. of W.
W. A. G. PLACE ARCHITECT
