Name: Alaska-Yukon-Pacific Exposition Foundry,
UW Engineering Annex

Foundry (Engineering Annex)

UNIVERSITY OF WASHINGTON

April 2019

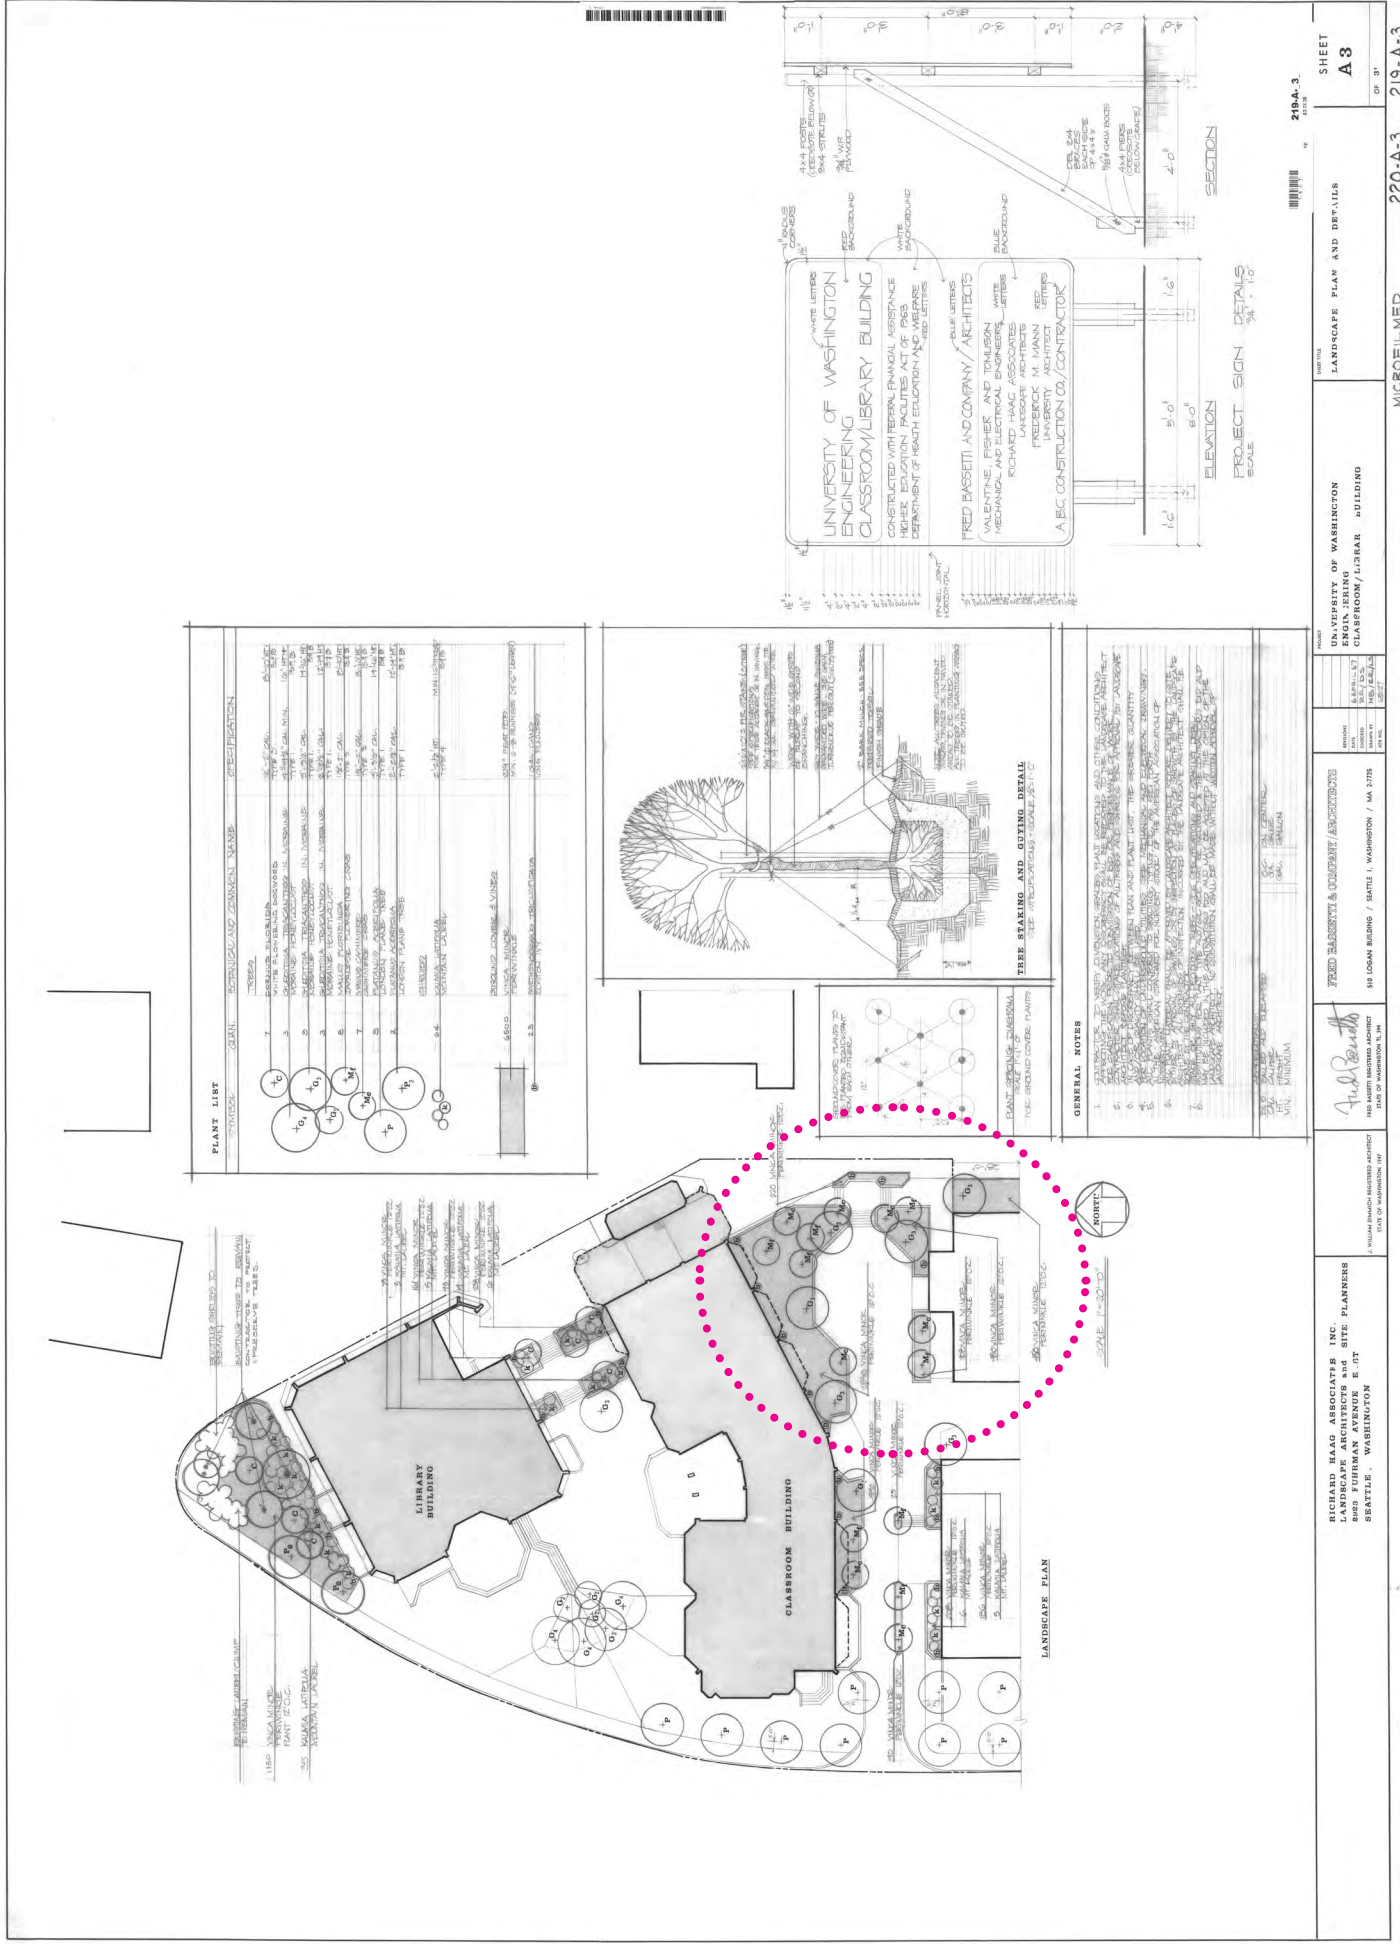
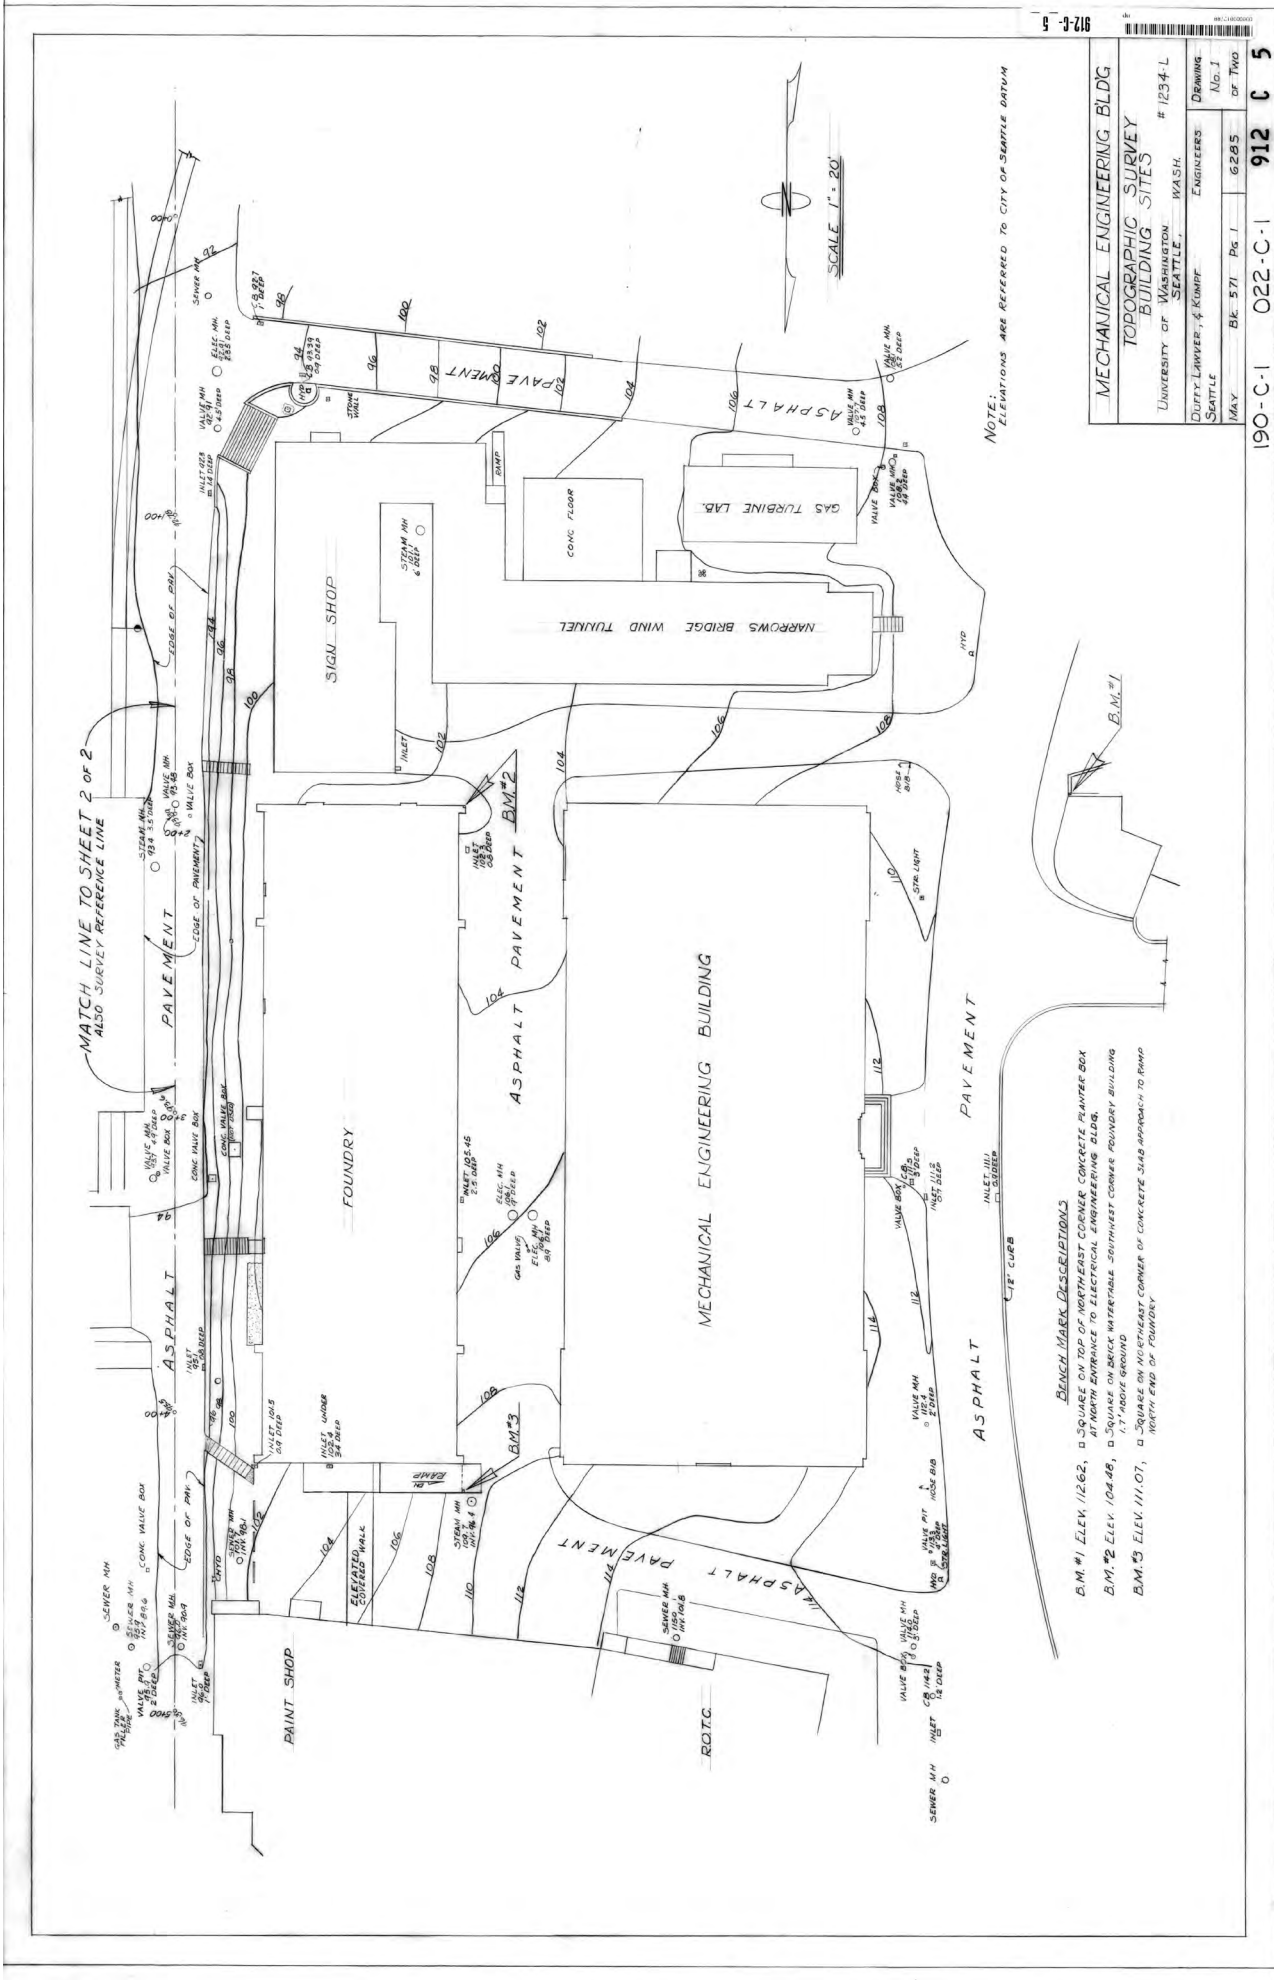
Figure 78. Loew Hall landscape plan (1967), with landscape changes in front of the Engineering Annex circled.

The landscape consists of small beds at the north end of the site, and a narrow 15-foot-wide, steeply sloped strip along the east facade that runs the length of the building. The service court space along the west side of the building is paved up to the foundation. **(Figure 78)**

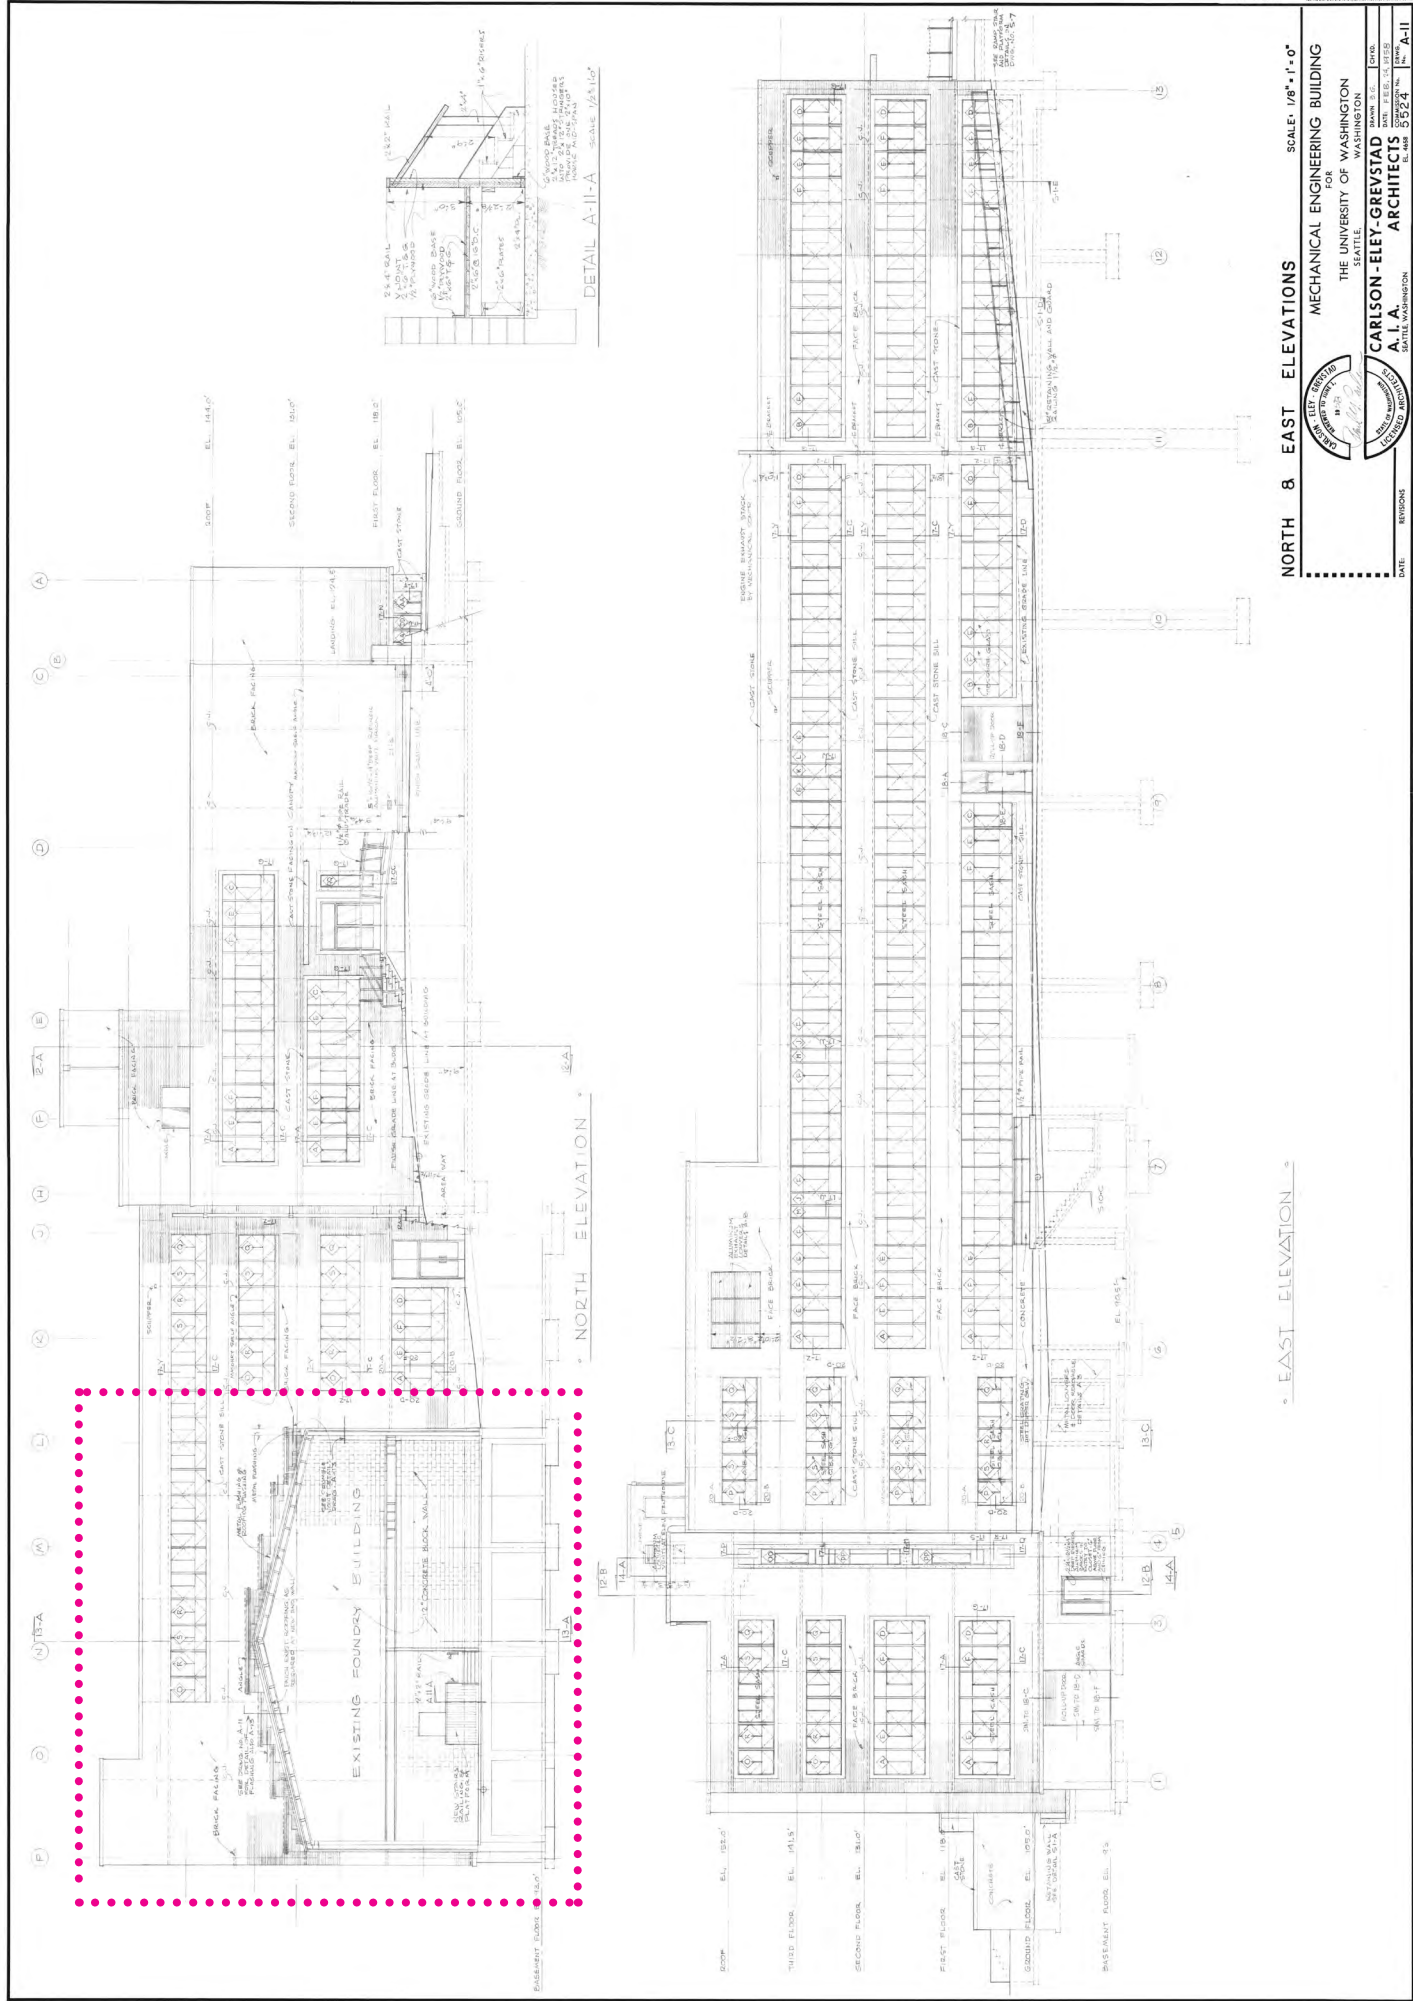
190 A 13

Figure 80. 1958 Mechanical Engineering Building showing the new south end-wall for the Engineering Annex.

NORTH 8 EAST ELEVATIONS SCALE: 1/8" = 1'-0"

MECHANICAL ENGINEERING BUILDING
FOR
THE UNIVERSITY OF WASHINGTON
SEATTLE

Connecting the Mechanical Engineering Building's southeast wing to the south end of the Engineering Annex required removal of the south end wall, and approximately 5 to 8 feet of the side walls, of the Engineering Annex. A new reinforced concrete block wall and associated foundation was built as the new south end wall for the Engineering Annex with a six-inch air space between this end wall and the concrete structure of the Mechanical Engineering Building. The location for the new south wall of the Engineering Annex was shifted slightly north of its original location in order to accommodate the Mechanical Engineering Building. Existing wood framing and roof structure for the Engineering Annex were anchored to this new end wall. Stepped wall projections along the north wall of the Mechanical Engineering Building transition to the counter flashing over the cavity between the two buildings and the parapet of the new end wall. Brick cladding on the side walls of the Engineering Annex was rebuilt and the southernmost windows at each floor were removed and replaced with solid, brick clad walls.
